# **Ganatsekiagon Creek Parcel 24 Erosion Threshold Analysis**

**TACCGATE Parcel 24 Whitevale East  
Pickering, Ontario**

Submitted:  
**August 7, 2025**

GEO Morphix Project No. 24118

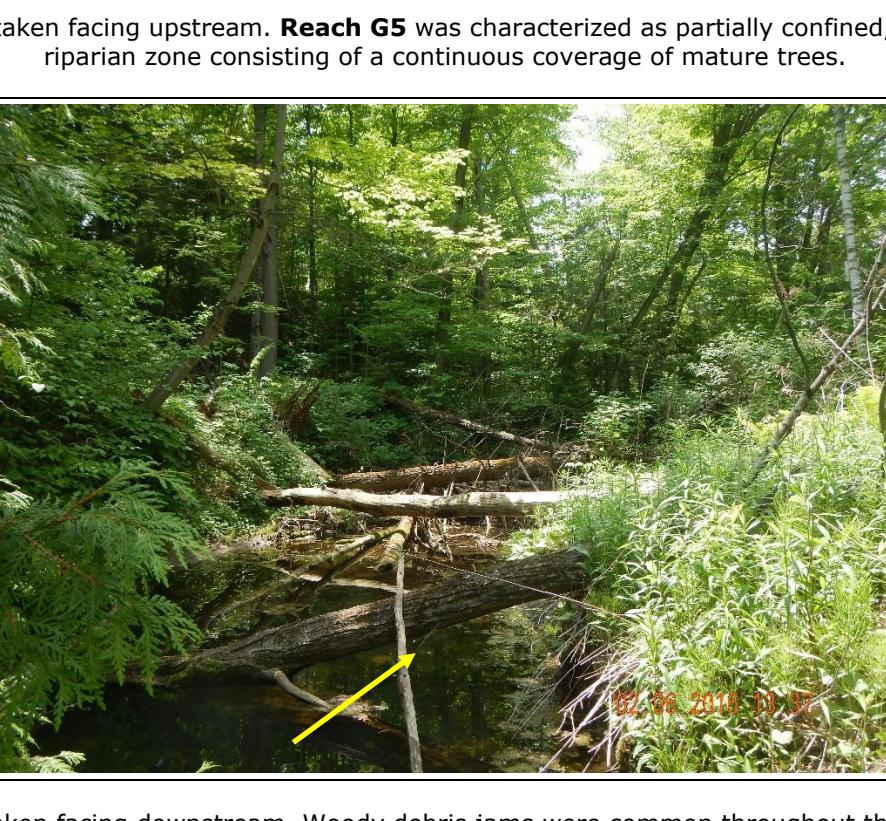
<p><b>Photo 2</b> Seaton Parcel 24, TACC Developments, Pickering, Ontario <b>Reach G5</b></p>

<p>Photo taken facing downstream. Woody debris jams were common throughout the reach, resulting in accumulation and deposition of sand and gravel.</p>

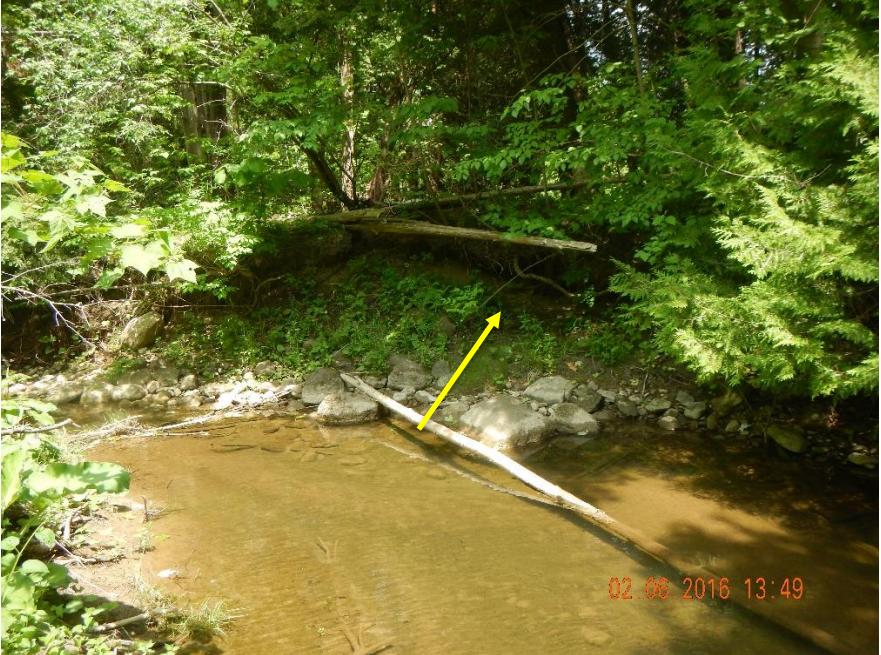
<p><b>Photo 3</b> Seaton Parcel 24, TACC Developments, Pickering, Ontario <b>Reach G5</b></p>

<p>Photo taken facing downstream. An occurrence of valley wall contact was identified in <b>Reach G5</b>.</p>
<p><b>Photo 4</b> Seaton Parcel 24, TACC Developments, Pickering, Ontario <b>Reach G5</b></p>

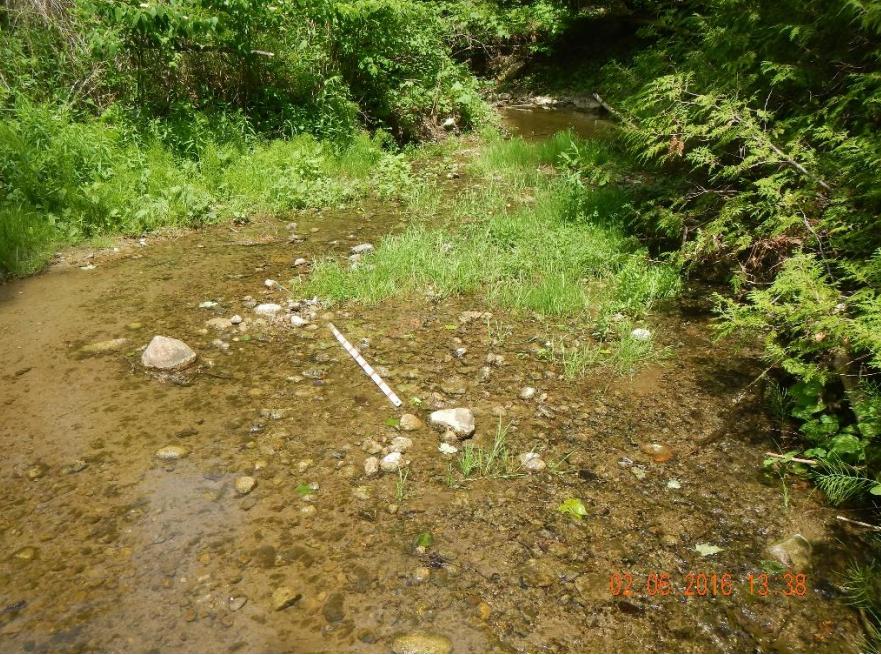
<p>Photo taken facing downstream. Bed substrate ranged from sand to cobbles and small boulders.</p>

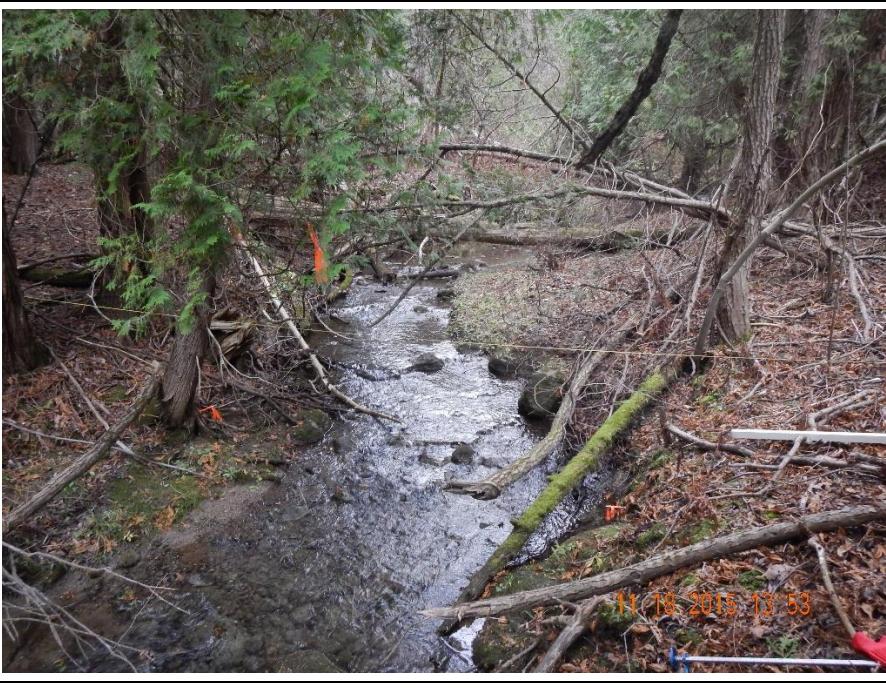
<p><b>Photo 5</b> Seaton Parcel 24, TACC Developments, Pickering, Ontario <b>Reach G6</b></p>

<p>Photo taken facing upstream. <b>Reach G6</b> flowed through a partially confined valley, with a wide and continuous riparian zone consisting of mature trees.</p>

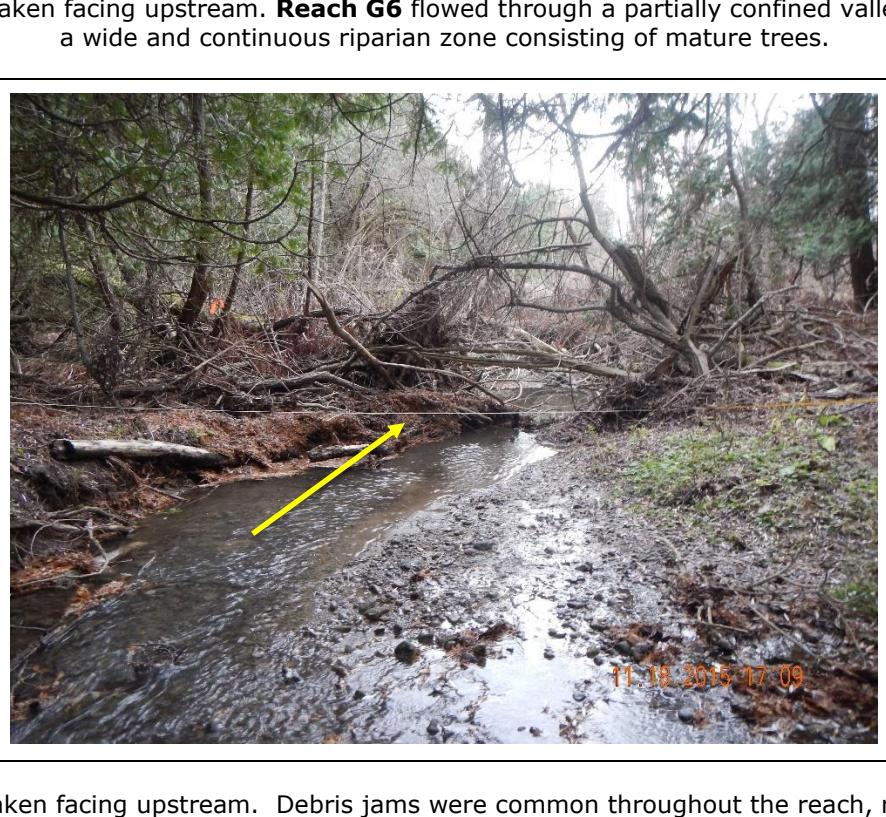
<p>Photo taken facing upstream. Debris jams were common throughout the reach, resulting in deposits of sand and gravel.</p>

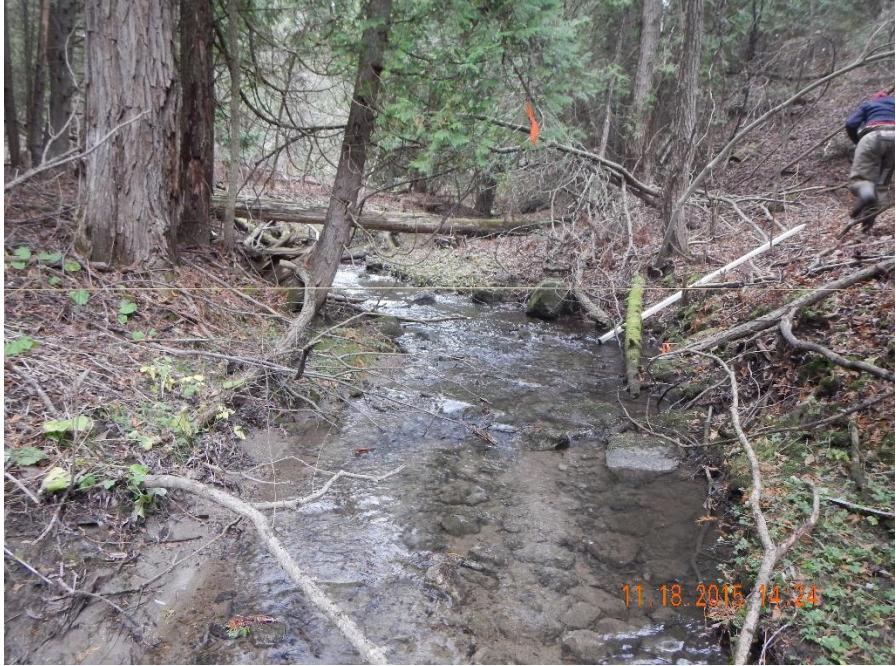
<p><b>Photo 7</b> Seaton Parcel 24, TACC Developments, Pickering, Ontario Reach G6</p>

<p>Photo taken facing upstream. Bed substrate consisted of sand, gravel and cobbles.</p>

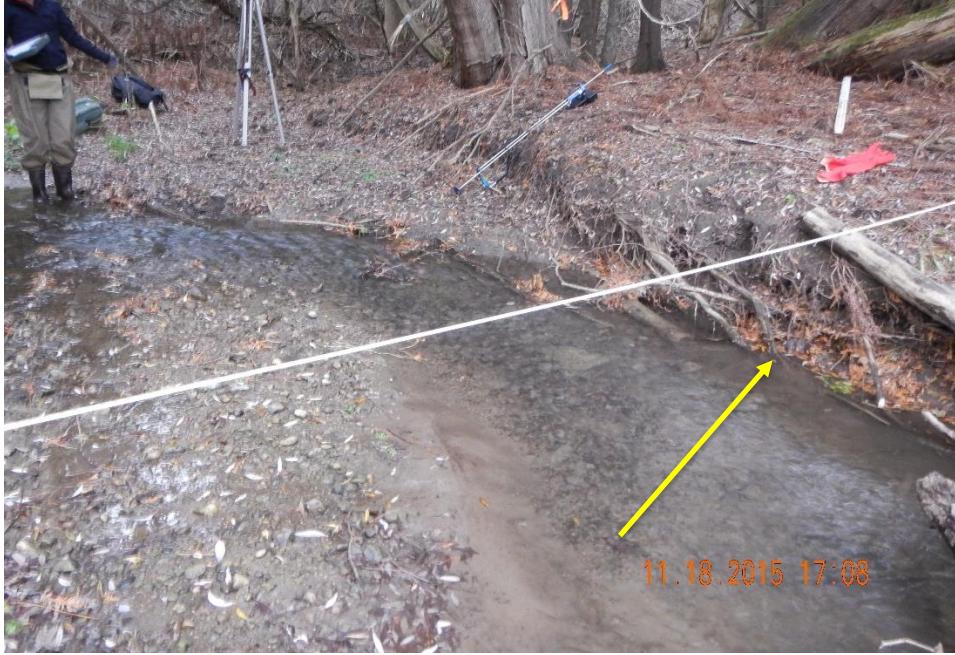
<p>Photo taken facing the left bank. Undercutting was identified along the banks, and exposed roots were present throughout.</p>

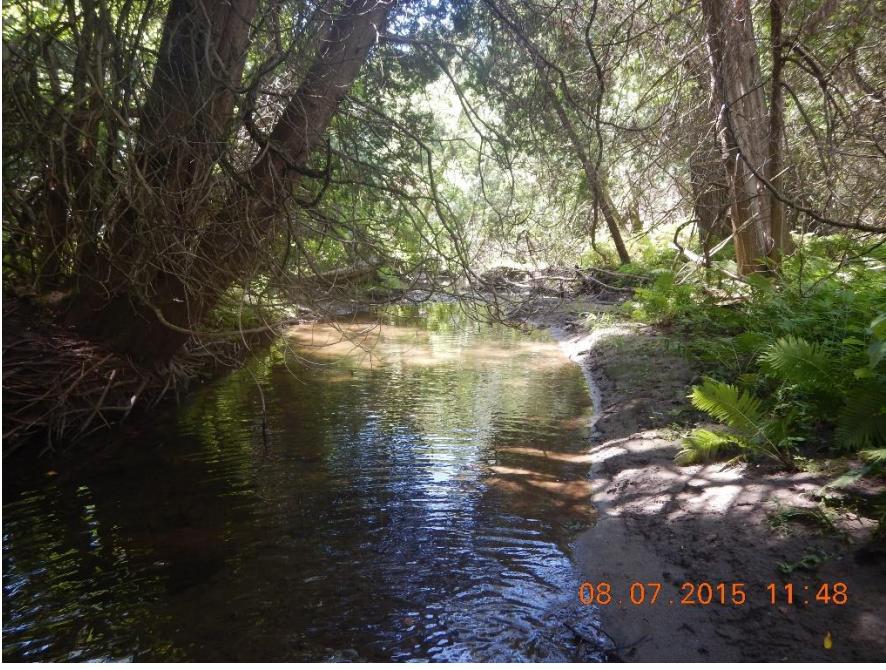
<p><b>Photo 9</b> Seaton Parcel 24, TACC Developments, Pickering, Ontario <b>Reach G7</b></p>

<p>08.07.2015 11:48</p>
	<p>Photo taken facing downstream. <b>Reach G7</b> flowed through an unconfined valley with a wide, continuous riparian zone of mature trees.</p>
<p><b>Photo 10</b> Seaton Parcel 24, TACC Developments, Pickering, Ontario <b>Reach G7</b></p>

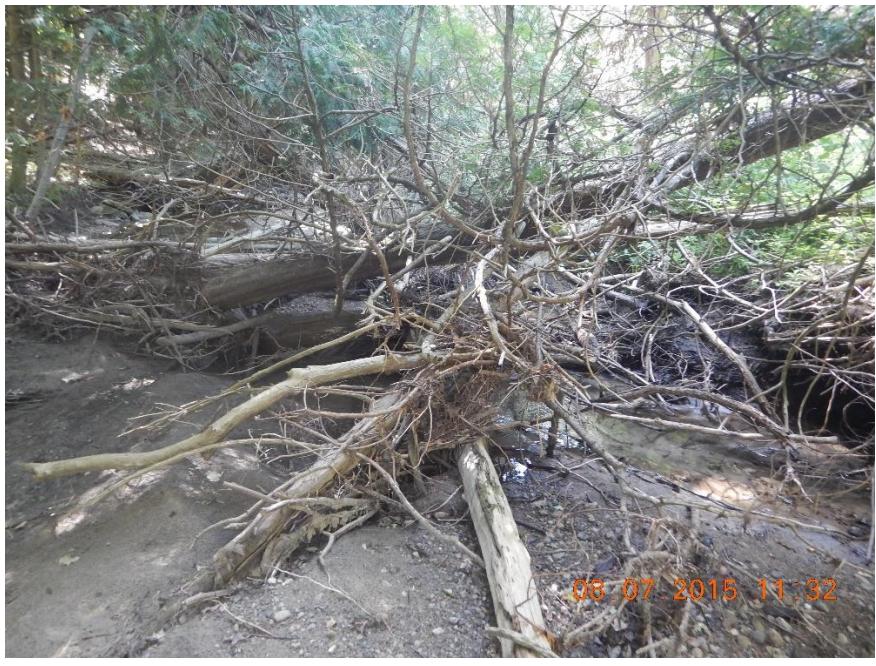
<p>08.07.2015 11:32</p>
	<p>Photo taken facing the right bank. Large woody debris was found in moderate densities throughout the reach.</p>

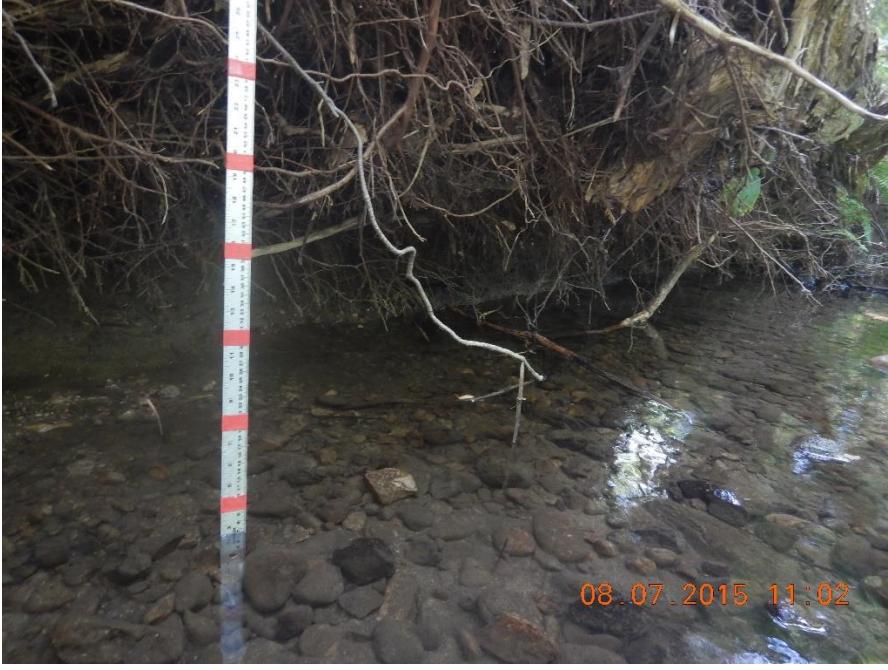
<p><b>Photo 11</b> Seaton Parcel 24, TACC Developments, Pickering, Ontario Reach G7</p>

<p>08.07.2015 11:02</p>
	<p>Photo taken facing the left bank. Undercutting of up to 40 cm was observed along 30-60% of the banks.</p>
<p><b>Photo 12</b> Seaton Parcel 24, TACC Developments, Pickering, Ontario Reach G7</p>

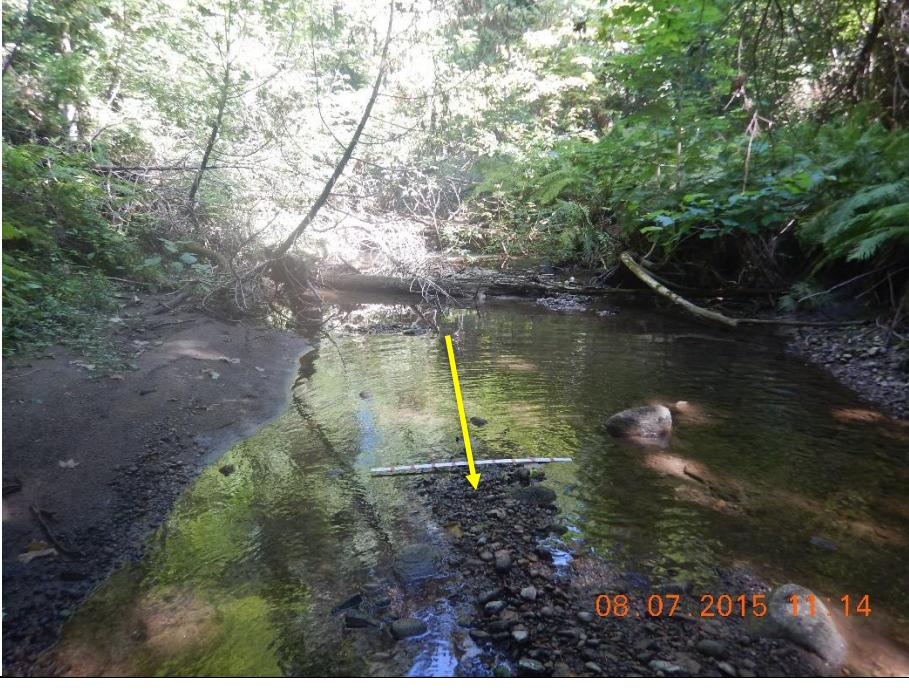
<p>08.07.2015 11:14</p>
	<p>Photo taken facing downstream. Sand, gravel and cobble deposits were commonly observed along the bed.</p>

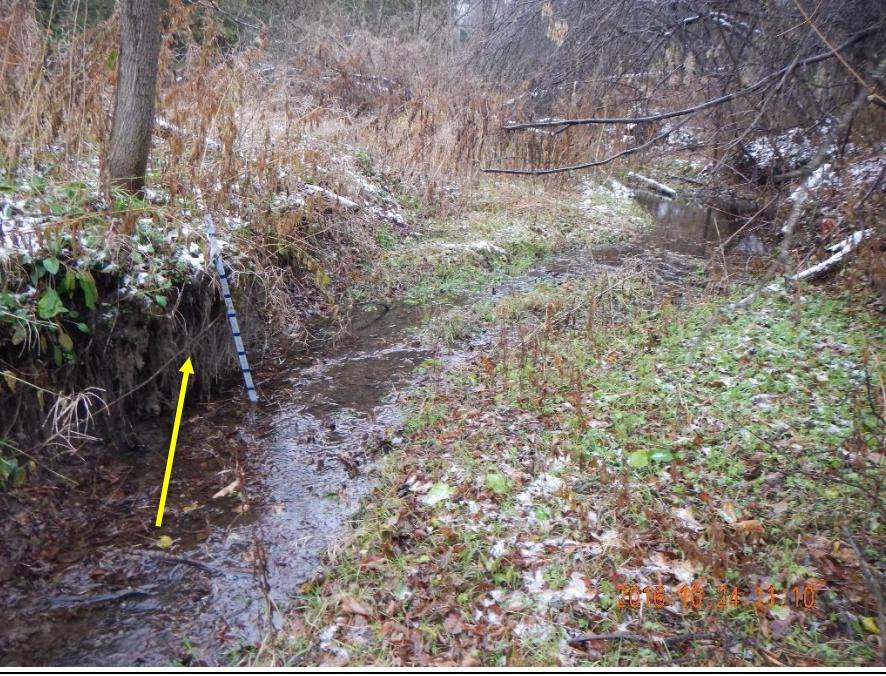
**Reach GB2** was assigned an RGA score of 0.27, indicating the reach is in transition/stress. The dominant adjustment process was widening, as evidenced by the frequent undercutting of 60-100% of the banks. The RSAT score was 24, indicating the reach is in fair condition, with channel stability as the limiting factor due to the widespread bank erosion. The Downs (1995) classification indicated that the reach is enlarging (E).

<p>2016 10 24 11 10</p> <p>Photo taken facing upstream. Undercutting was prevalent within <b>Reach GB2</b>, observed along 60-100% of the banks. Bank angles were steep along the outside of meander bends.</p>

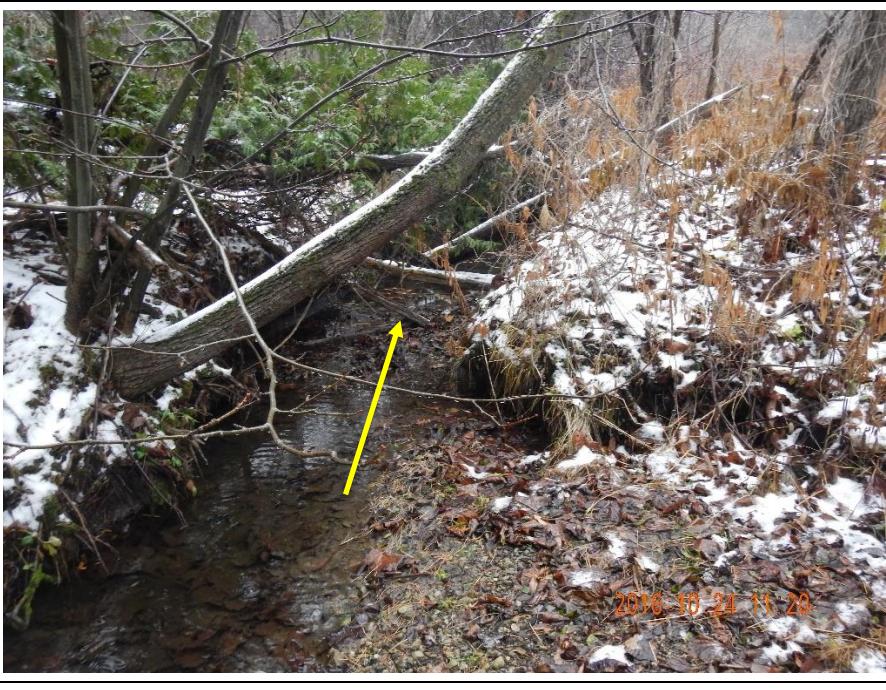
<p><b>Photo 15</b> Seaton Parcel 24, TACC Developments, Pickering, Ontario <b>Reach GB2</b></p>

<p>Photo taken facing downstream. Leaning/fallen trees and woody debris were observed throughout <b>Reach GB2</b>.</p>
<p><b>Photo 16</b> Seaton Parcel 24, TACC Developments, Pickering, Ontario <b>Reach GB2</b></p>

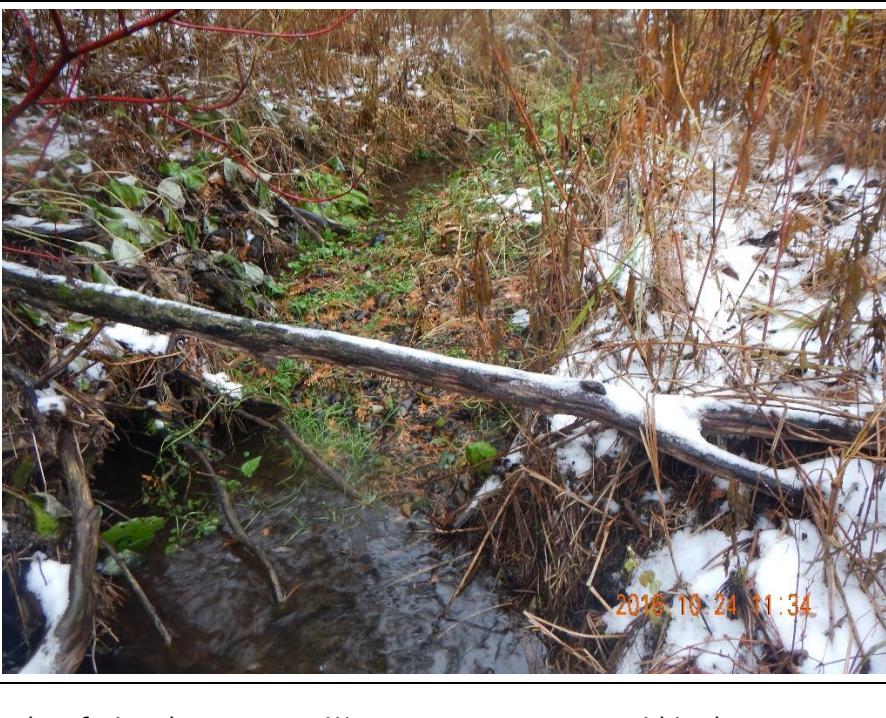
<p>Photo taken facing downstream. Watercress was present within the stream at several locations through GB2.</p>

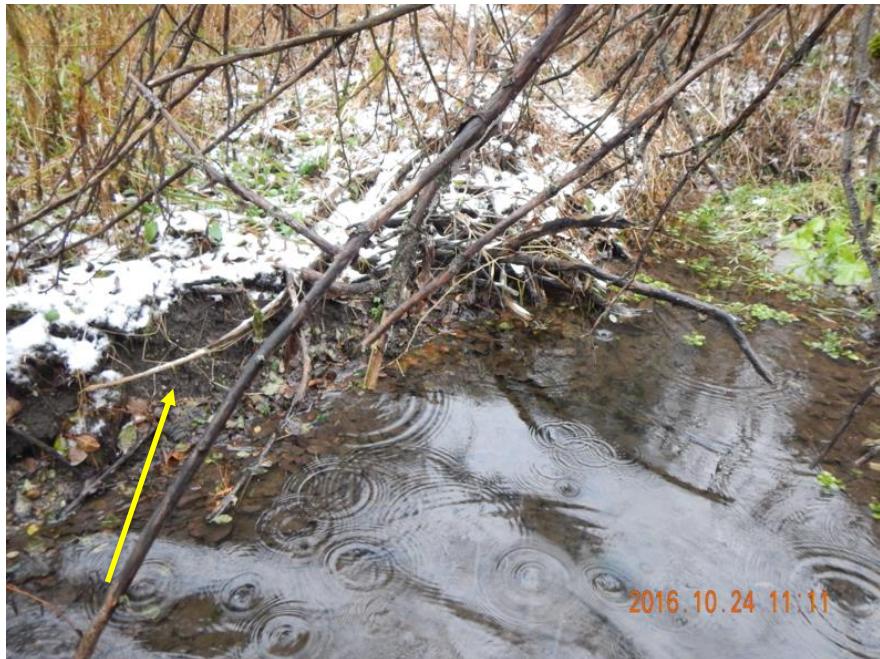
**Photo 17**  
Seaton Parcel 24, TACC Developments, Pickering, Ontario  
Reach GB2

Bank substrate consisted primarily of fairly compact lean clay, while bed materials were composed of sandy loam underlying sand and gravel deposits.
