June 11, 2025

Reference No. 2406-S114

**Re: Slope Stability Assessment  
For Proposed Residential Redevelopment  
1794 Appleview Road  
City of Pickering**

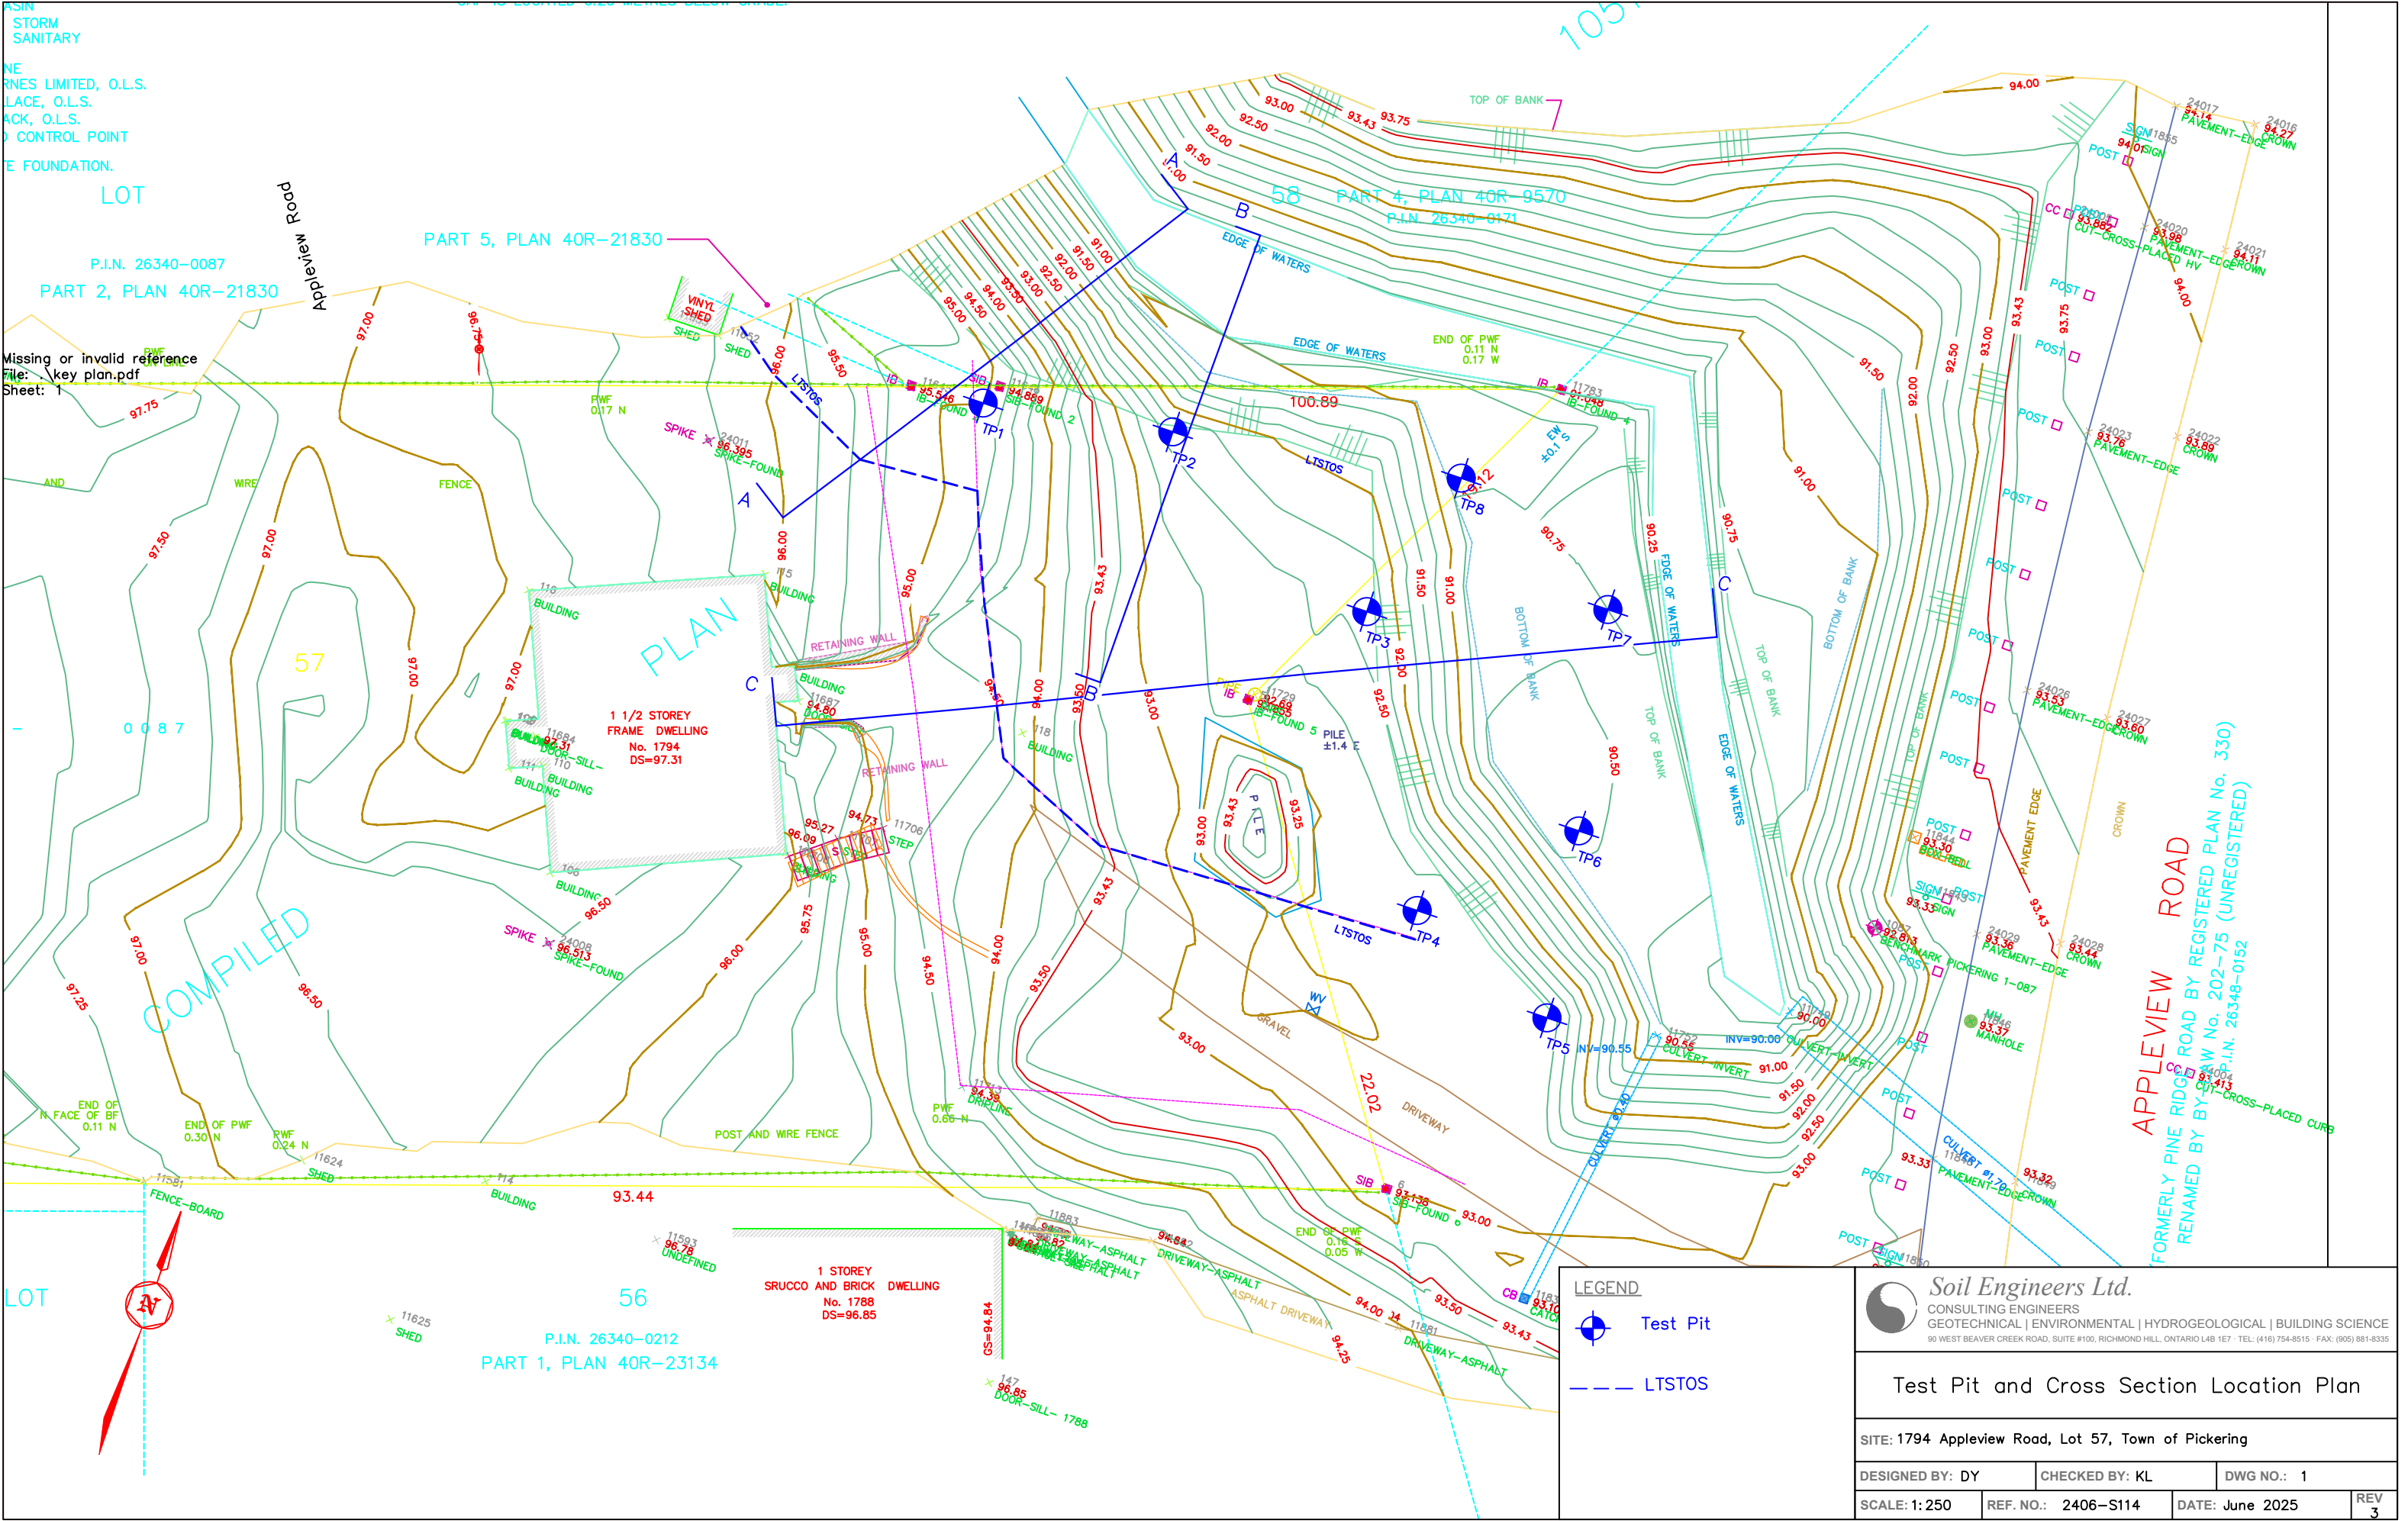
The LTSTOS, incorporating the stable slope gradient, T.E.A, as required and staked TRCA boundary, is established and is illustrated on Drawing No. 1. A development setback/Erosion Access Allowance will be required beyond the LTSTOS.

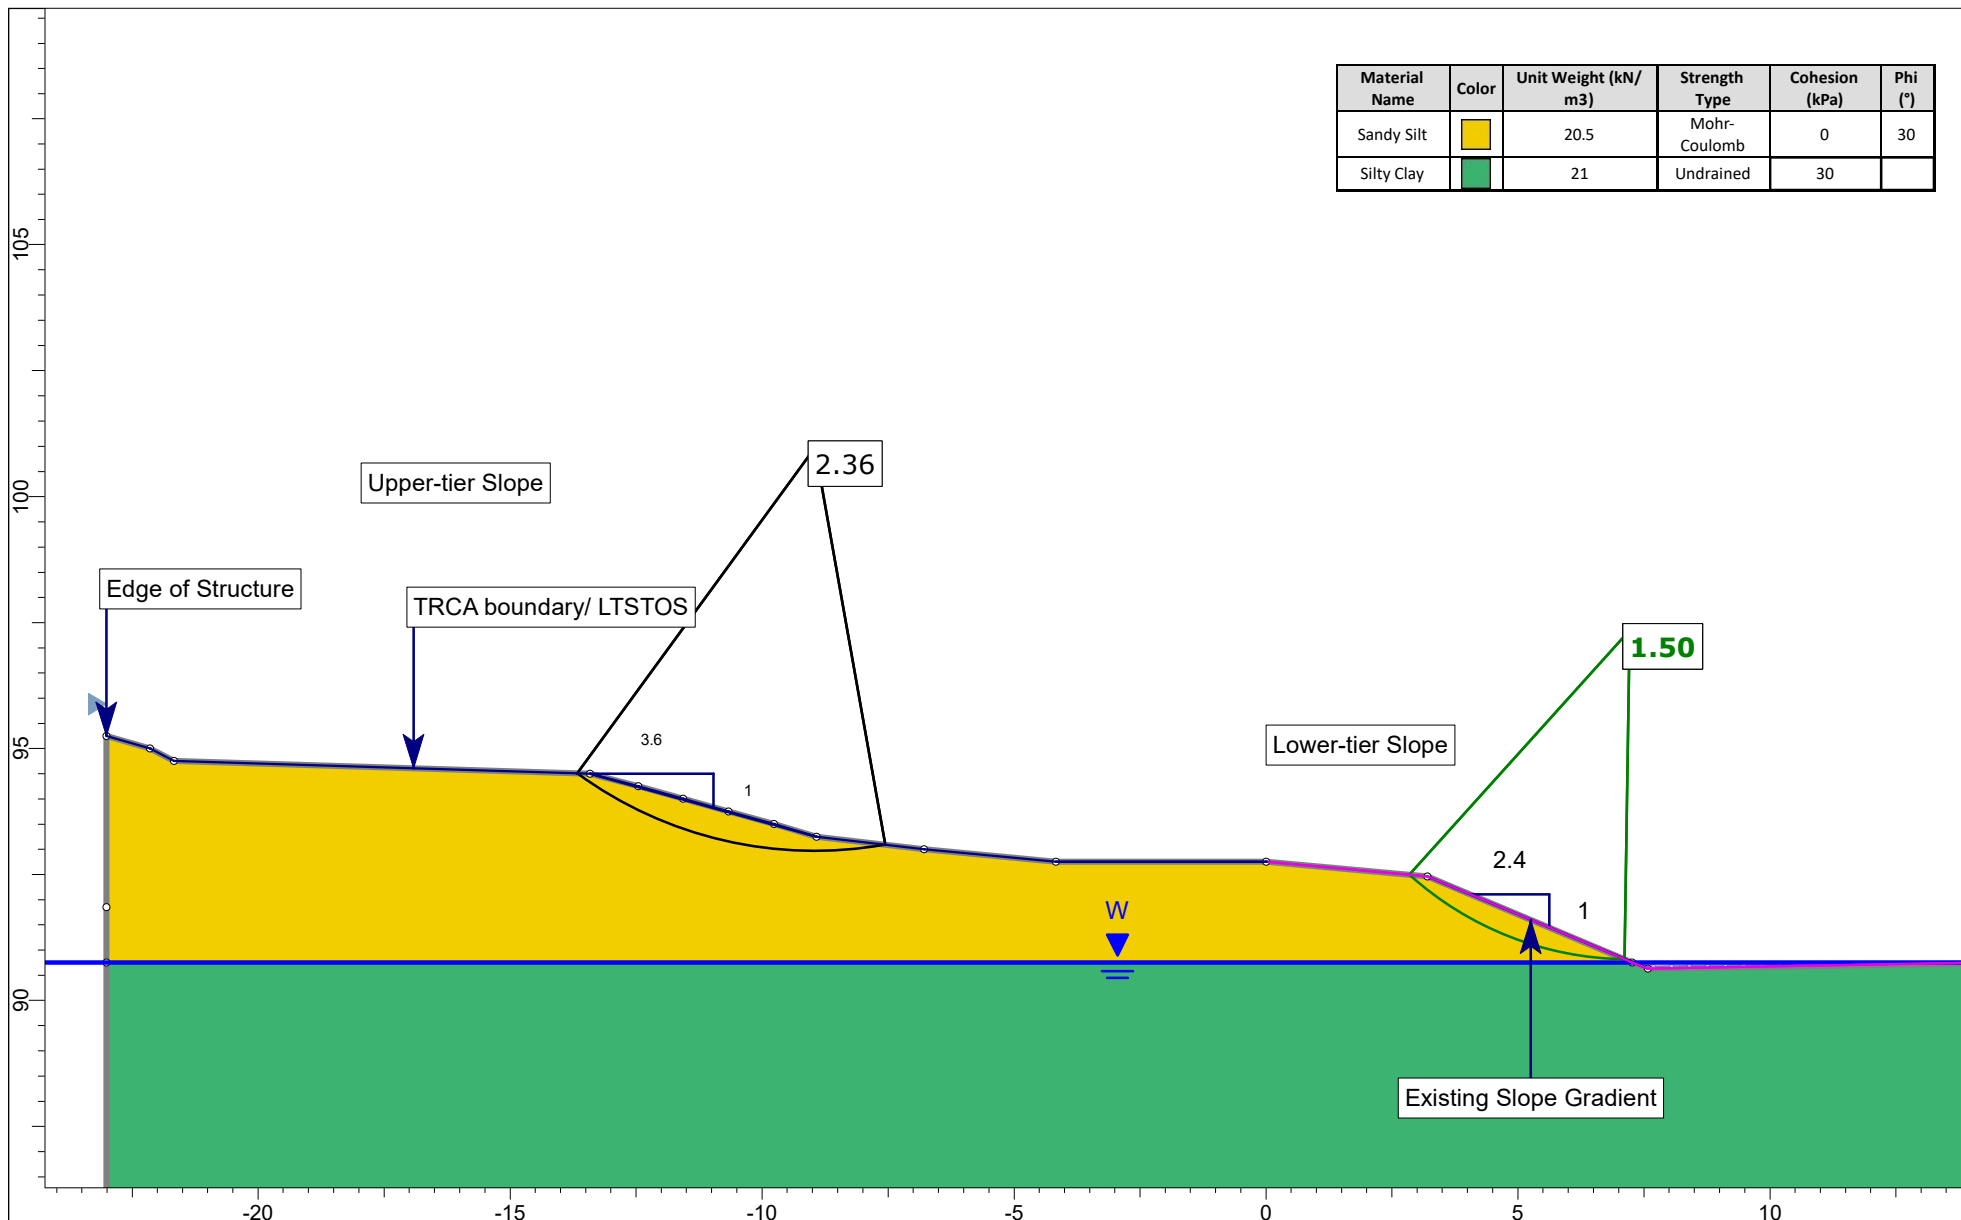
The result of the analysis at Cross-Sections A-A, under existing conditions, show that the minimum FOS is calculated to be 1.05, which fails to meet the Ontario Ministry of Natural Resources (MNR) guideline requirements for active land use (minimum FOS of 1.5), while Cross-Sections B-B and C-C yielded FOS above 1.50. The results of the analysis for the existing condition of the slope are presented on Drawing Nos. 2 to 4.

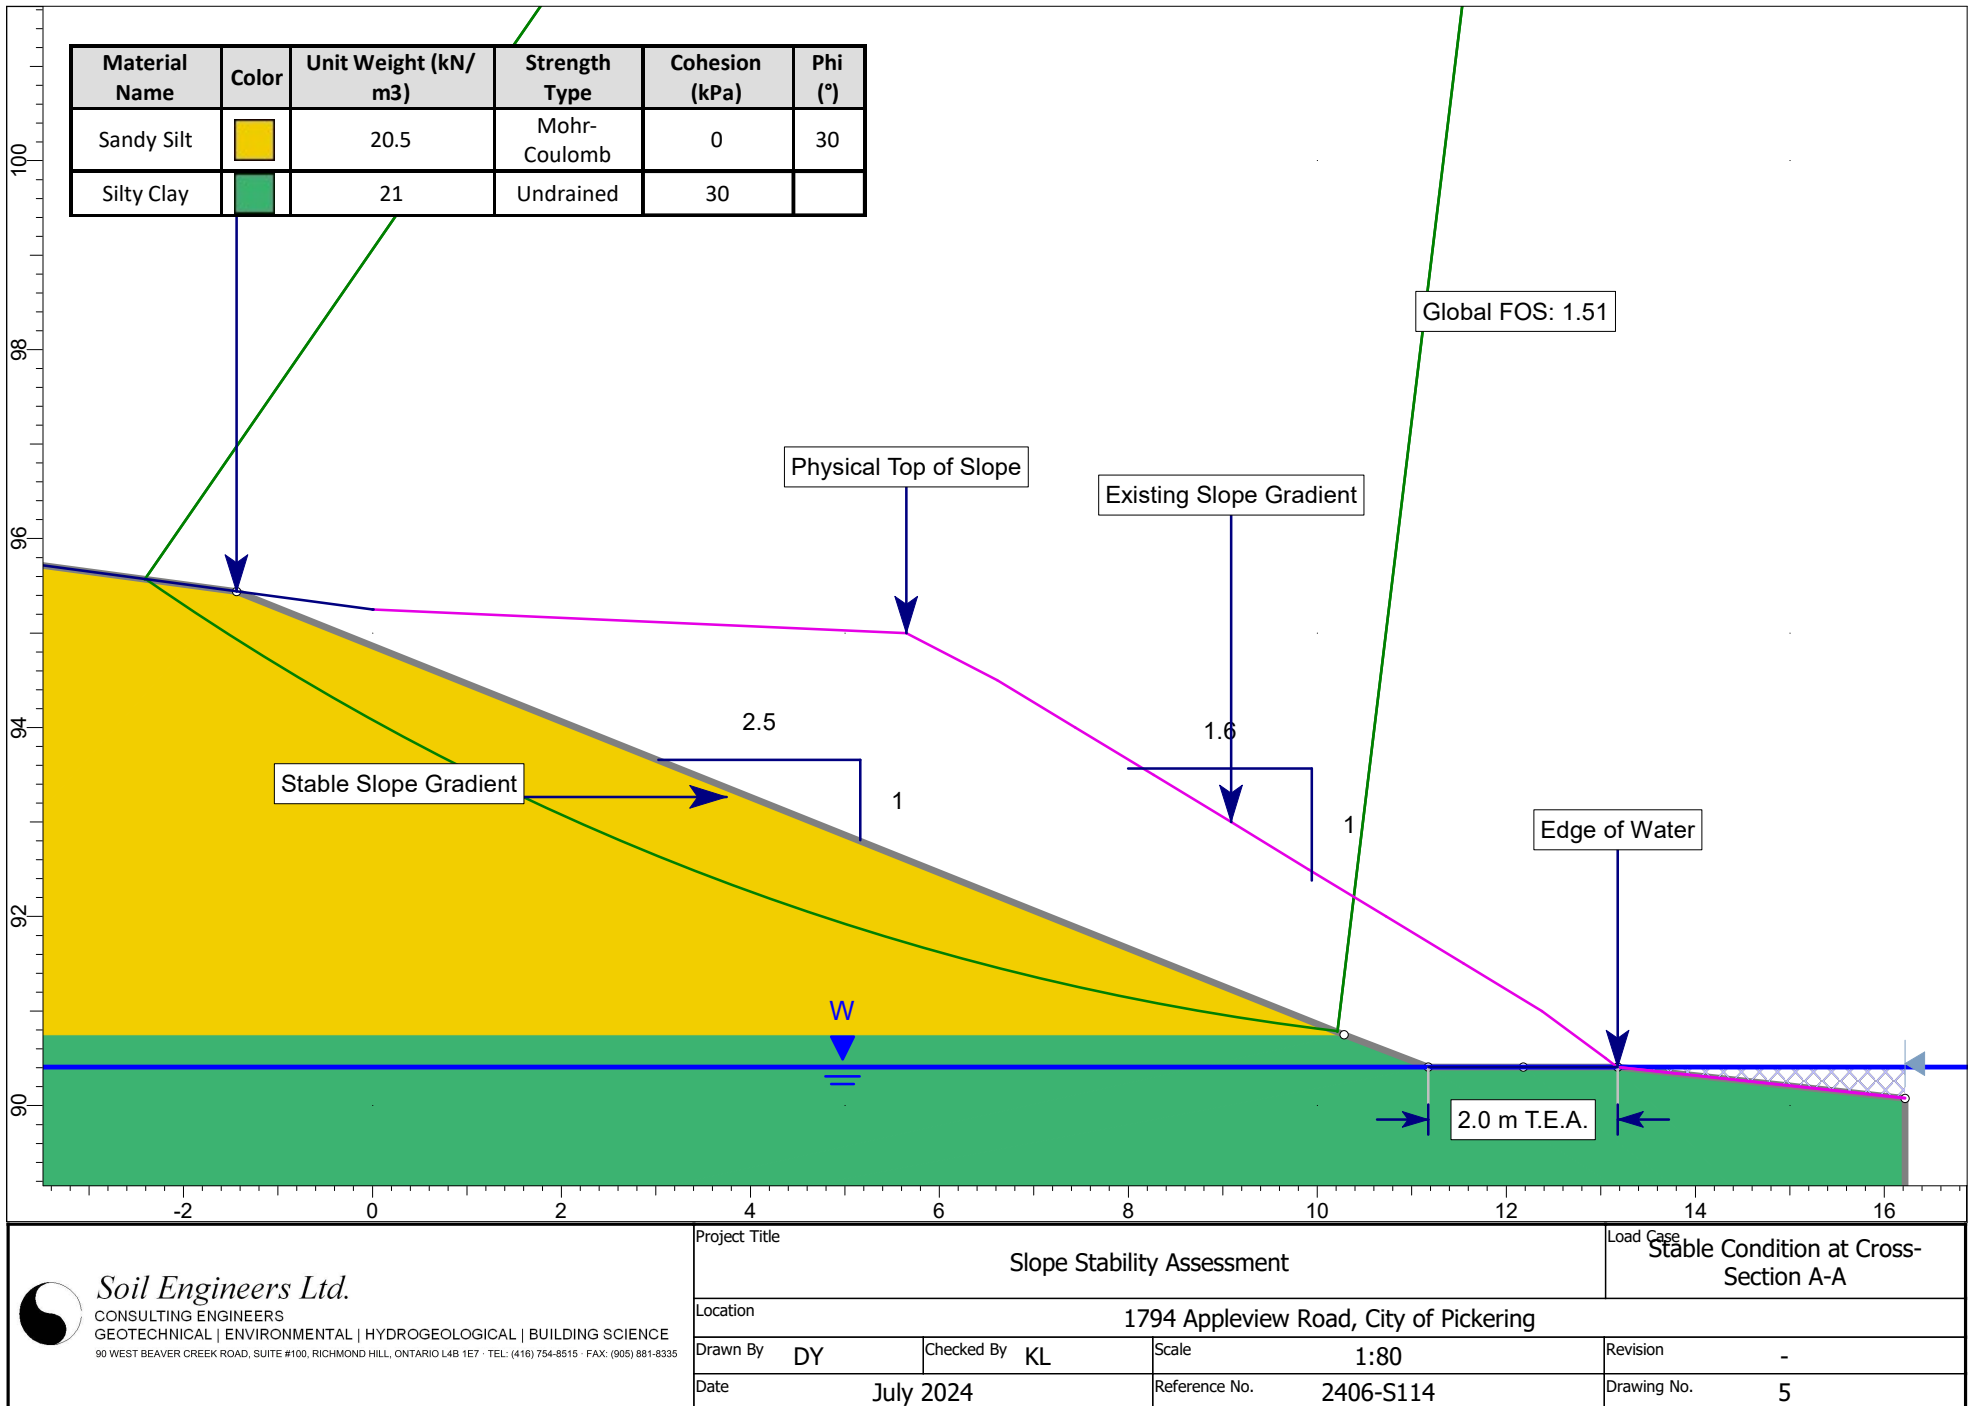
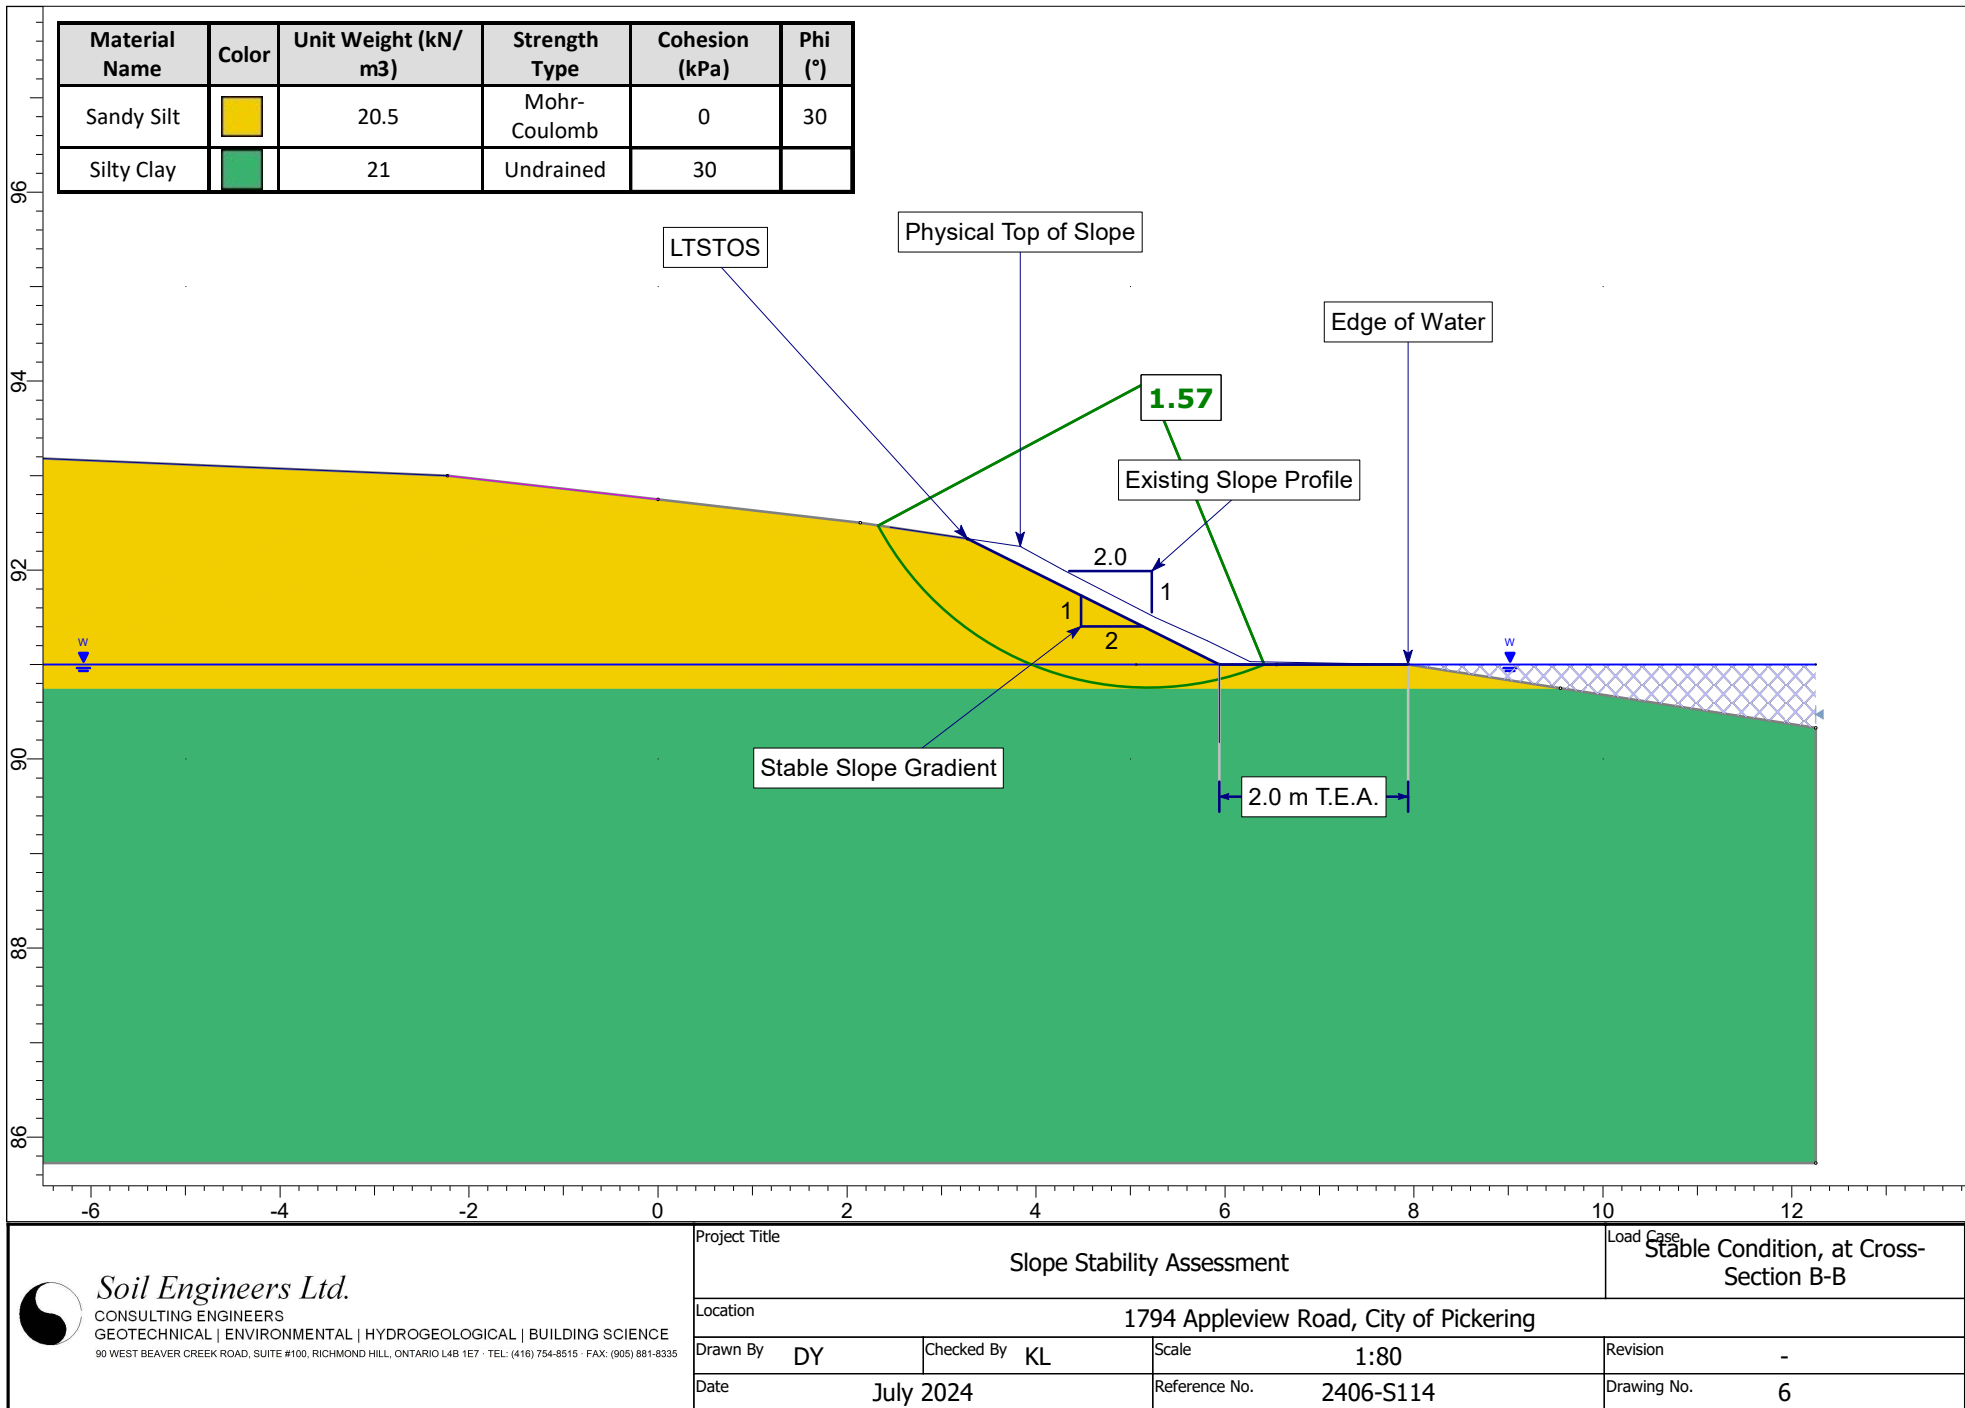
For the cross-sections having a FOS less than 1.50 and/or where insufficient T.E.A. is identified, the slope cross-sections are remodelled with the stable slope gradients along with the required T.E.A., where necessary. The analytical results of the remodelled slope section yielded minimum FOS above 1.50, which meet MNR guideline requirement for active land use. The results are summarized in the table below and are presented on Drawing Nos. 5 and 6.

Cross-Section	Stable Slope Gradient	Applied T.E.A (m)	Resulting FOS
A-A	2.5H:1V	2.0	1.51
B-B	2.0H:1V	2.0	1.57
C-C	2.4H:1V	Not Applied, due to Sufficient Flood Plain	Upper-Tier- 2.36 Lower-Tier- 1.50
