PROJECT NO: 52276

PROJECT NAME; 875 KINGSTON RD, PICKERING

DATE: 2022-08-22

Subsurface Utility Engineering CI/ASCE 38-02 Quality Levels.

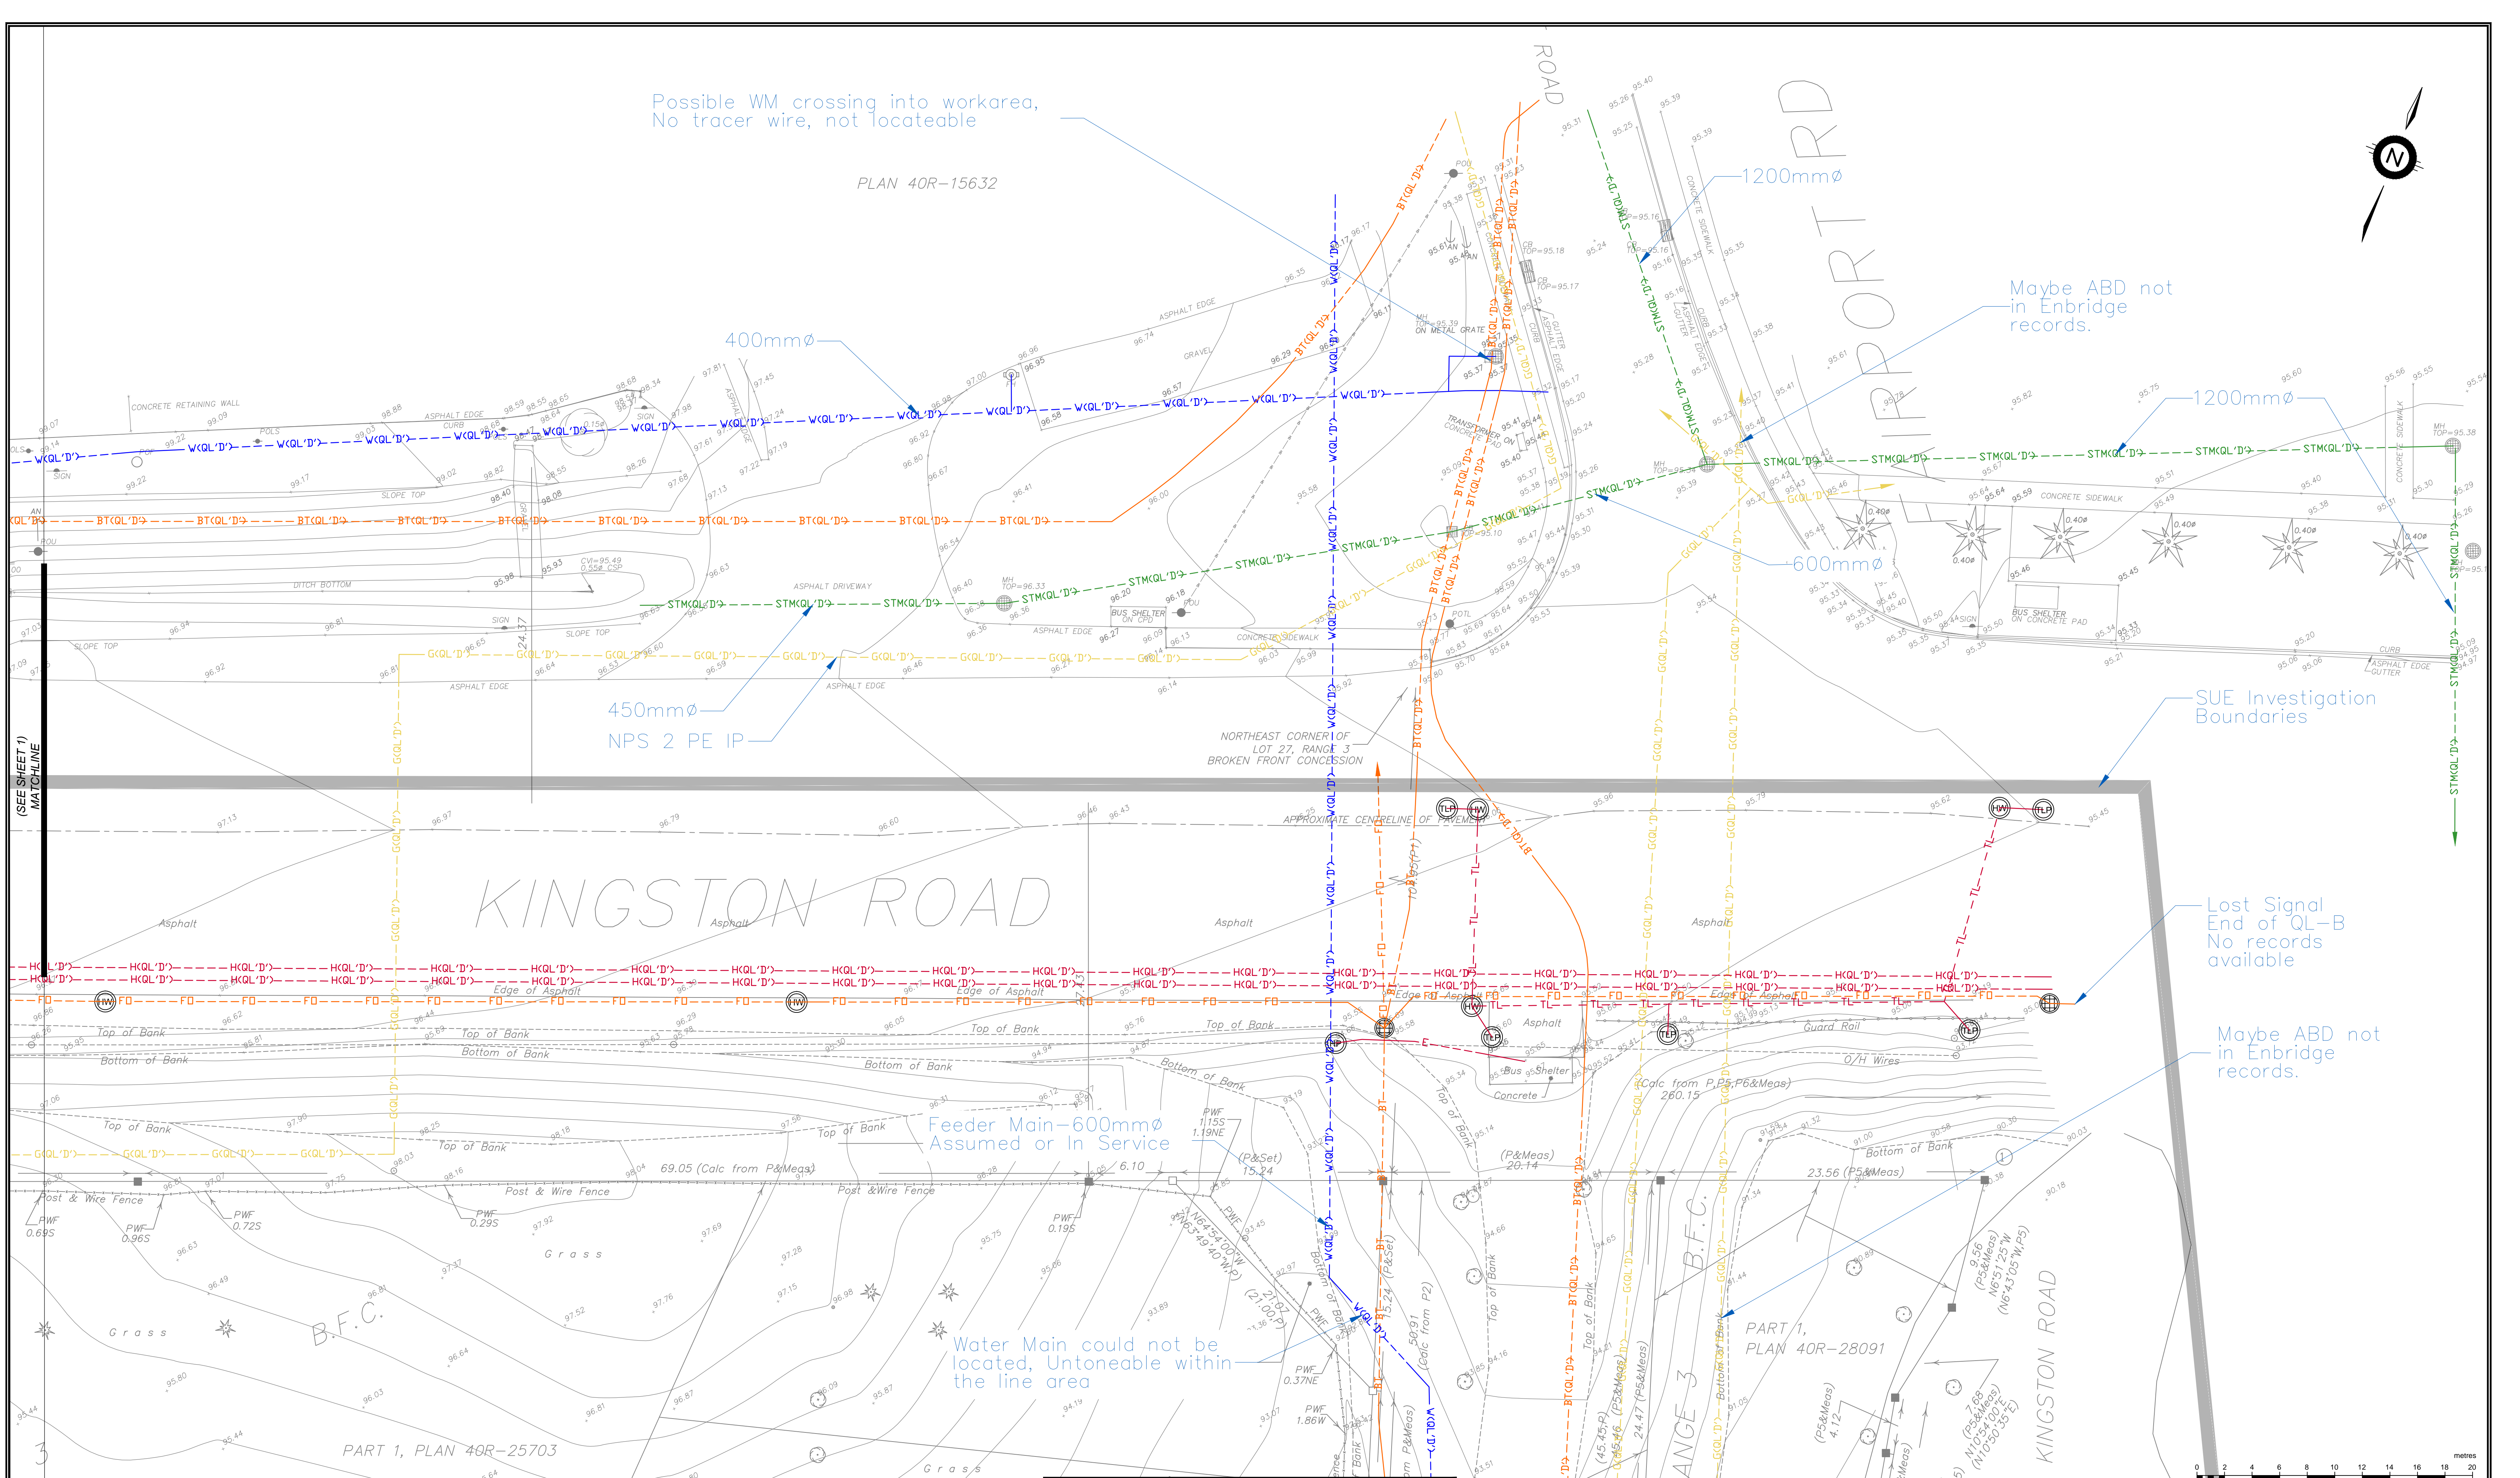
SHEET 2 of 5

Possible WM crossing into workarea,
No tracer wire, not locateable

Maybe ABD not in Enbridge records.

Lost Signal End of QL-B No records available

Feeder Main-600mm Assumed or In Service

Water Main could not be located, Untenable within the line area

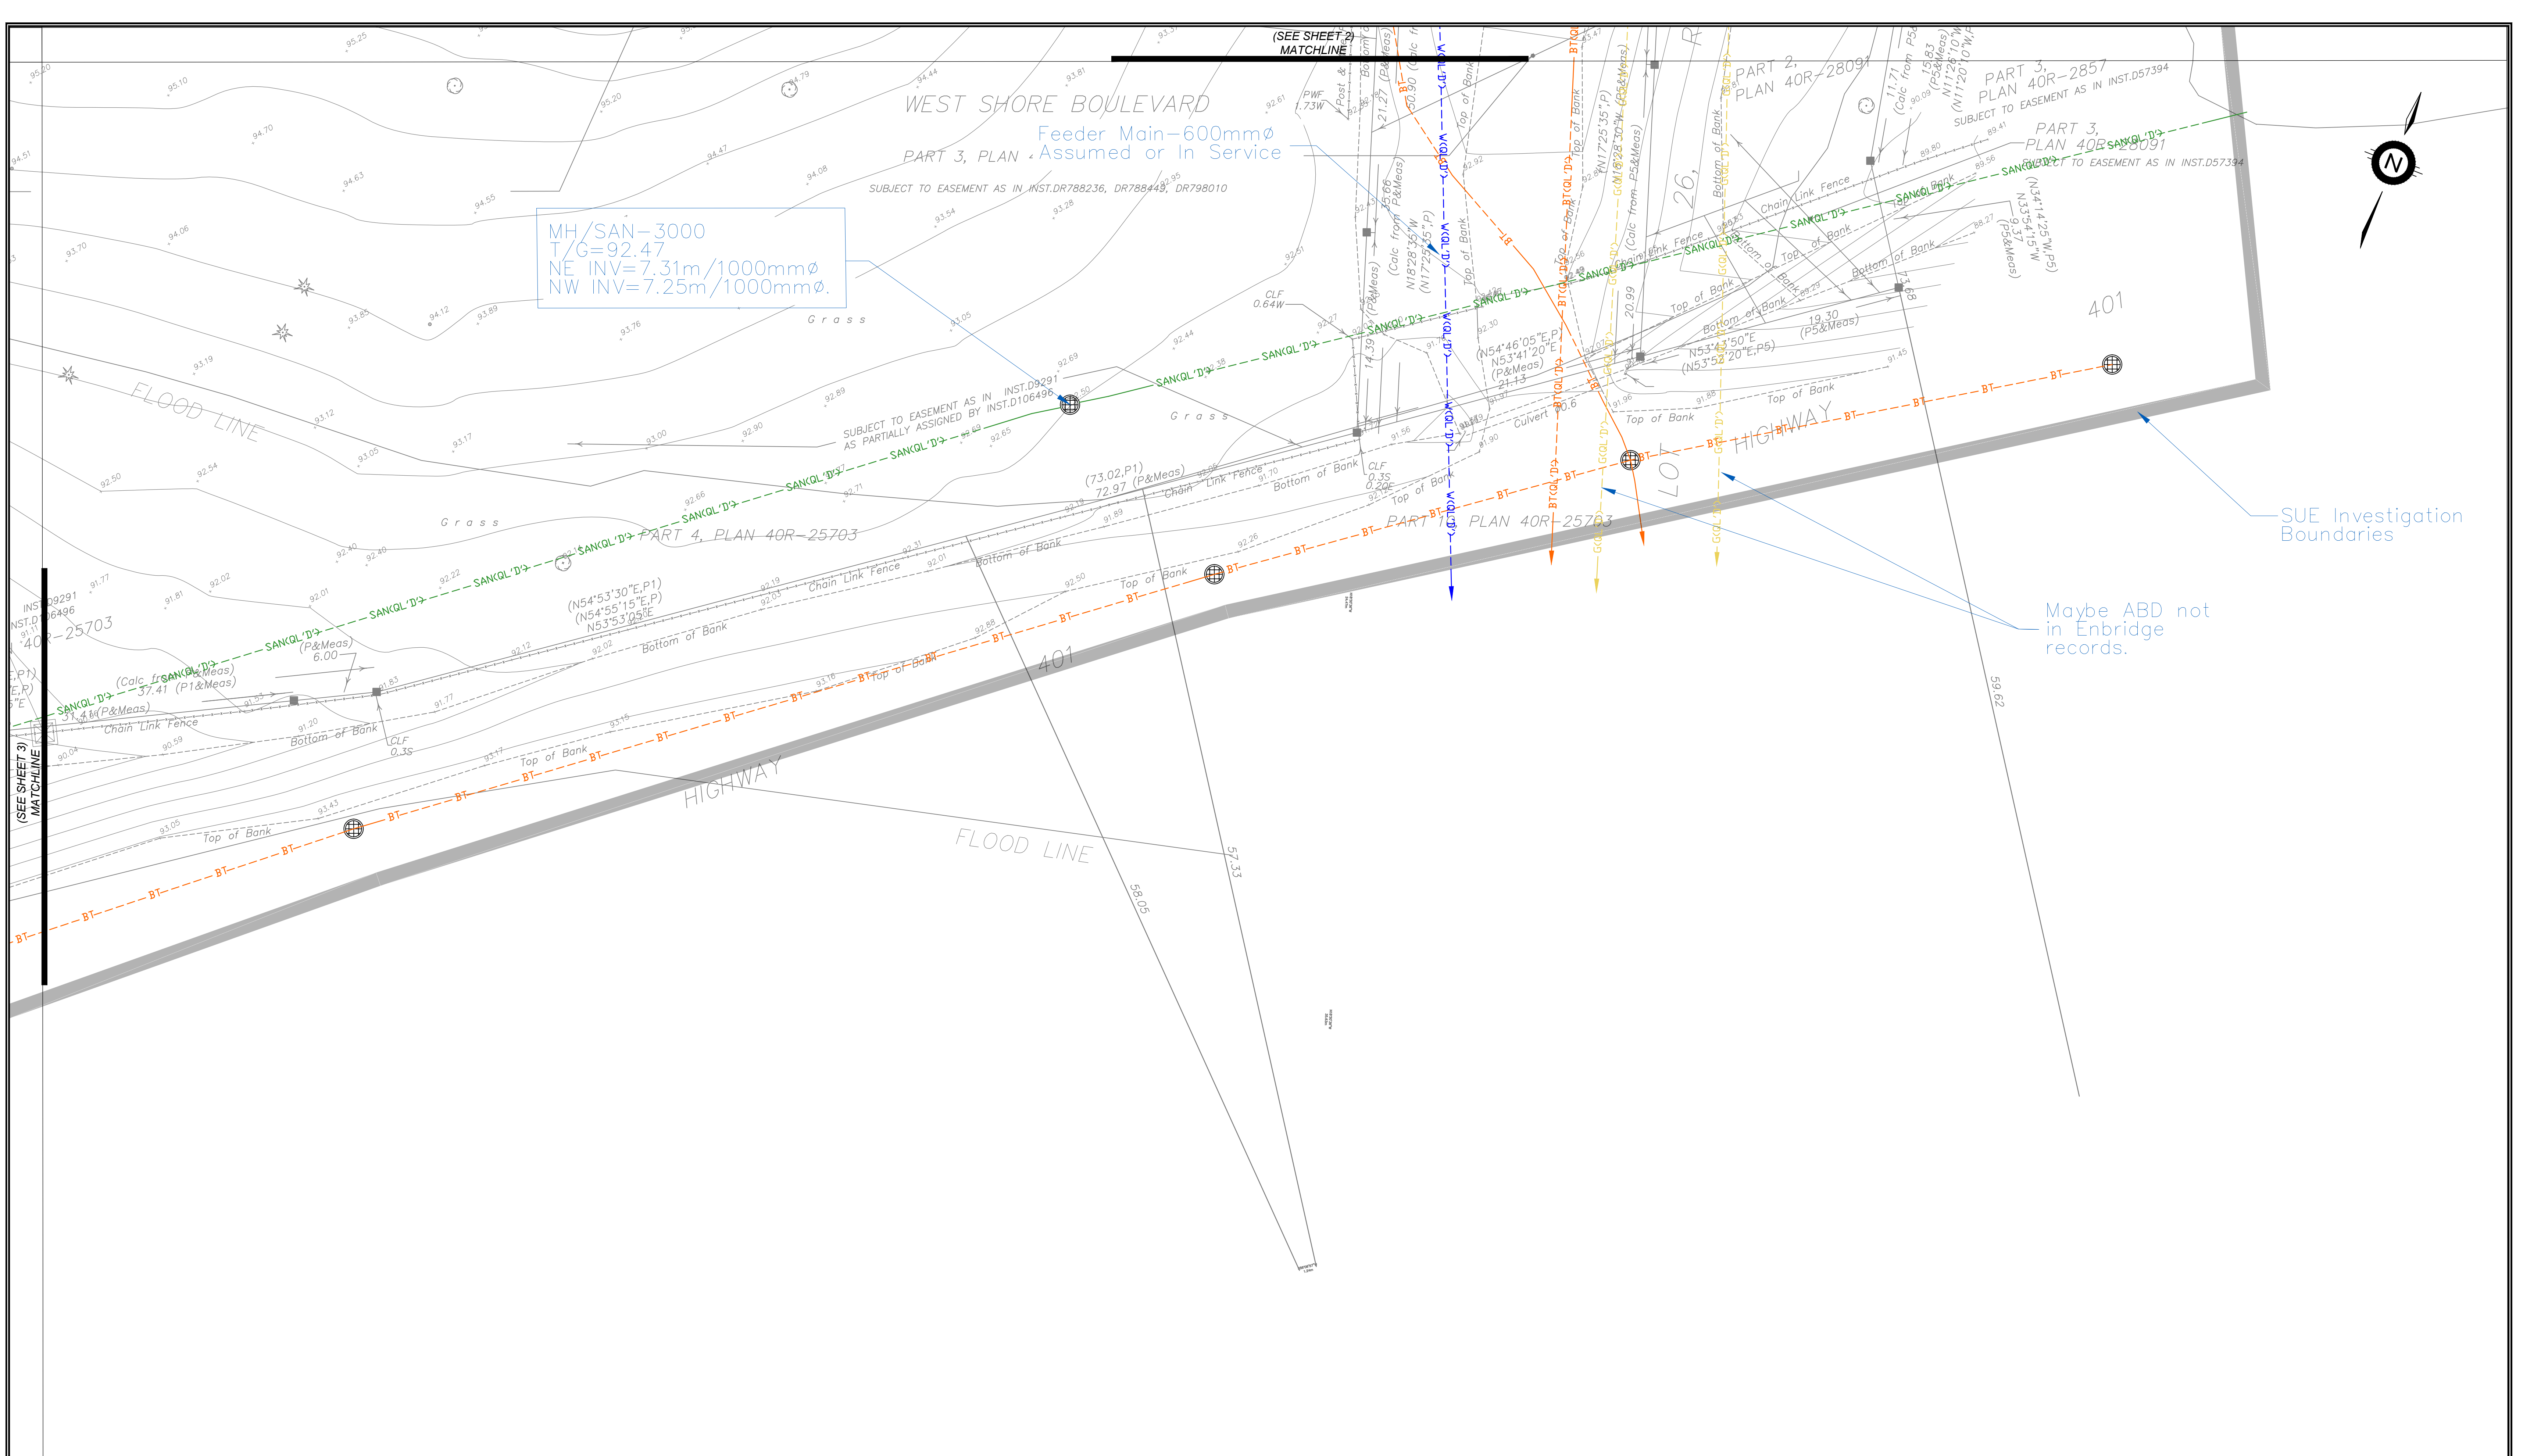
SHEET 4 of 5					
Rev. No.	Drawn By	Checked By	Date	Revision

MH/SAN-3000
 T/G=92.47
 NE INV=7.31m/1000mmØ
 NW INV=7.25m/1000mmØ.

Maybe ABD not in Enbridge records.
