# Arborist Report

## 230 Finch Avenue

### City of Pickering

**July 2021**      **220352**

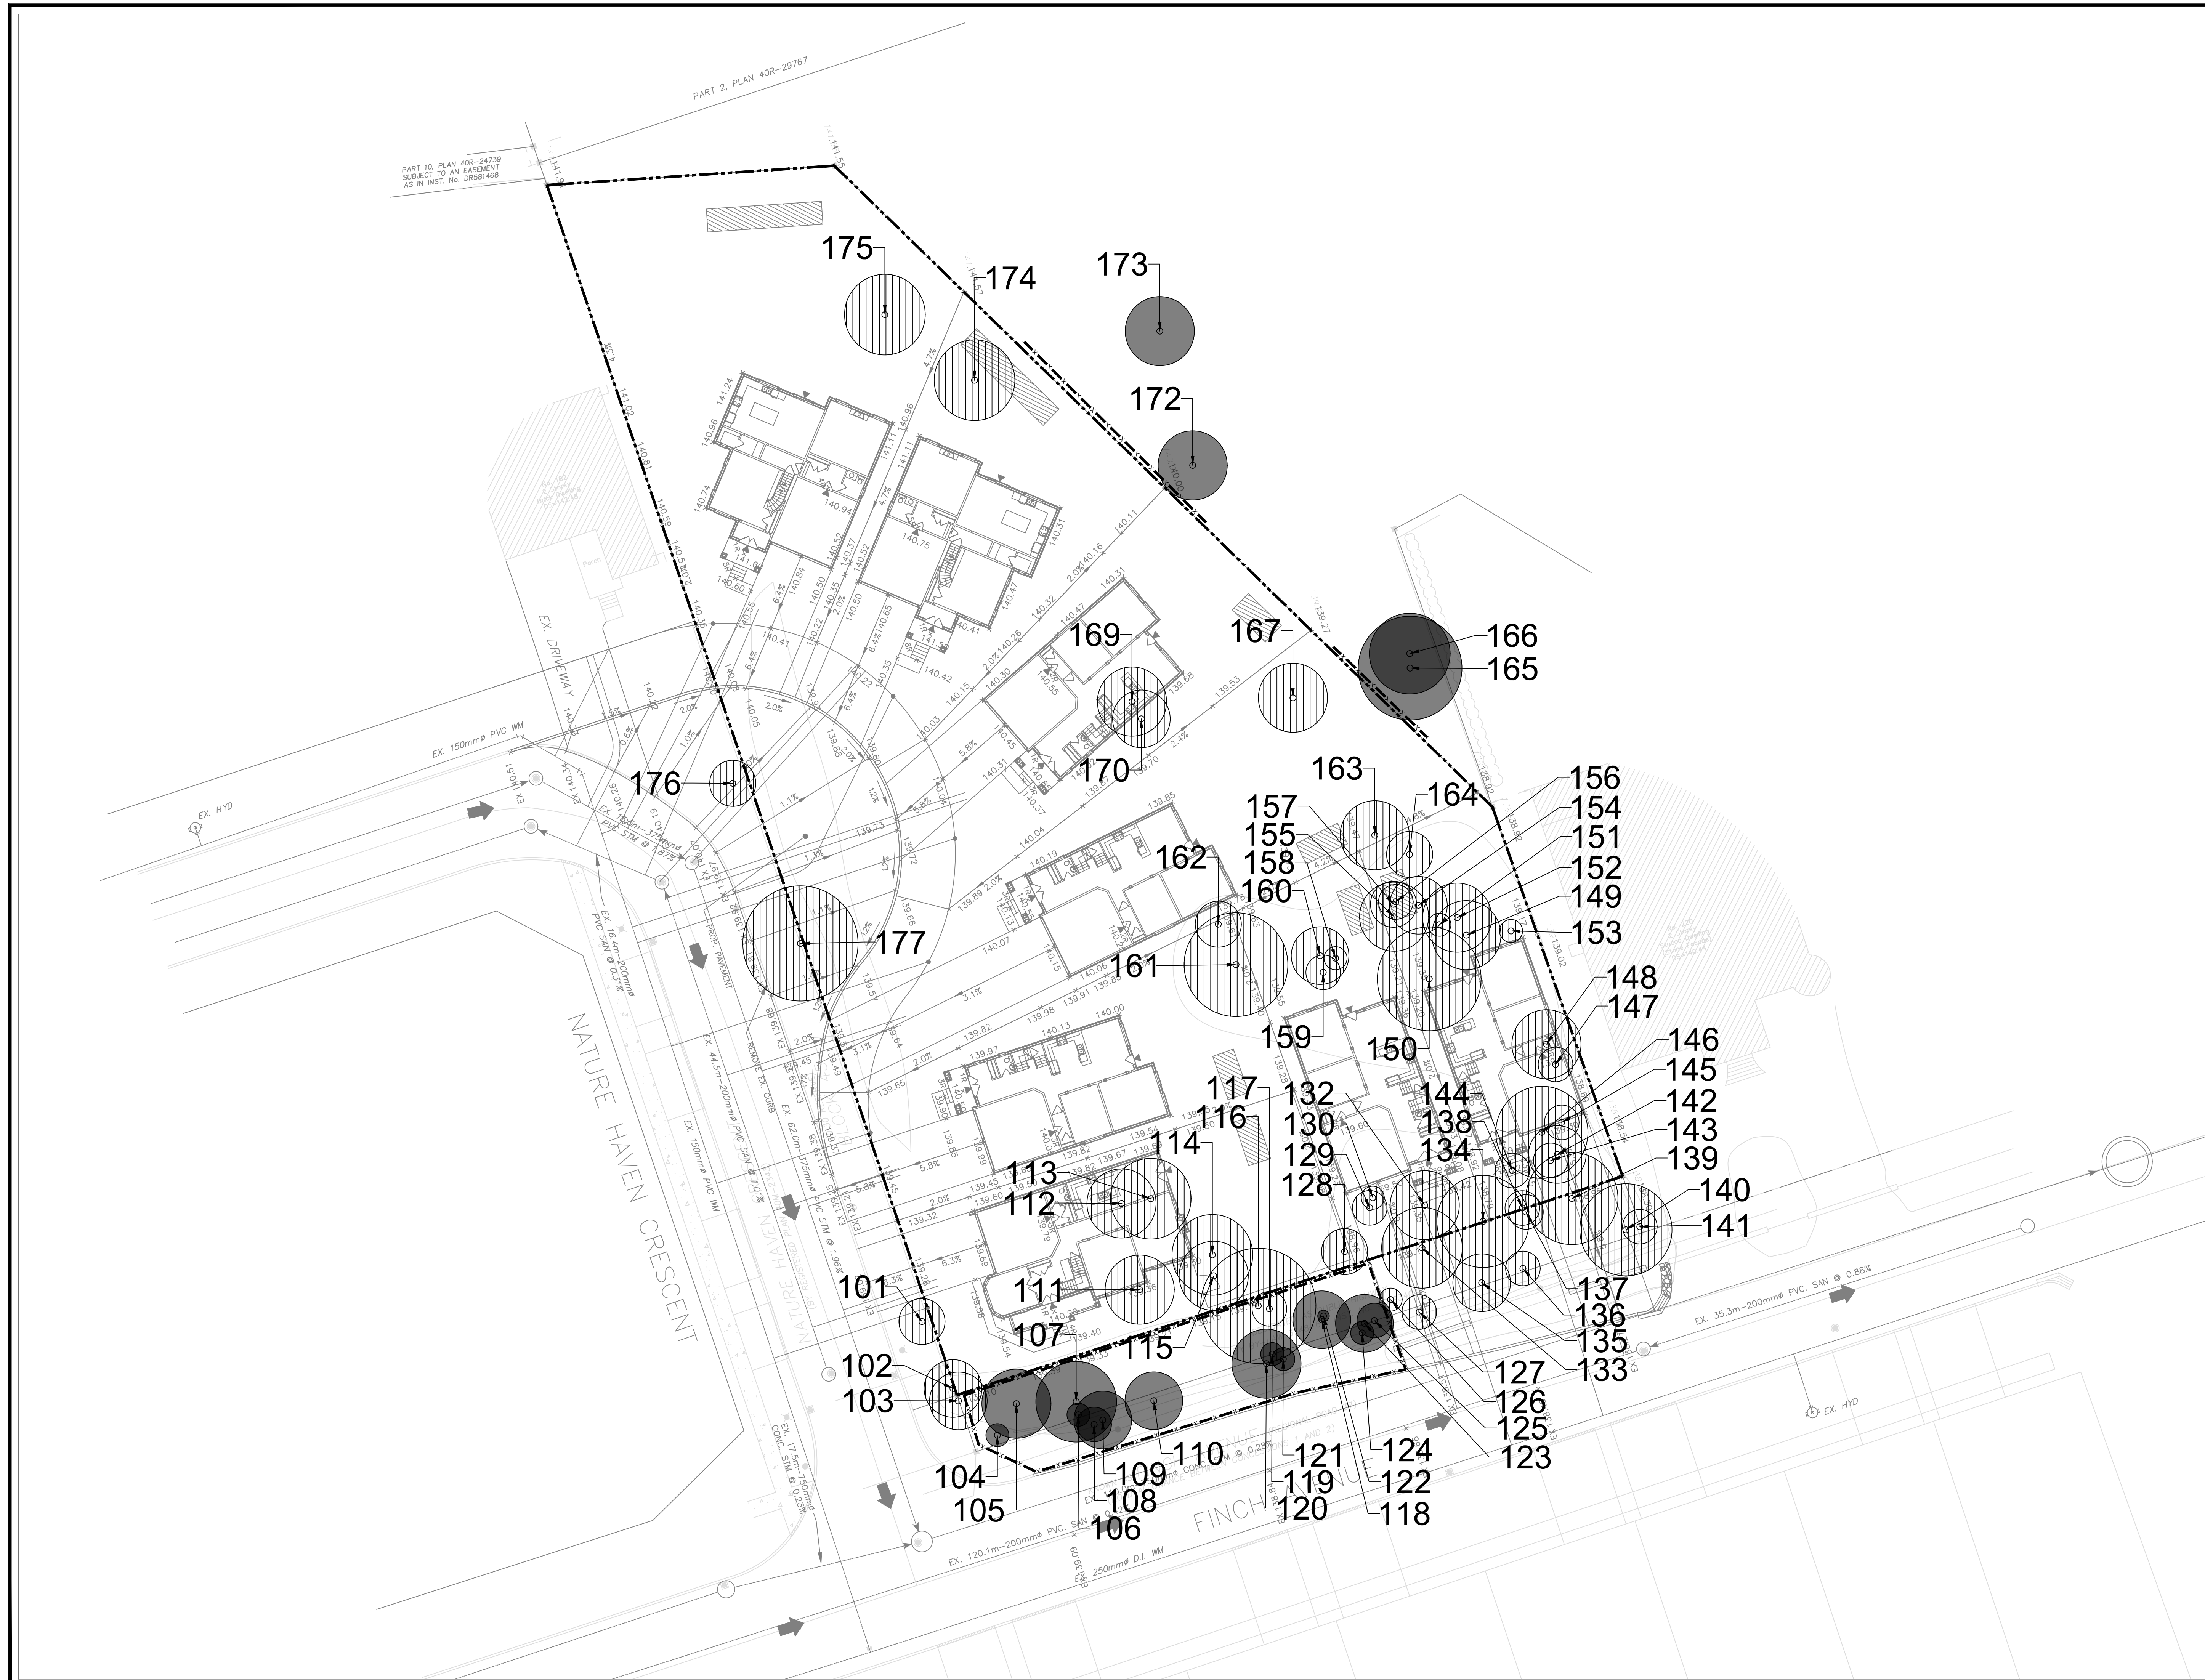
**TREE INVENTORY AND  
PRESERVATION PLAN**

The proposed development is for eight detached residential dwellings on lots fronting onto either Finch Avenue or Nature Haven Crescent. It is assumed that the entire property will be graded to accommodate the proposed development. All 42 trees  $\geq 15$  cm DBH recorded on the subject property are recommended for removal due to the proposed development. An additional 13 trees within the Finch Avenue ROW are recommended for removal due to the proposed development. A total of 15 trees  $\geq 15$  cm DBH within the Finch Avenue ROW and four trees on adjacent property to the east are recommended for preservation.

Trees located within the area of the proposed development are recommended for removal. On this basis, it is anticipated that the proposed development will require the removal of 42 trees on the subject property. An additional 13 trees within the Finch Avenue ROW are recommended for removal due to the proposed development. Of the 55 trees recommended for removal, eight trees (Trees No. 103, 126, 127, 135, 136, 139, 146, and 153) are in a state of decline and have a limited longevity. An additional seven trees (Trees No. 117, 137, 138, 141, 144, 145, and 159) are dead.

A total of 15 trees within the Finch Avenue ROW and four trees on adjacent property are recommended for preservation. Of the 19 trees recommended for preservation, nine trees (Trees No. 104, 106, 118, 119, 121, 122, 123, 124, and 125) are in poor condition and have a limited longevity.

Tree protection fencing is to be installed per the City of Pickering's guidelines and detail as shown in **Appendix C**.

All trees recommended for preservation shall be protected through the establishment of Tree Protection Zones (TPZs). Tree Preservation Fencing is to be installed per the City of Pickering's policy and details. The locations of proposed tree protection barriers are shown in the Tree Inventory and Preservation Plan (**Drawing TP-1; Appendix C**) No materials shall be stored inside or up against fencing, and a sign will be hung on the most visible side designating the TPZ.
