## Tree Inventory and Preservation Plan Report 1794 Appleview Road Pickering, Ontario

15 September 2025

KUNTZ FORESTRY CONSULTING INC Project P4728

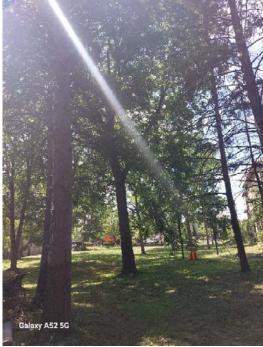
Image 5. Trees 164-169

The removal of an additional four trees, including Trees 167, 182, 185 and 199, are recommended regardless of the site plan due to their poor condition.

158	White Spruce	Picea glauca	19	G	G	G		2.0	1.8		Preserve
159	White Spruce	Picea glauca	19	G	G	G		1.5	1.8		Preserve
160	White Spruce	Picea glauca	37	G	G	G		5.0	2.4		Preserve
161	White Spruce	Picea glauca	36	G	G	G		3.0	2.4		Preserve (Injure)
162	White Spruce	Picea glauca	72	G	G	G		5.0	4.8		Preserve
163	Apple species	Malus spp.	25	G	G	F		2.0	1.8	Deadwood (M), epicormic branching (M)	Preserve
164	White Spruce	Picea glauca	42	G	G	G		3.0	3.0		Preserve (Injure)
165	White Spruce	Picea glauca	35	G	G	G		2.5	2.4		Preserve (Injure)
166	White Spruce	Picea glauca	31	G	G	G		2.0	2.4		Preserve
167	White Spruce	Picea glauca	29	F	F	Р	60	2.0	1.8		Remove (Condition)

- The existing gravel driveway is to be used for access during demolition.
- The existing foundation is located within the mTPZ's of Trees 161, 164, 165, 187 and 200. The foundation is to be removed carefully using small machinery under the supervision of a Certified Arborist. Any exposed roots should be left intact.

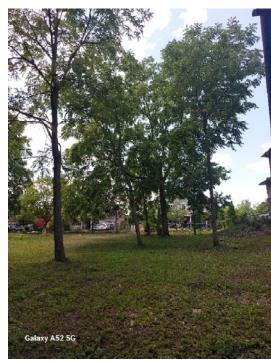
Image 7. Trees 170-177

The proposed development will require the removal of 11 trees, including Trees 170-176, and 178-181. All trees identified for removal either directly conflict with the proposed building footprints or driveways.

168	White Spruce	Picea glauca	17	G	G	G	1.5	1.8		Preserve
F	Manitoba Maple	Acer negundo	~29	F	F	F- G	3.0	1.8	Lean (M), Crook (M)	Preserve
169	Black Walnut	Juglans nigra	69	G	G	G	5.0	4.2		Preserve
170	Black Walnut	Juglans nigra	35	G	G	G	5.0	2.4		Remove
171	Black Walnut	Juglans nigra	27	G	F	G	3.0	1.8	Crook (L)	Remove
172	Black Walnut	Juglans nigra	27	G	G	G	3.0	1.8		Remove
173	Black Walnut	Juglans nigra	64	G	G	G	2.0	4.2		Remove
174	Black Walnut	Juglans nigra	21	G	G	G	5.0	1.8		Remove
175	Black Walnut	Juglans nigra	20	G	G	G	2.0	1.8		Remove
176	White Spruce	Picea glauca	16	G	G	G	0.5	1.8		Remove
177	Black Walnut	Juglans nigra	16	G	G	G	1.0	1.8		Remove
178	White Mulberry	Morus alba	28	G	F	F- G	2.0	1.8	Union at 2m, epicormic branching (L)	Preserve
179	Black Walnut	Juglans nigra	58	G	F	F- G	5.0	3.6	Poor form (L), crook (L), deadwood (L)	Remove
180	Silver Maple	Acer saccharinum	28	F	F	F- G	2.0	1.8	Union at 5m, one stem removed	Remove

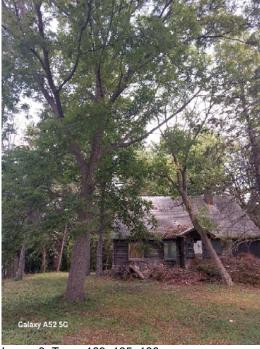
Image 8. Trees 169, 185, 186

196	Silver Maple	Acer saccharinum	53	F	F	F- G	4.0	3.6	Union at 2m, stem wound with rot (L)	Preserve
197	Austrian Pine	Pinus nigra	35	G	G	G	3.0	2.4		Preserve
198	Austrian Pine	Pinus nigra	38	G	G	G	3.0	2.4		Preserve
199	Apple species	Malus spp.	40	P- F	F	P- F	3.0	2.4	Deadwood (H), union at 2m	Remove (Condition)
200	Manitoba Maple	Acer negundo	27	F	F	F	3.0	1.8	Lean (L), bowing (M)	Preserve (Injure)
212	White Spruce	Picea glauca	40				2.5	2.4		Preserve
213	Silver Maple	Acer saccharinum	31	F	F	F	3.0	2.4	Lean (L), bowed (M),	Preserve
214	Manitoba Maple	Acer negundo	45	F	F	F- G	3.5	2.4	Lean (M)	Preserve
215	White Spruce	Picea glauca	36	G	G	G	3.0	2.4		Preserve
216	White Spruce	Picea glauca	25	G	G	G	2.0	1.8		Preserve
217	White Spruce	Picea glauca	35	G	G	G	2.5	2.4		Preserve (Injure)
218	Norway Maple	Acer platanoides	40	G	G	G	2.5	2.4		Preserve (Injure)
219	White Spruce	Picea glauca	57	G	G	G	3.0	3.6		Preserve (Injure)

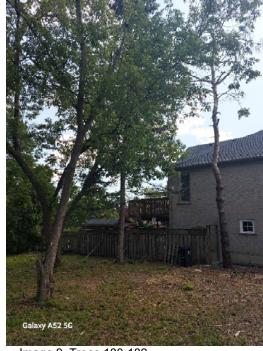
Image 9. Trees 180-182

181	White Spruce	Picea glauca	32	G	G	G	2.0	2.4		Remove
182	Manitoba Maple	Acer negundo	75	Р	P- F	F- G	5.0	4.8	Active stem failure, fruiting bodies (M), poor form (M)	Remove (Condition)
183	Black Walnut	Juglans nigra	44	G	G	G	4.0	3.0		Preserve
184	Little-leaf linden	Tilia cordata	56	F	F- G	F- G	4.0	3.6	Union at 2m, deadwood (L)	Preserve
185	Manitoba Maple	Acer negundo	48	F	F	P- F	5.0	3.0	Lean (L-M), epicormic branching (M), deadwood (M)	Remove (Condition)
186	White Spruce	Picea glauca	60	G	G	F- G	4.0	3.6	Deadwood (L)	Preserve
187	White Spruce	Picea glauca	58	G	G	G	4.0	3.6		Preserve (Injure)
188	Horsechestnut	Aesculus hippocastanum	25, 18	F- G	F- G	F- G	3.0	1.8	Union at 1m and 1.4m	Preserve
189	White Spruce	Picea glauca	45	G	G	F	3.0	3.0	Deadwood (M)	Preserve
191	Austrian Pine	Pinus nigra	44	G	G	G	2.5	3.0	_	Preserve
192	Austrian Pine	Pinus nigra	42	G	G	G	2.5	3.0		Preserve
193	Austrian Pine	Pinus nigra	40	G	G	G	2.5	2.4		Preserve
