ARBORIST REPORT

**Proposed 3 Storey Condo Townhouses Development
666, 668, 672, 678, 682 Liverpool Rd.**

City of Pickering

June 4, 2025

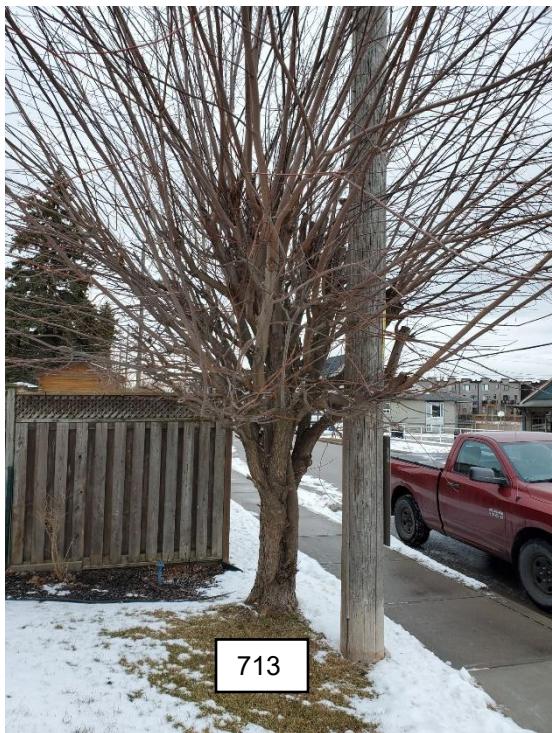
713

City ROW tree #713 will have excavation occurring within approximately 20% of its TPZ up to the trunk base for the removal of the existing curb stop. This tree will not survive the proposed construction impacts and may become destabilized. This tree has also been topped due to overhead utility lines. It is recommended this tree be removed.

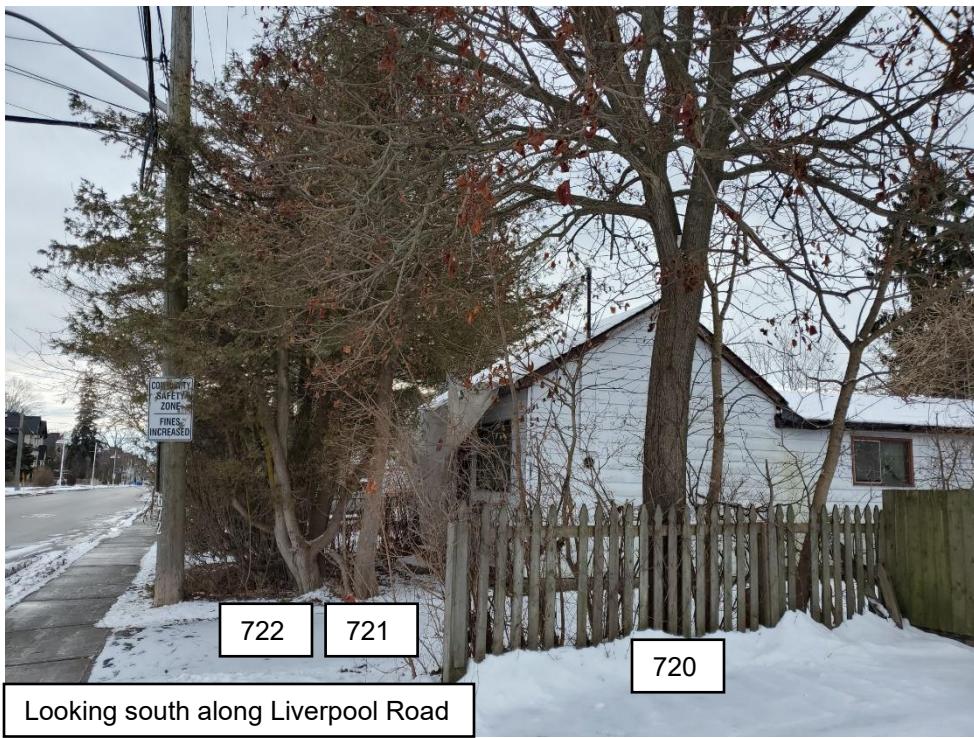
Looking south along Liverpool Road

There are 8 observed boundary trees (#720, 722, 724, 725, 726, 727, 738-boundary with City), (#749-boundary with private adjacent landowner(s)) that were bisecting the private subject site that are recommended for removal. Written consent from the respective co-owner(s) of these trees will be required to be forwarded to the City through the development application process prior to the removal of these trees.
