ARBORIST REPORT

Report Revised December 20, 2024

PROJECT NAME: 1163 Kingston Road
PROJECT NUMBER: TRC148
DATE OF INSPECTIONS: August 9, 2023
October 23, 2023
PERSONS PRESENT: Mike Hukezalie, ISA Certified Arborist

LOCATION: 1101A, 1105, 1163 Kingston Rd
Pickering, Ontario.
DESCRIPTION: Arborist report

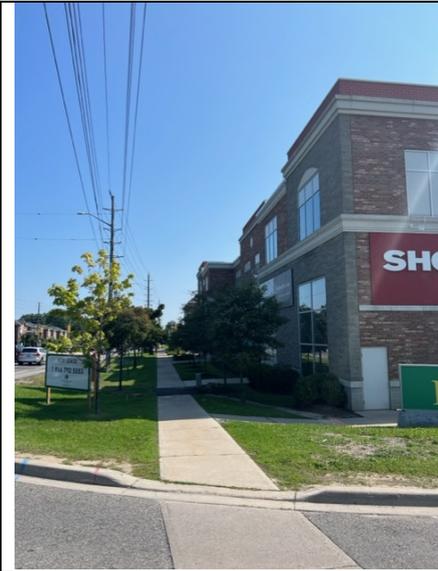
Image #1: View looking east along Kingston Road towards tree #501

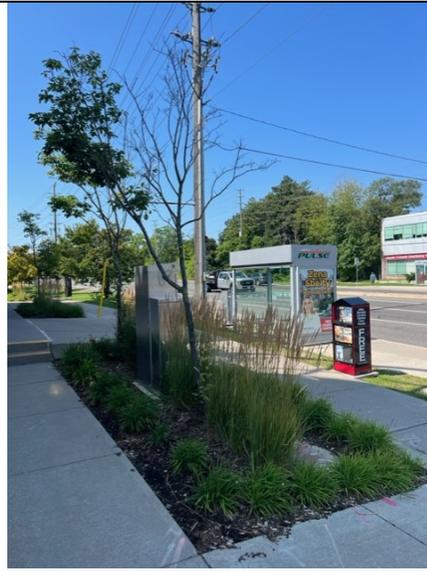
Image #2: View looking west along Kingston Road towards tree #521

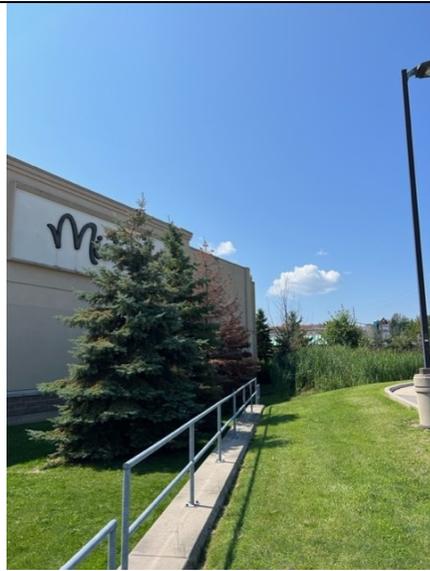
Image #7: View looking west towards group of conifer trees (#553 in foreground)

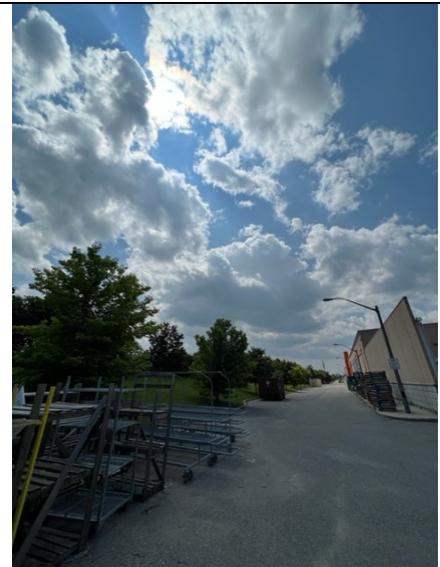
Image #12: View looking west along laneway running behind Home Depot (tree #593 in foreground)

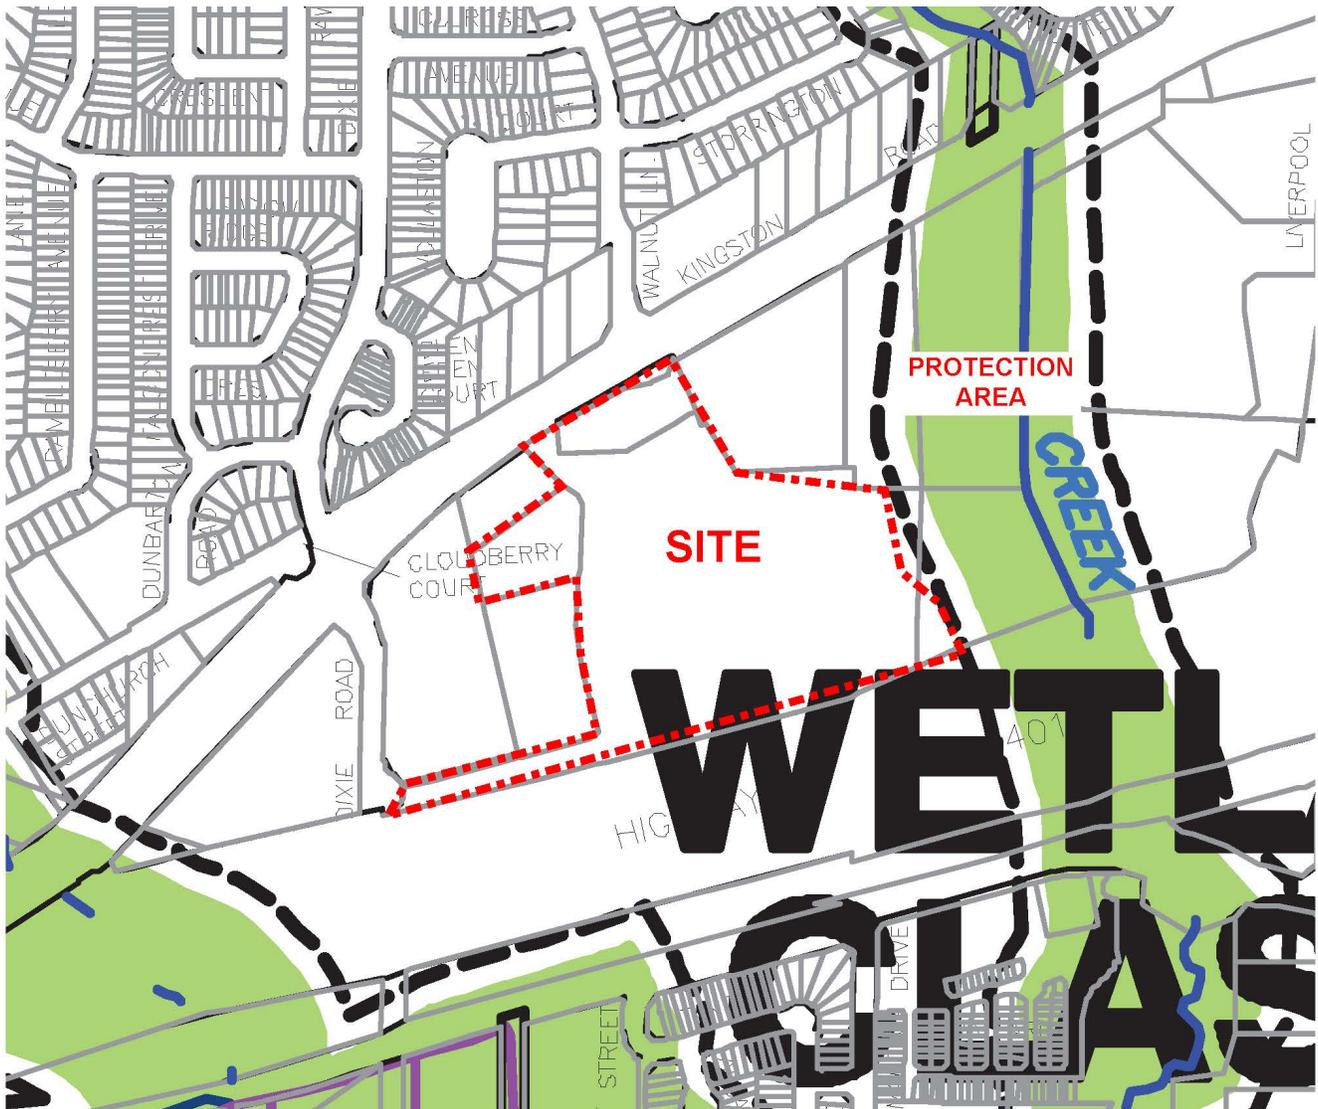
Appendix C – City of Pickering Protection Area

Refer to Appendix C for an overview of the site in relation to the adjacent protection area as outlined by the City. A very small portion of the Protection Area falls within the site, however there are no trees found on site within this protection area.
