**RE: Coastal Study**  
**640 Liverpool Road, Pickering**  
**Project No. 2204589**

GEI Consultants (GEI) is pleased to provide a coastal study in support of the proposed residential development to be constructed at 640 Liverpool Road in Pickering, Ontario.

Coastal Inspection/Site Visit Photographs (Dec. 3, 2022)

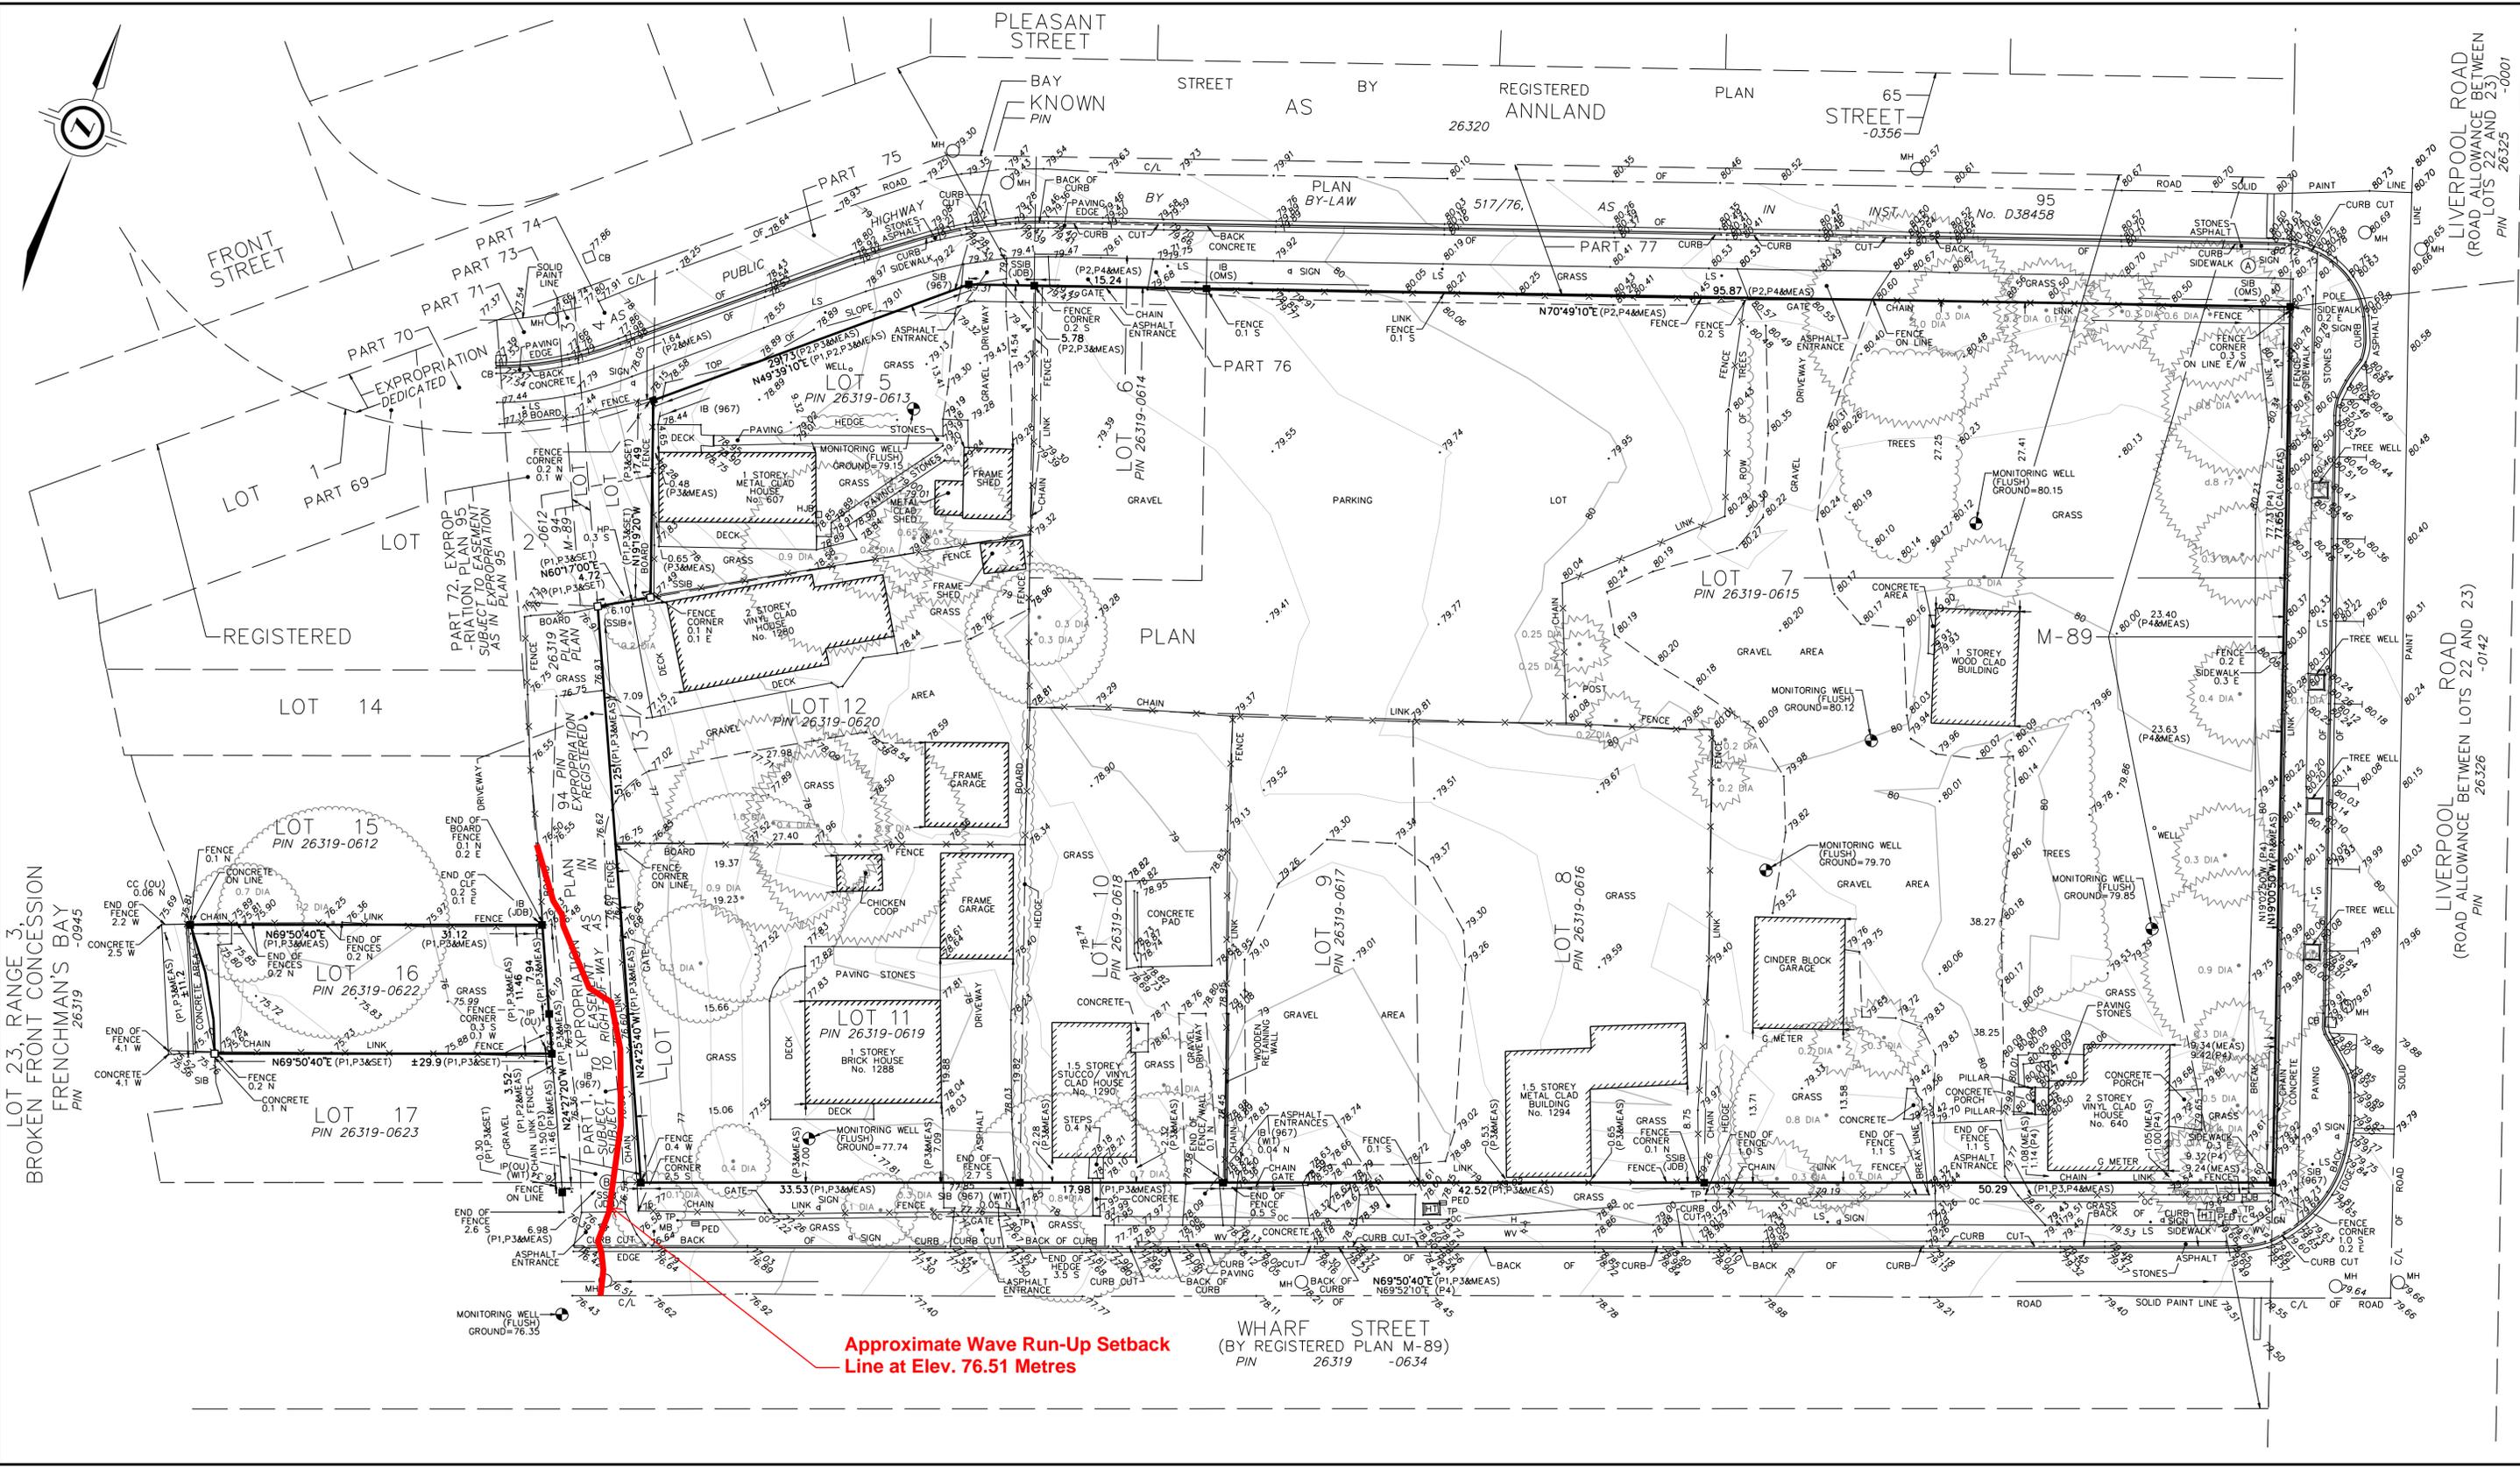
PLAN OF SURVEY SHOWING TOPOGRAPHY OF  
 PART OF LOTS 6 AND 7 AND  
 LOTS 5, 8, 9, 10, 11, 12 AND 16  
 REGISTERED PLAN M-89  
 (GEOGRAPHIC TOWNSHIP OF PICKERING)  
 NOW IN THE  
 CITY OF PICKERING  
 REGIONAL MUNICIPALITY OF DURHAM  
 SCALE 1 : 300

Site geometry is based on survey data collected May 31, 2022 by J.D. Barnes Limited. The ground near the 100-year lake level has a fairly shallow slope up to the east, at approximately 17.5:1 (H:V) between elevations 76 metres and 77 metres.

The wave uprush elevation was determined to be 76.51 metres. This elevation line and setback was annotated on the topographic survey of the property provided within Enclosure 1. The wave uprush does not encroach onto the proposed condominium development area and therefore additional provisions for floodproofing are not required for this particular development.

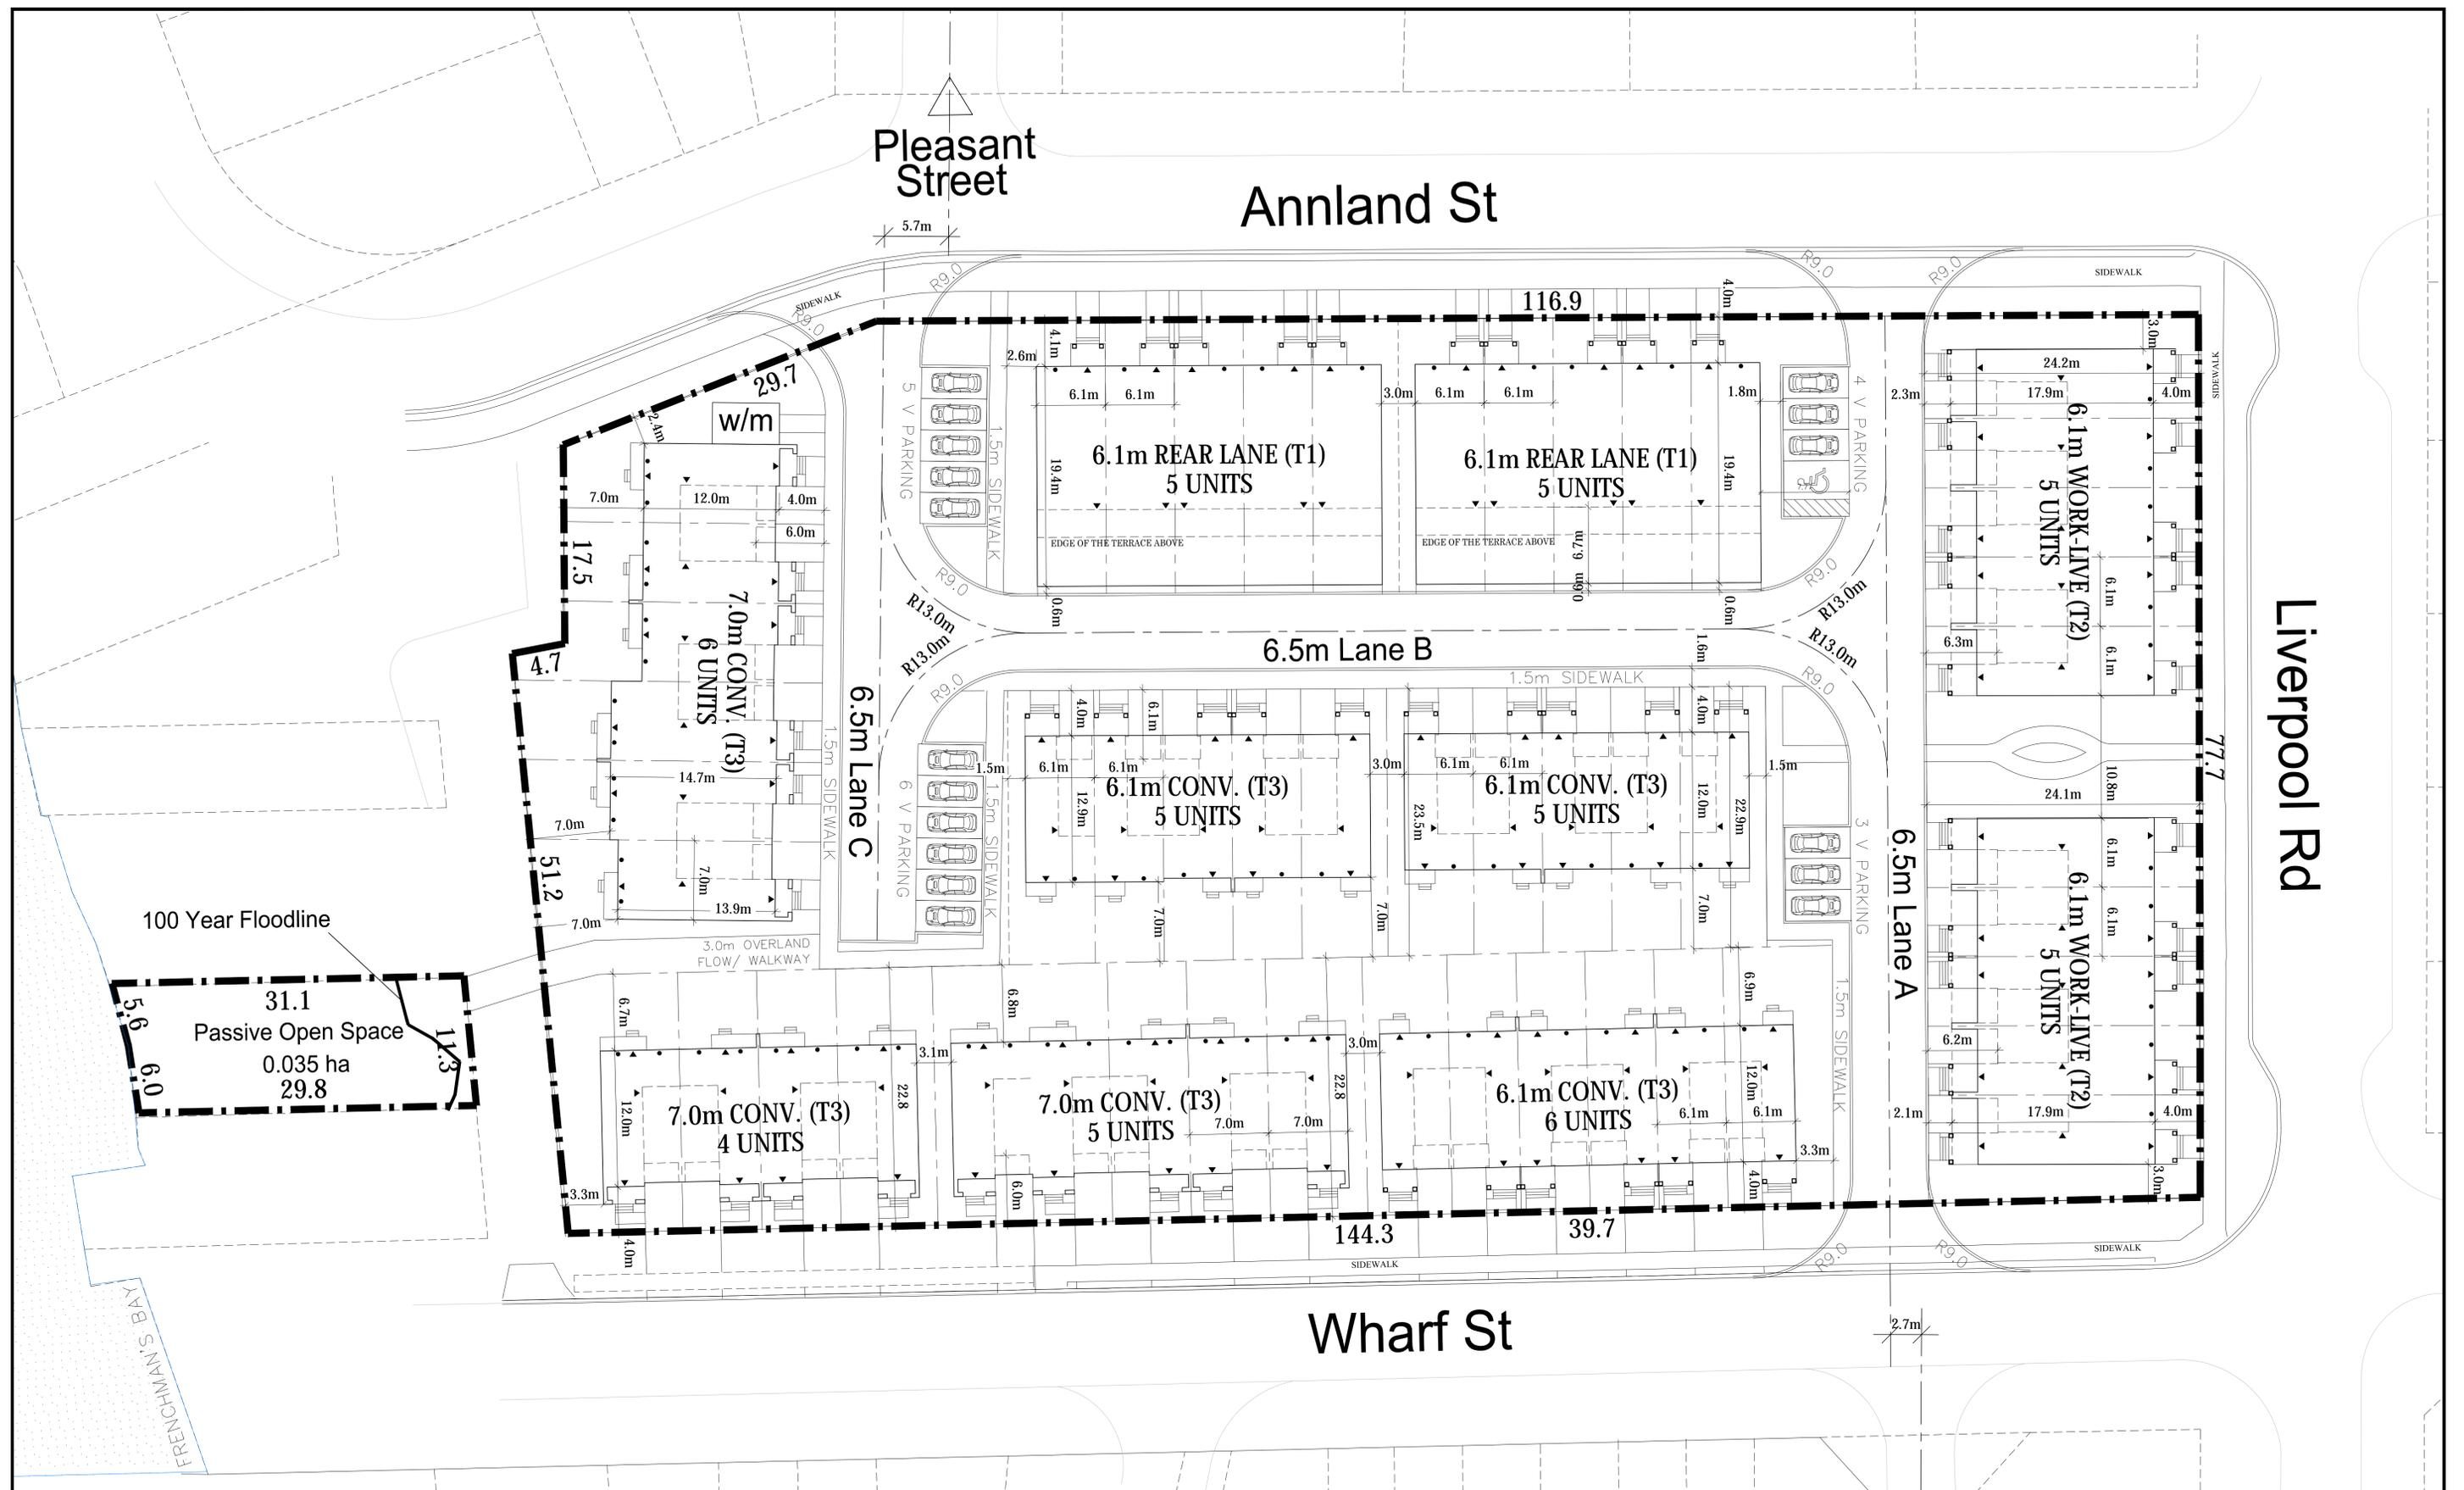
SITE PLAN			
Drawn by:	Checked by:	Date:	Drawing No.
JWL	SA	NOV. 2022	A101
Scale: 1 : 250			Project No. 2022-10

The proposed development will consist of 10 townhouse blocks with 4 to 6 townhouses per block (for a total of 51 townhouse units) connected by internal private laneways. The majority of the development (1.136 ha) is setback on the order of 40 metres east of Frenchman's Bay where the residential condominium development will be constructed. There is a small parcel of land (0.035

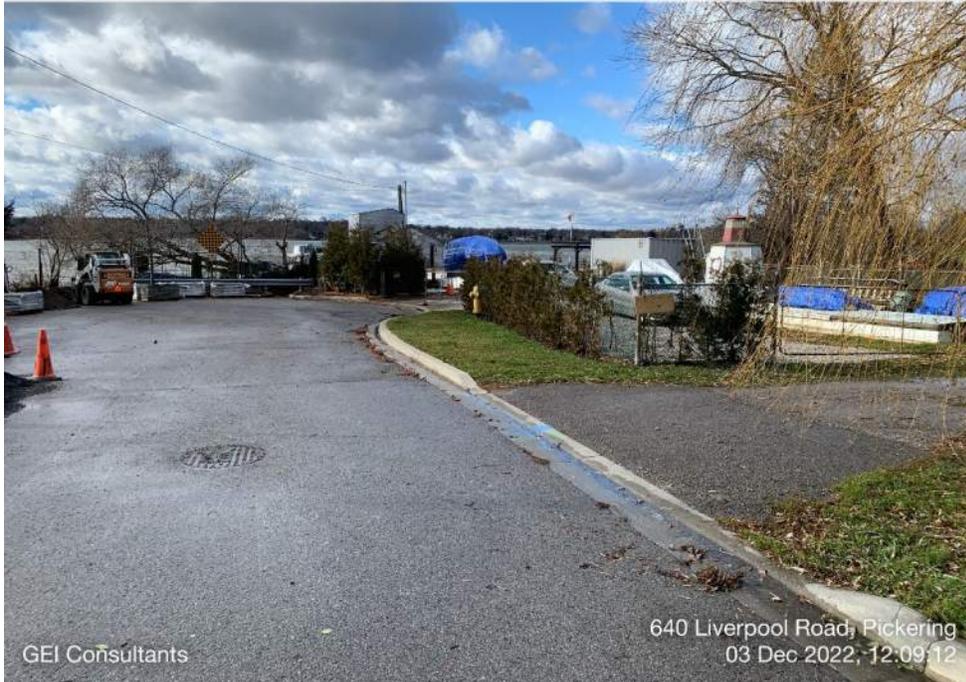
**PHOTOGRAPH 1**

On Wharf Street,  
looking west  
towards  
Frenchman's Bay.

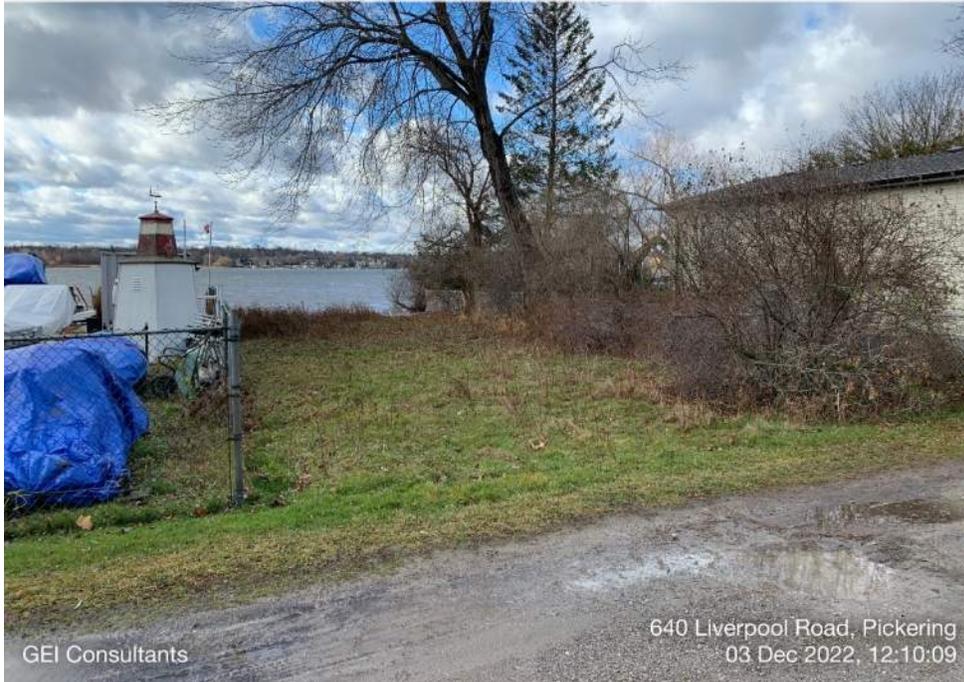
**PHOTOGRAPH 3**

The 0.035 ha parcel of land adjacent to the shoreline of Frenchman's Bay is approximately 12 metres wide (north to south) and 31 metres long (east to west). This parcel is bounded by Frenchman's Bay to the west, a private access laneway to the east and residential properties to the north and south. The property has a very gentle slope upwards to the east, going from approximately Elev 75.7 metres adjacent to the shoreline to approximately Elev 76.4 metres adjacent to the private access laneway. This parcel of land is vacant and grassed.

**Description:**  
View looking west on the 0.035 ha parcel of vacant land that is adjacent to the shoreline (remainder of property is not directly adjacent to shoreline and is to the east of the private access road).

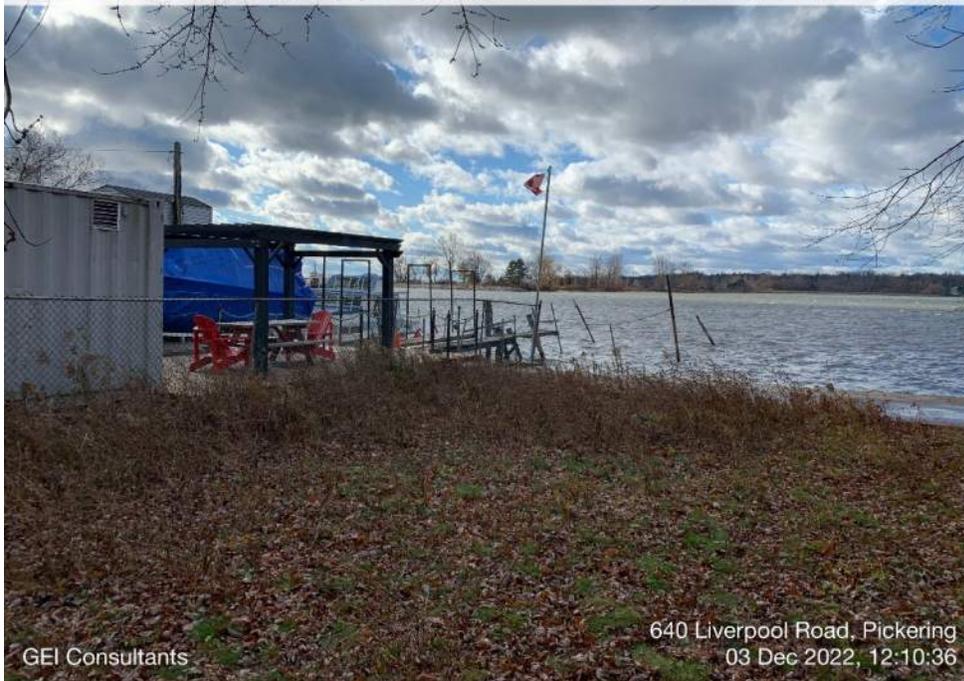
**PHOTOGRAPH 4**

but are still supporting the slab. The masonry blocks on the south side of the slab have essentially deteriorated to rubble.

**Description:**  
View of the south side of the 0.035 ha parcel of land adjacent to the shoreline.

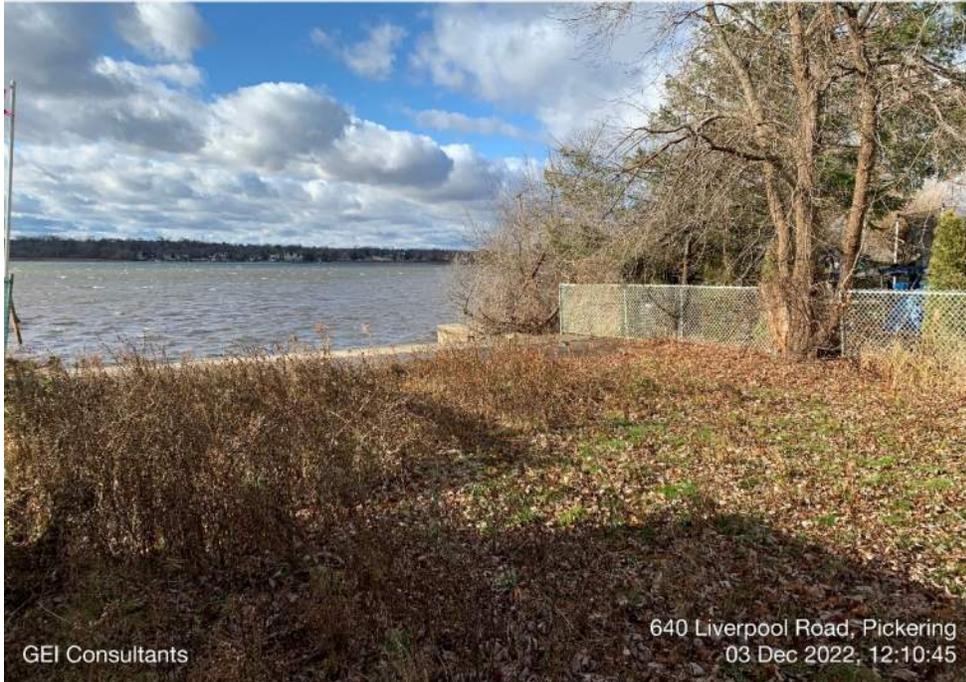
**PHOTOGRAPH 5**

Directly adjacent to the shoreline, there exists a 4.5-metre-wide concrete slab on ground surface. The 2-metre section of the concrete slab adjacent to the shoreline has settled, cracked and separated from the remaining portion of the concrete slab which is still in relatively good condition. The furthest west portion of the slab (directly adjacent to the shoreline) is supported by concrete masonry blocks. The masonry blocks supporting the north side of the slab are in poor condition

**Description:**  
View of the north side of the 0.035 ha parcel of land adjacent to the shoreline.

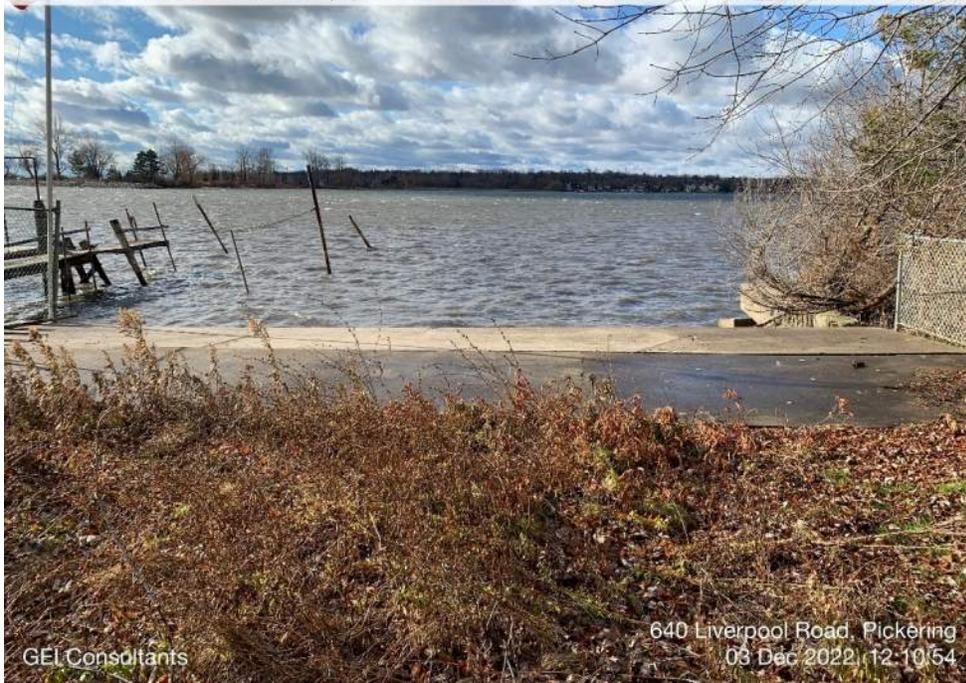
**PHOTOGRAPH 6**

**Description:**  
View looking directly out to Frenchman's Bay with the concrete structure visible that is directly adjacent to the shoreline.

It is understood that the parcel of land closest to the shoreline will not be developed and will be left as a passive land use. There may be a portion of the stormwater management for the development that is directed onto this parcel, which would be determined during detailed design. Regardless, the existing coastal protection is in a poor state of repair, and as part of any development, it would be prudent to include reconstruction of the shoreline protection.

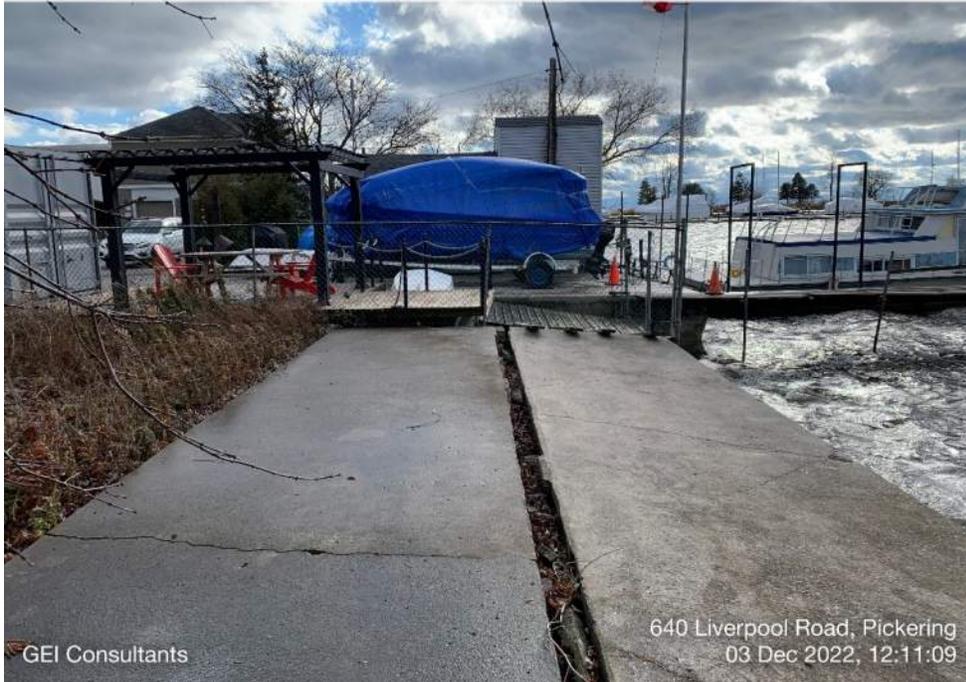
**PHOTOGRAPH 7**

**Description:**  
View looking south along the concrete structure adjacent to the shoreline. The portion of the concrete slab on the west side has separated and settled.

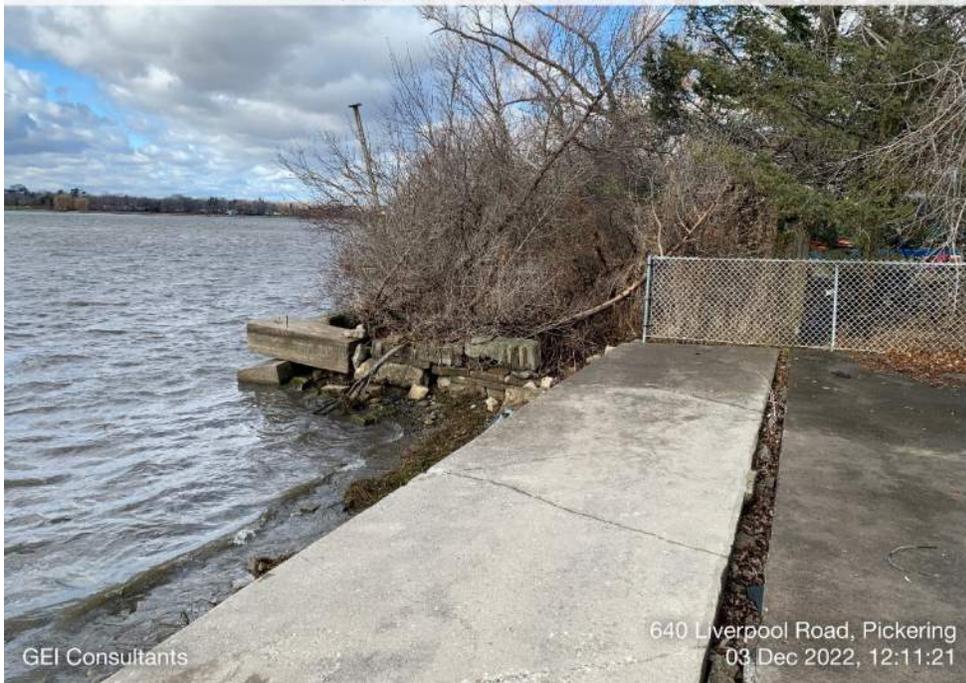
**PHOTOGRAPH 8**

**Description:**  
Another view of the top of the concrete structure that is adjacent to the shoreline.

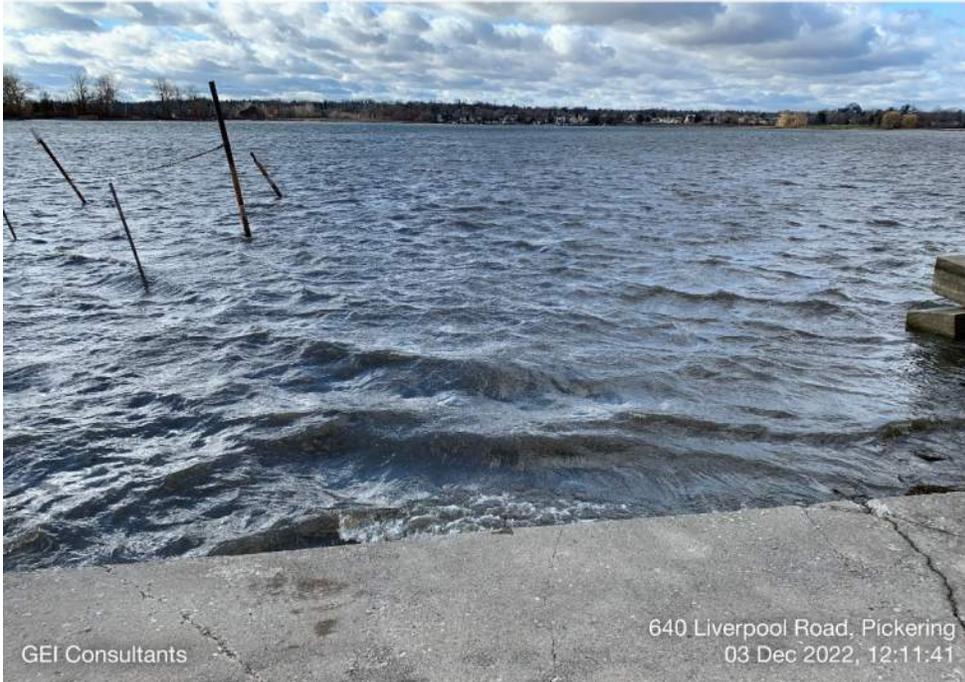
**PHOTOGRAPH 9**

At approximately noon on Dec. 3, 2022, the wind speed was 43 km/hr and was coming from a direction of 290 degrees. Based on visual observations only, the wave height was estimated at 0.3 metres. Based on publicly available data, the surface water elevation within Frenchman's Bay was 74.4 metres which is about 1.7 metres lower than the 100-year maximum flood level.

View looking directly out to Frenchman's Bay. Wind speeds in excess of 40 km/hr occurred during inspection causing waves on the order of 0.3 metres high.

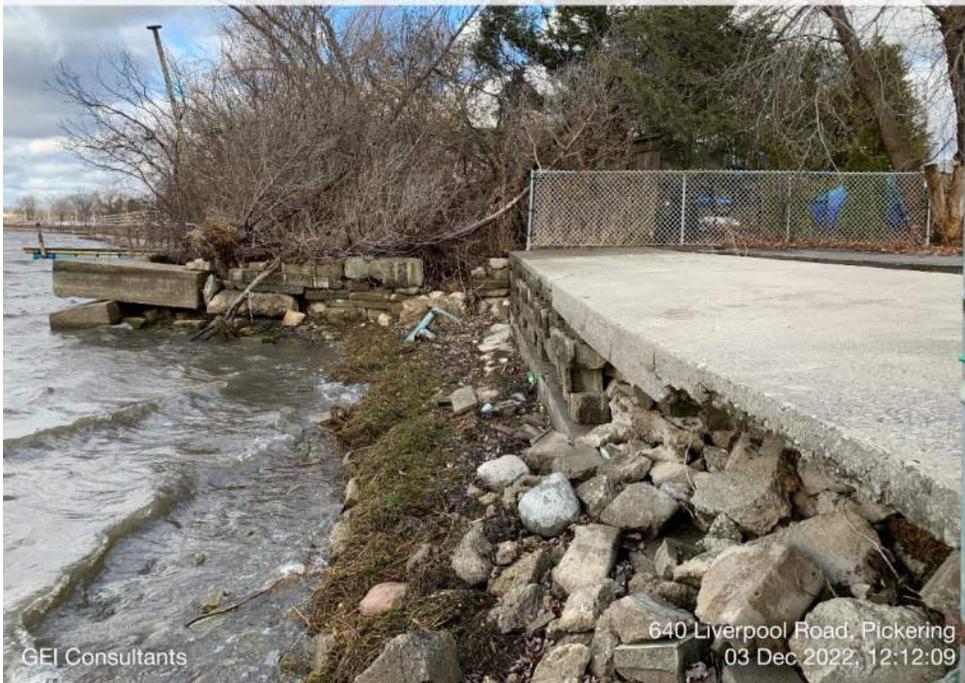
**PHOTOGRAPH 10**

The top of the concrete slab to the base of the coastal protection ranges between 1.0 to 1.2 metres in height. At the base of the coastal protection exists a mixture of algae and rubble that gently slopes down to the surface water level (over about a 1 metre span). The grade below the water appears to continue its gentle slope into Frenchman's Bay. Directly to the south of this parcel of land there exists a dock, and directly to the north of this parcel of land there exists a mixture of blocks and rubble that jut slightly out into Frenchman's Bay.

View of the shoreline consisting of shallow beach with algae and rubble, along with the concrete structure in poor state of repair.

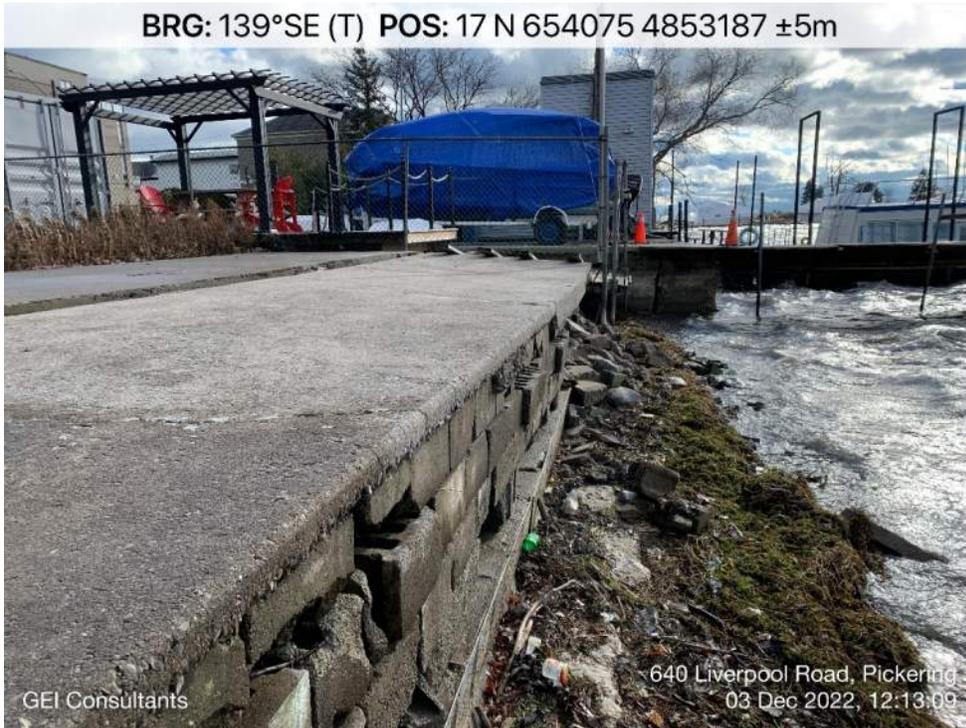
**PHOTOGRAPH 11**

View looking across the concrete structure adjacent to the shoreline.

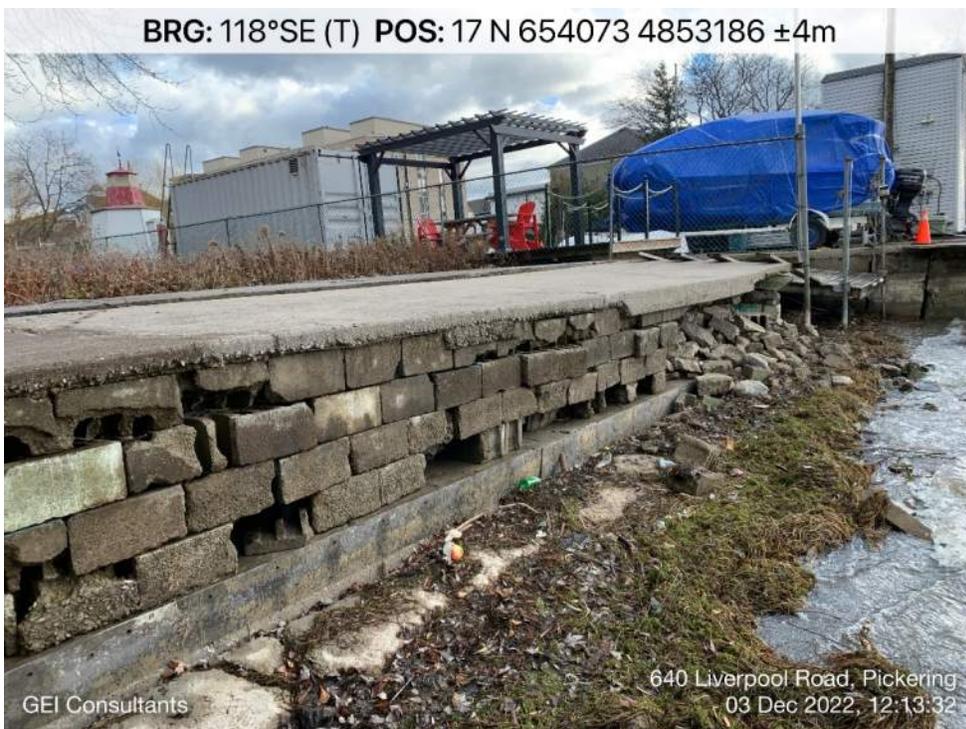
**PHOTOGRAPH 12**

The concrete structure consists of a concrete slab supported by partially disintegrated or rubbilized concrete blocks.

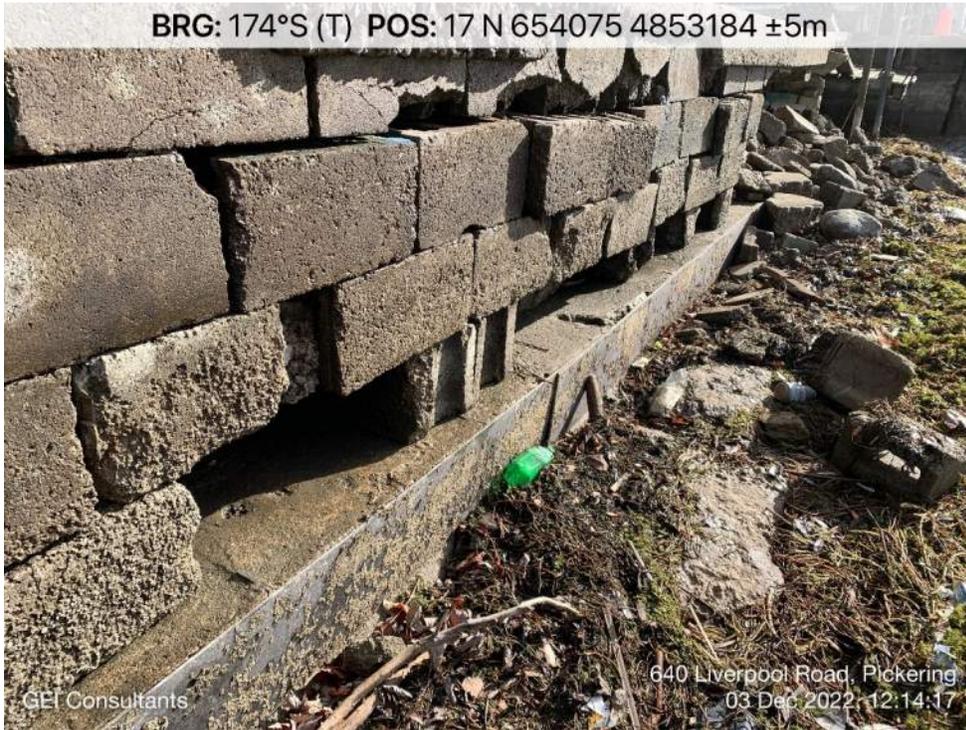
PHOTOGRAPH 13

The width of the concrete masonry blocks (from the north to the south property line) are supported on a cast-in-place concrete foundation that has been protected from erosion by a thin metal sheet. Further investigation would be required to determine the level of competency of this foundation and if it could be left in place for any future potential rehabilitation of this area during development.

The partially disintegrated concrete blocks are support by what appears to be a concrete foundation that has not been undermined nor has been significantly eroded.

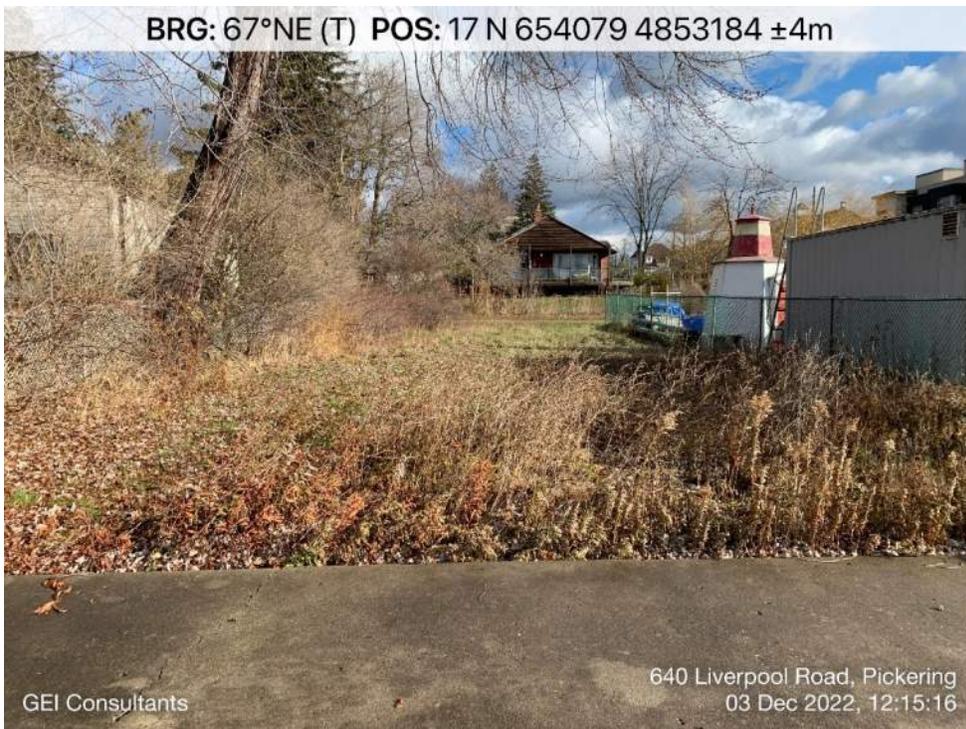
PHOTOGRAPH 14

View looking east up along the 0.035 ha parcel of land towards the larger development area to the east.

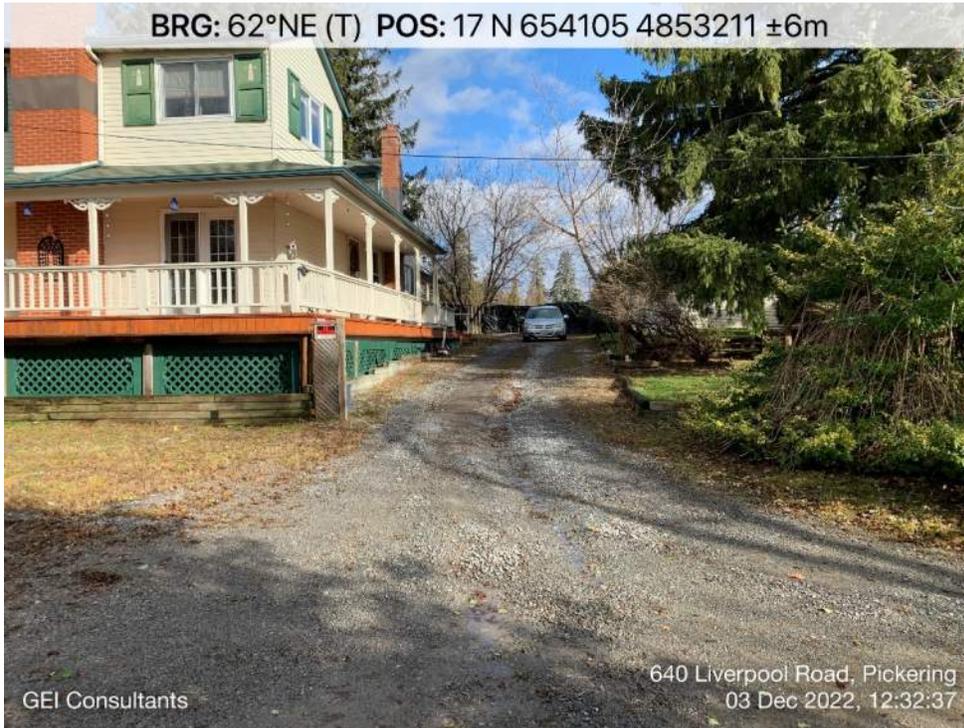
**PHOTOGRAPH 15**

View looking east near the north end of the proposed development area, just east of the private access road near the shoreline.

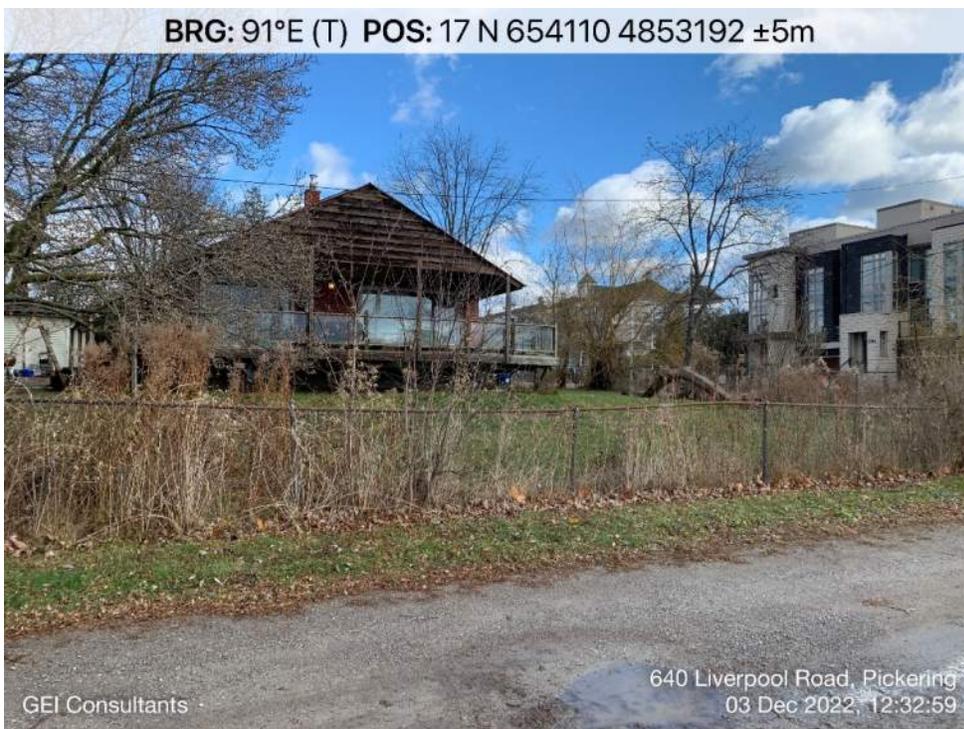
**PHOTOGRAPH 16**

View looking east near the centre of the proposed development area, just east of the private access road near the shoreline.

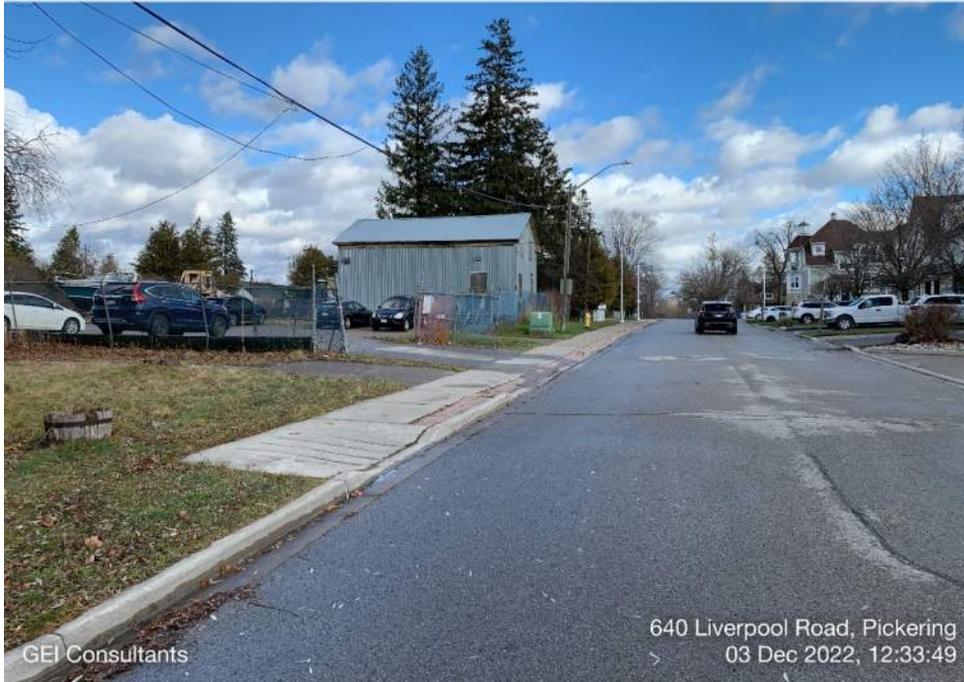
PHOTOGRAPH 17

**Description:**  
View looking east up Wharf Street, with the proposed development to the north of Wharf Street.

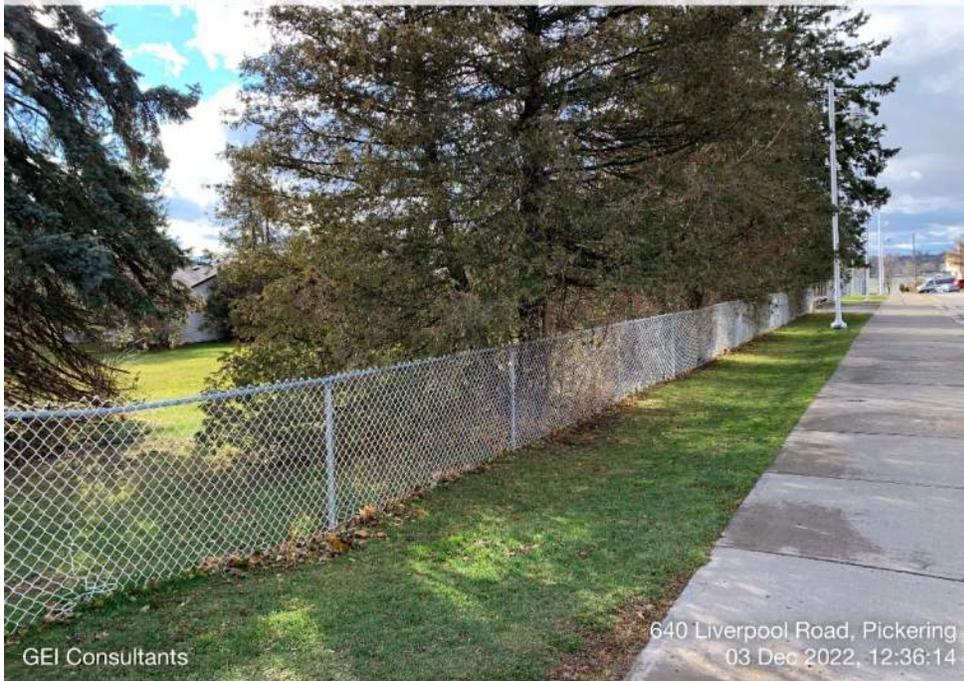
PHOTOGRAPH 18

**Description:**  
View looking along Liverpool Road, with the proposed development to the west of Liverpool Road.

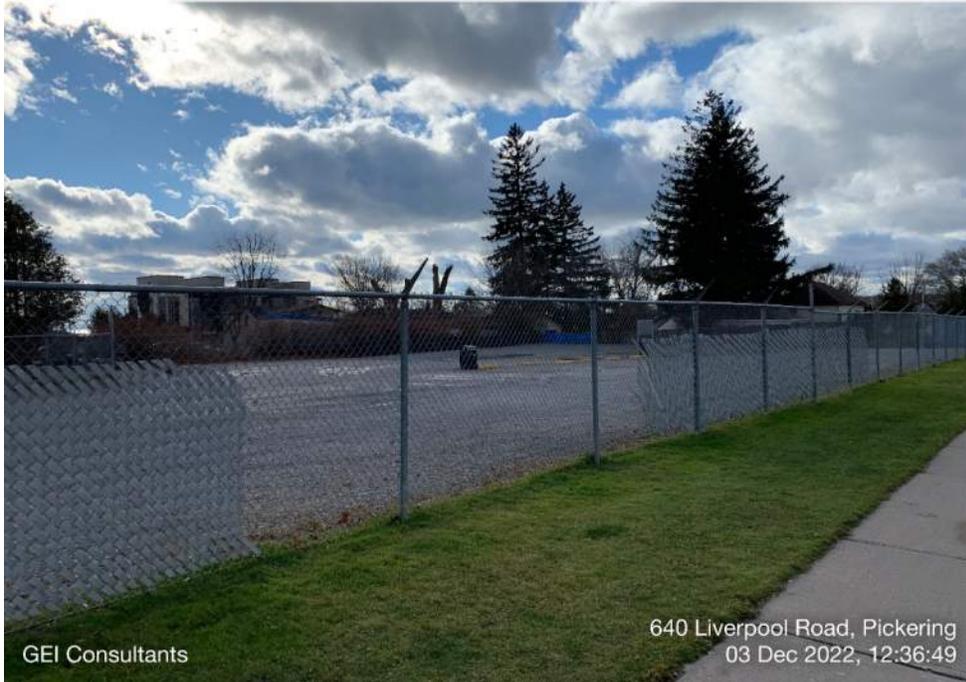
**PHOTOGRAPH 19**

View looking along Annland Street, with the proposed development to the west of Annland Street.
