**RE: Coastal Study**  
**640 Liverpool Road, Pickering**  
**Project No. 2204589**

GEI Consultants (GEI) is pleased to provide a coastal study in support of the proposed residential development to be constructed at 640 Liverpool Road in Pickering, Ontario.

Coastal Inspection/Site Visit Photographs (Dec. 3, 2022)

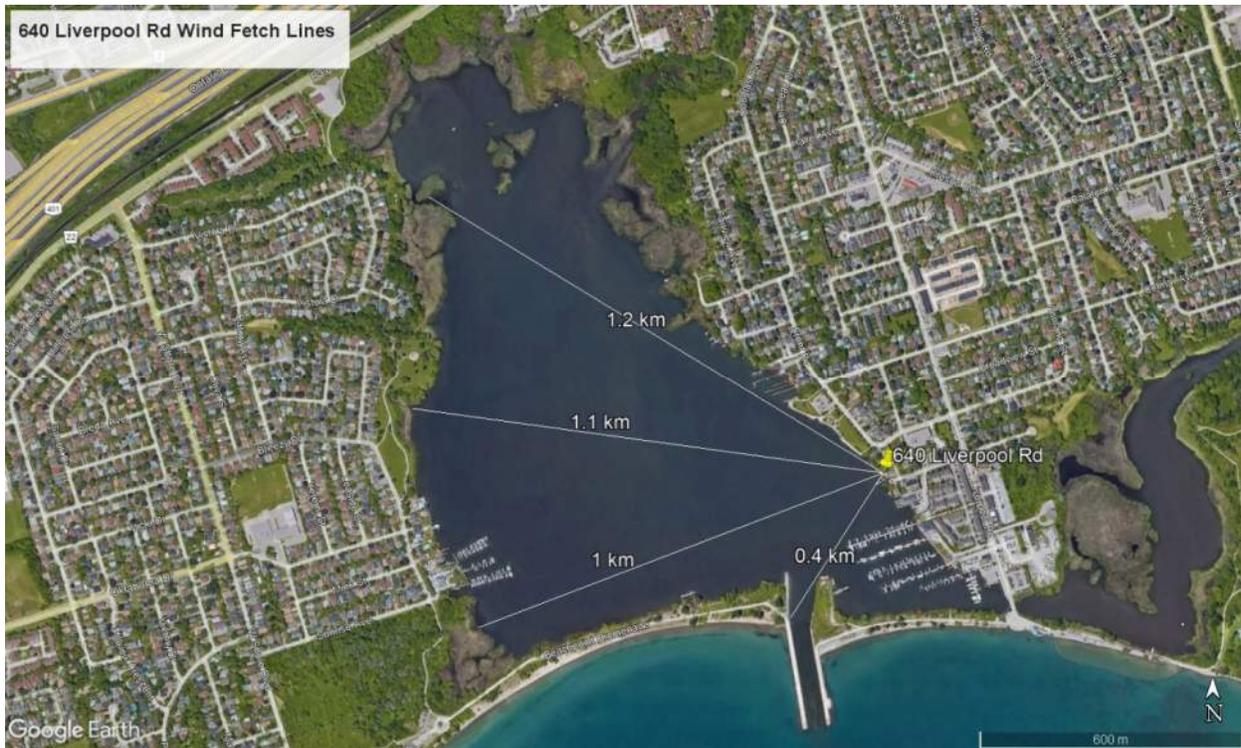
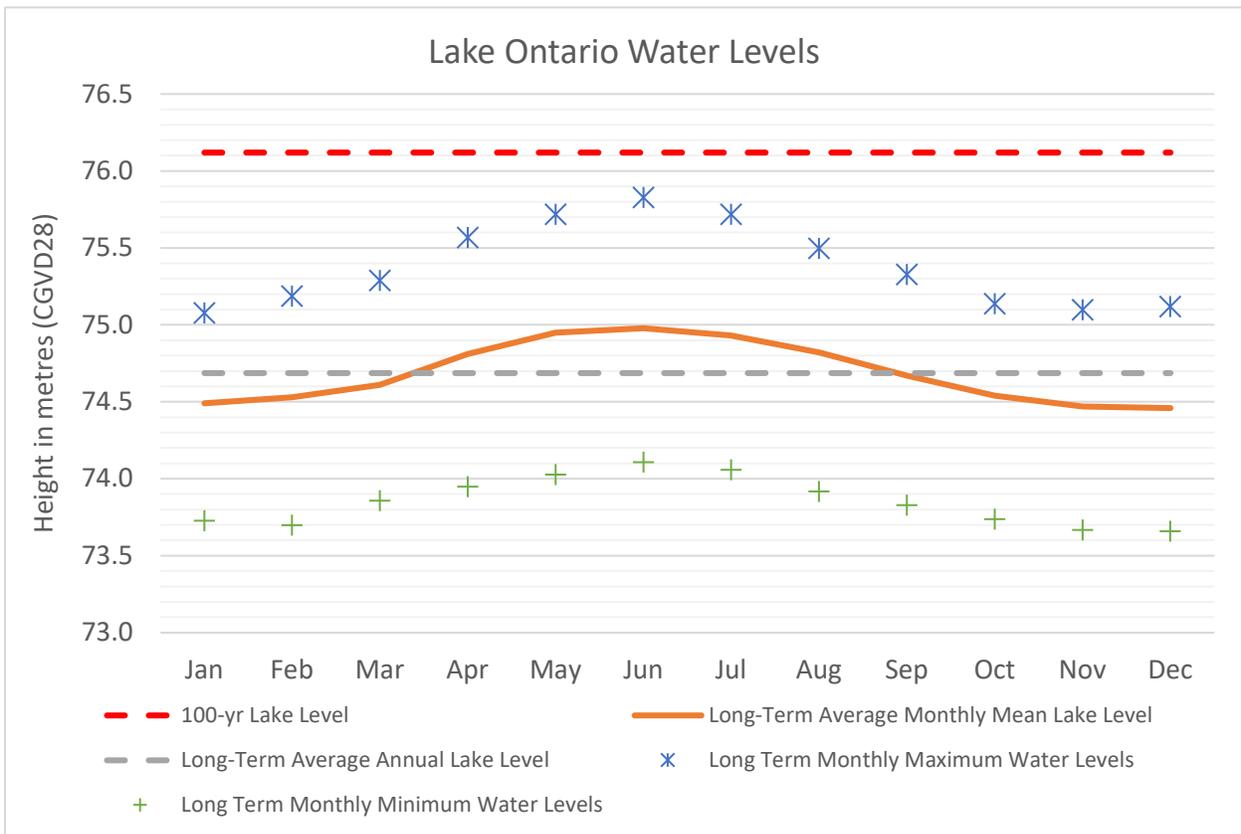
Wind Fetch Distances & Lake Ontario Water Levels

The site's location on the east side of Frenchman's Bay is relatively protected from wind and waves. Representative wind fetch lines are provided within Enclosure 3. The longest uninterrupted wind fetch is 1.2 kilometers with winds from the northwest.

most of the 0.035 ha open space parcel. For comparison, the long-term average Lake Ontario water level is 74.69 metres<sup>4</sup>. This information is presented graphically within Enclosure 3 for reference.
