# **Phase One Environmental Site Assessment**

# 3225 Balsam Road (Concession 5 Road), Pickering, ON

# 869547 Ontario Inc.

Report Date: September 10, 2021

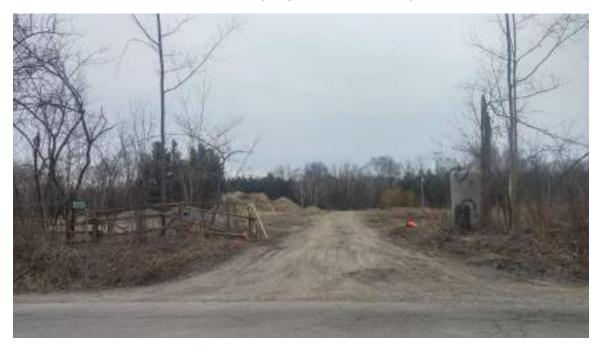
Photo 1 – View of the entrance to the West Portion of Phase One Property (looking east). The Site has an address number of 3225 Balsam Road/Sideline 4.

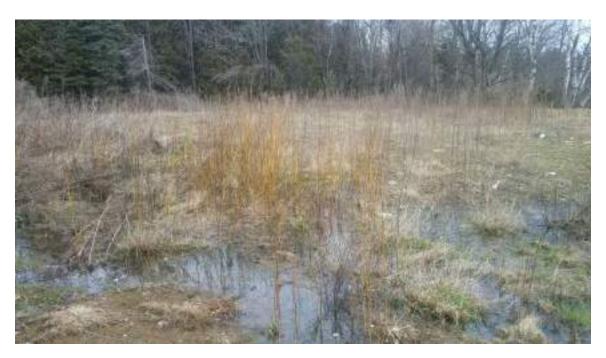
Photo 3 - View of the approximate area of the former residential house (looking northeast).

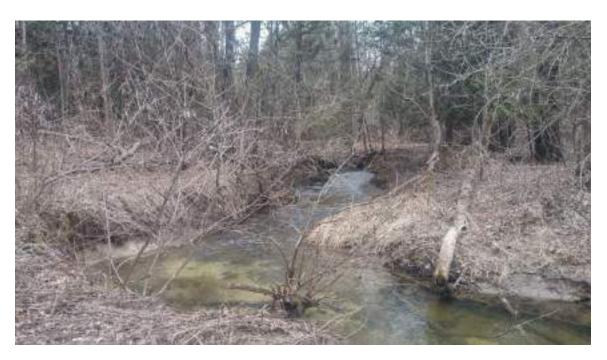
Photo 5 – View of the Carruthers Creek and the outlying floodplains noted near the center of the Phase One Property.

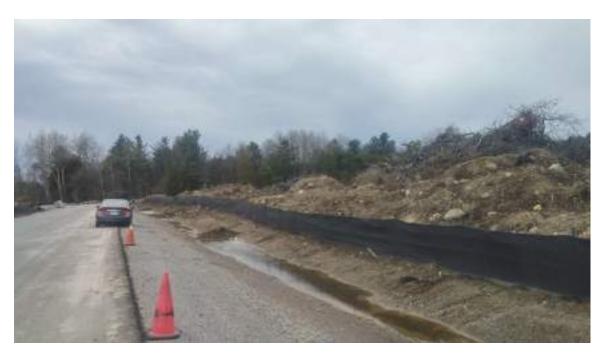
Photo 8 – View of the south property boundary of the East Portion of the Site with Dexshire Drive (looking west). A ditch and piles of the soil, fill, and could be seen near the boundary area.

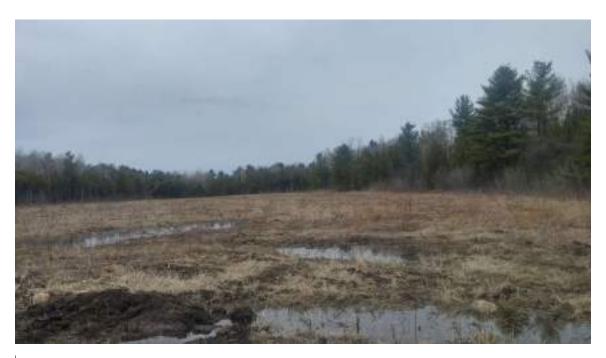
Photo 9 – View of the East Portion of the Phase One Property (looking north). Water puddles were noted.

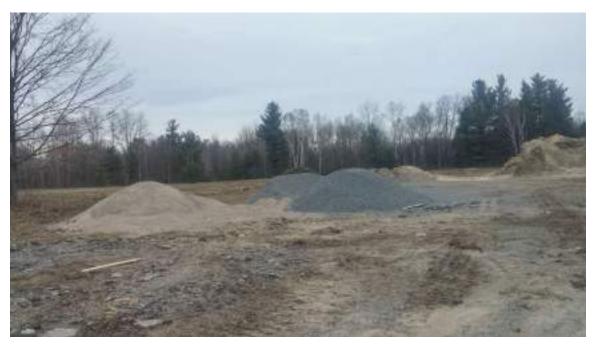
Photo 10 – View of stockpiles of gravel, sand and soil materials noted near the entrance of the West Portion of the Phase One Property (looking northeast).

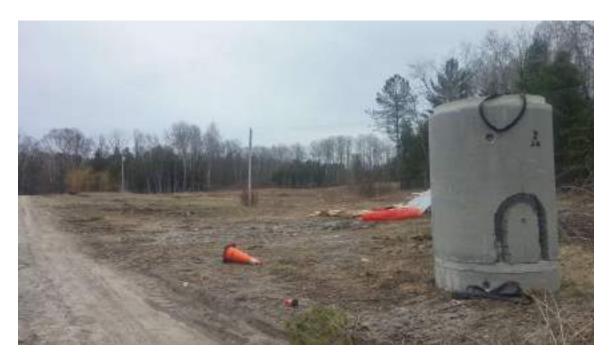
Photo 11 – View of a pre-cast concrete cylinder object noted near the entrance of the West Portion of the Phase One Property (looking southeast)

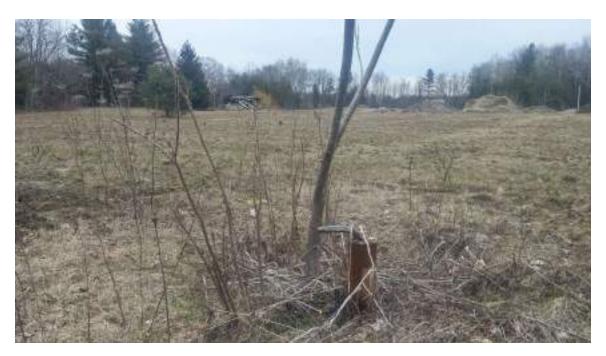
Photo 12 – View of a water well noted in the northwest corner of the West Portion of the Phase One Property (looking southeast)

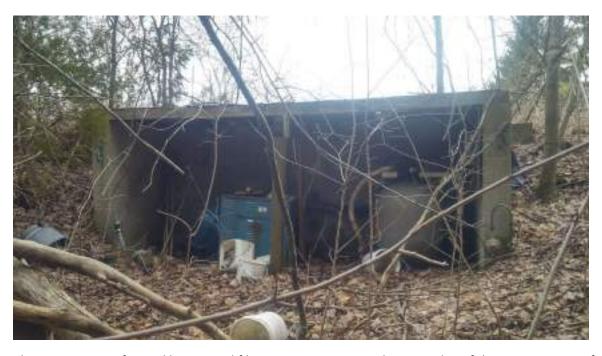
Photo 14 – View of a pool heater and filter storage area near the east edge of the West Portion of the Phase One Property (looking west)

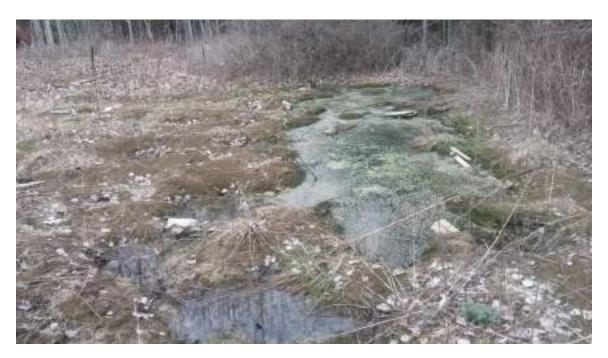
Photo 15 – View of poorly drained area(s) noted in the West Portion of the Site

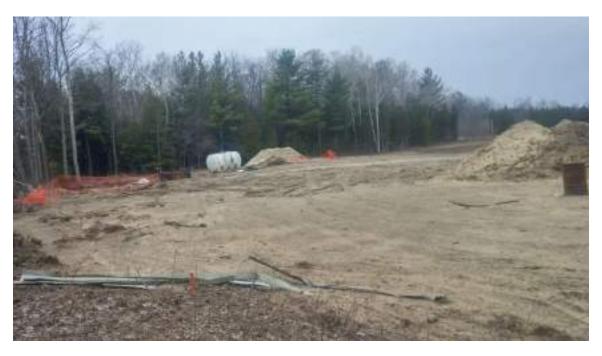
Photo 16 - View of soil stockpiles generated from two (2) excavated pits in the West Portion of the Site. A plastic storage tank was noted.

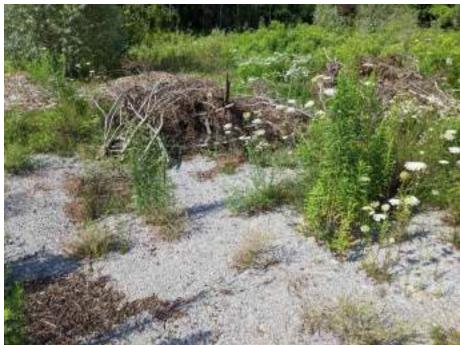
Site Photo 6. Area of formal residential house located in the western portion of the Site. Gravel present, no evidence of building structures or basements.

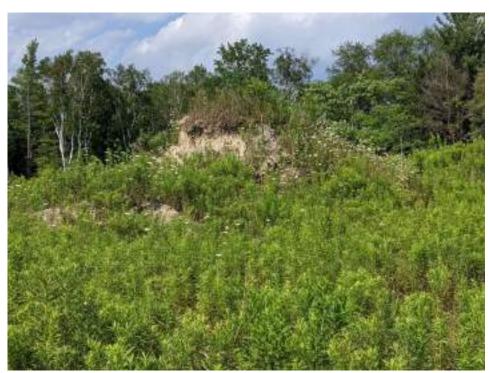
-	Rail Spurs	No rail spur was observed at the Site on the day of site reconnaissance.
-	Stressed Vegetation	No stressed vegetation was observed at the Site on the day of site reconnaissance.
SS1	Fill and Debris	Fill material and debris were noted in the western portion of the Site on the
331	Material	day of site reconnaissance.
On-site I	Buildings or Structures

Site Photo 7. Piles of fill material and debris were noted in the western portion of the Site

1) GeoPro recommends that a Sampling and Analysis Plan and a Soil Characterization Report in accordance with O. Reg. 406/19 are conducted at the Site to characterize the subsurface soil conditions in the soil being excavated at the Site

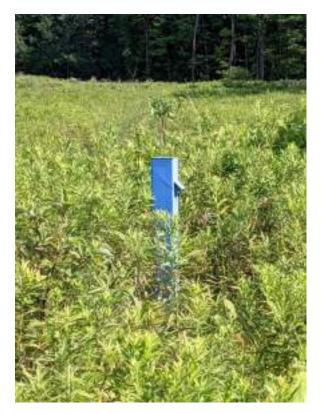
-	Storage Tanks	No underground/above the ground storage tank ("USTs/ASTs") was observed at the Site on the day of site reconnaissance.
-	On-Site Wells	Monitoring wells were observed at the Site on the day of site reconnaissance.

Site Photo 8. Monitoring wells noted throughout the Site

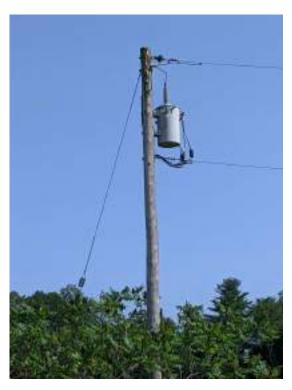
-	Other observation	Transformer was noted on a telephone pole in the western portion of the Site. No staining, spills, or discolouration was noted.
-		Woodland covers the central portion, southwest portion, and northern portion of the Site, access to the woodland was limited
Addition	al Potential Environment	al Concerns – Designated Substances

Site Photo 9. Transformer located on a telephone pole in the western portion of the Site. No spills, staining, discoloration or leaks observed.

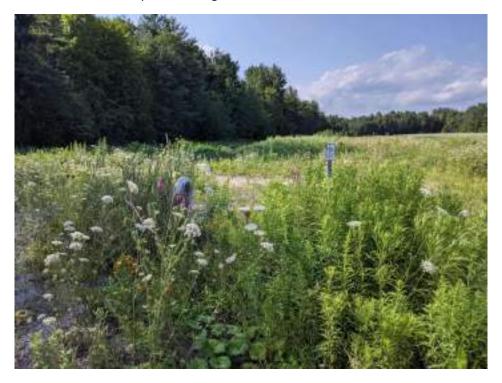
-	Underground Utilities	No gas meters or buried gas lines were observed on the Site. A high pressure watermain was observed on the day of site reconnaissance.

Site Photo 10. Underground water utilities present in the eastern portion of the Site

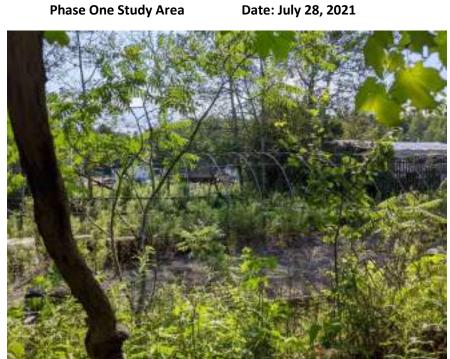
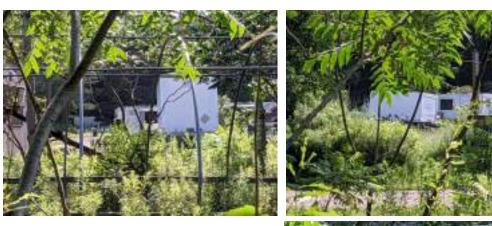
Study Area Photo 1. Industrial Storage at 3330 Balsam Road. Photo taken facing west.

Study Area Photo 2. Alternative views of the Industrial Storage at 3330 Balsam Road.

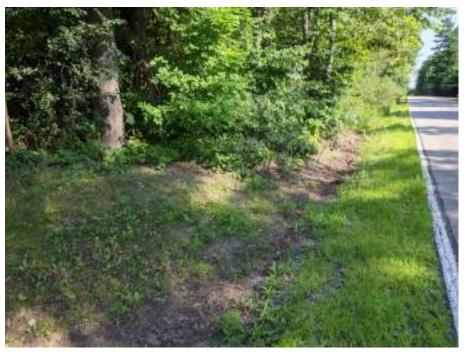
Study Area Photo 4. Ditches observed running along Balsam Road.
