December 21, 2022  
CT3414.01

**Re: Phase One and Phase Two Environmental Site Assessment Updates  
1280, 1288, 1290, 1292, 1294 Wharf Street and 607 Annland Street, Pickering,  
ON**

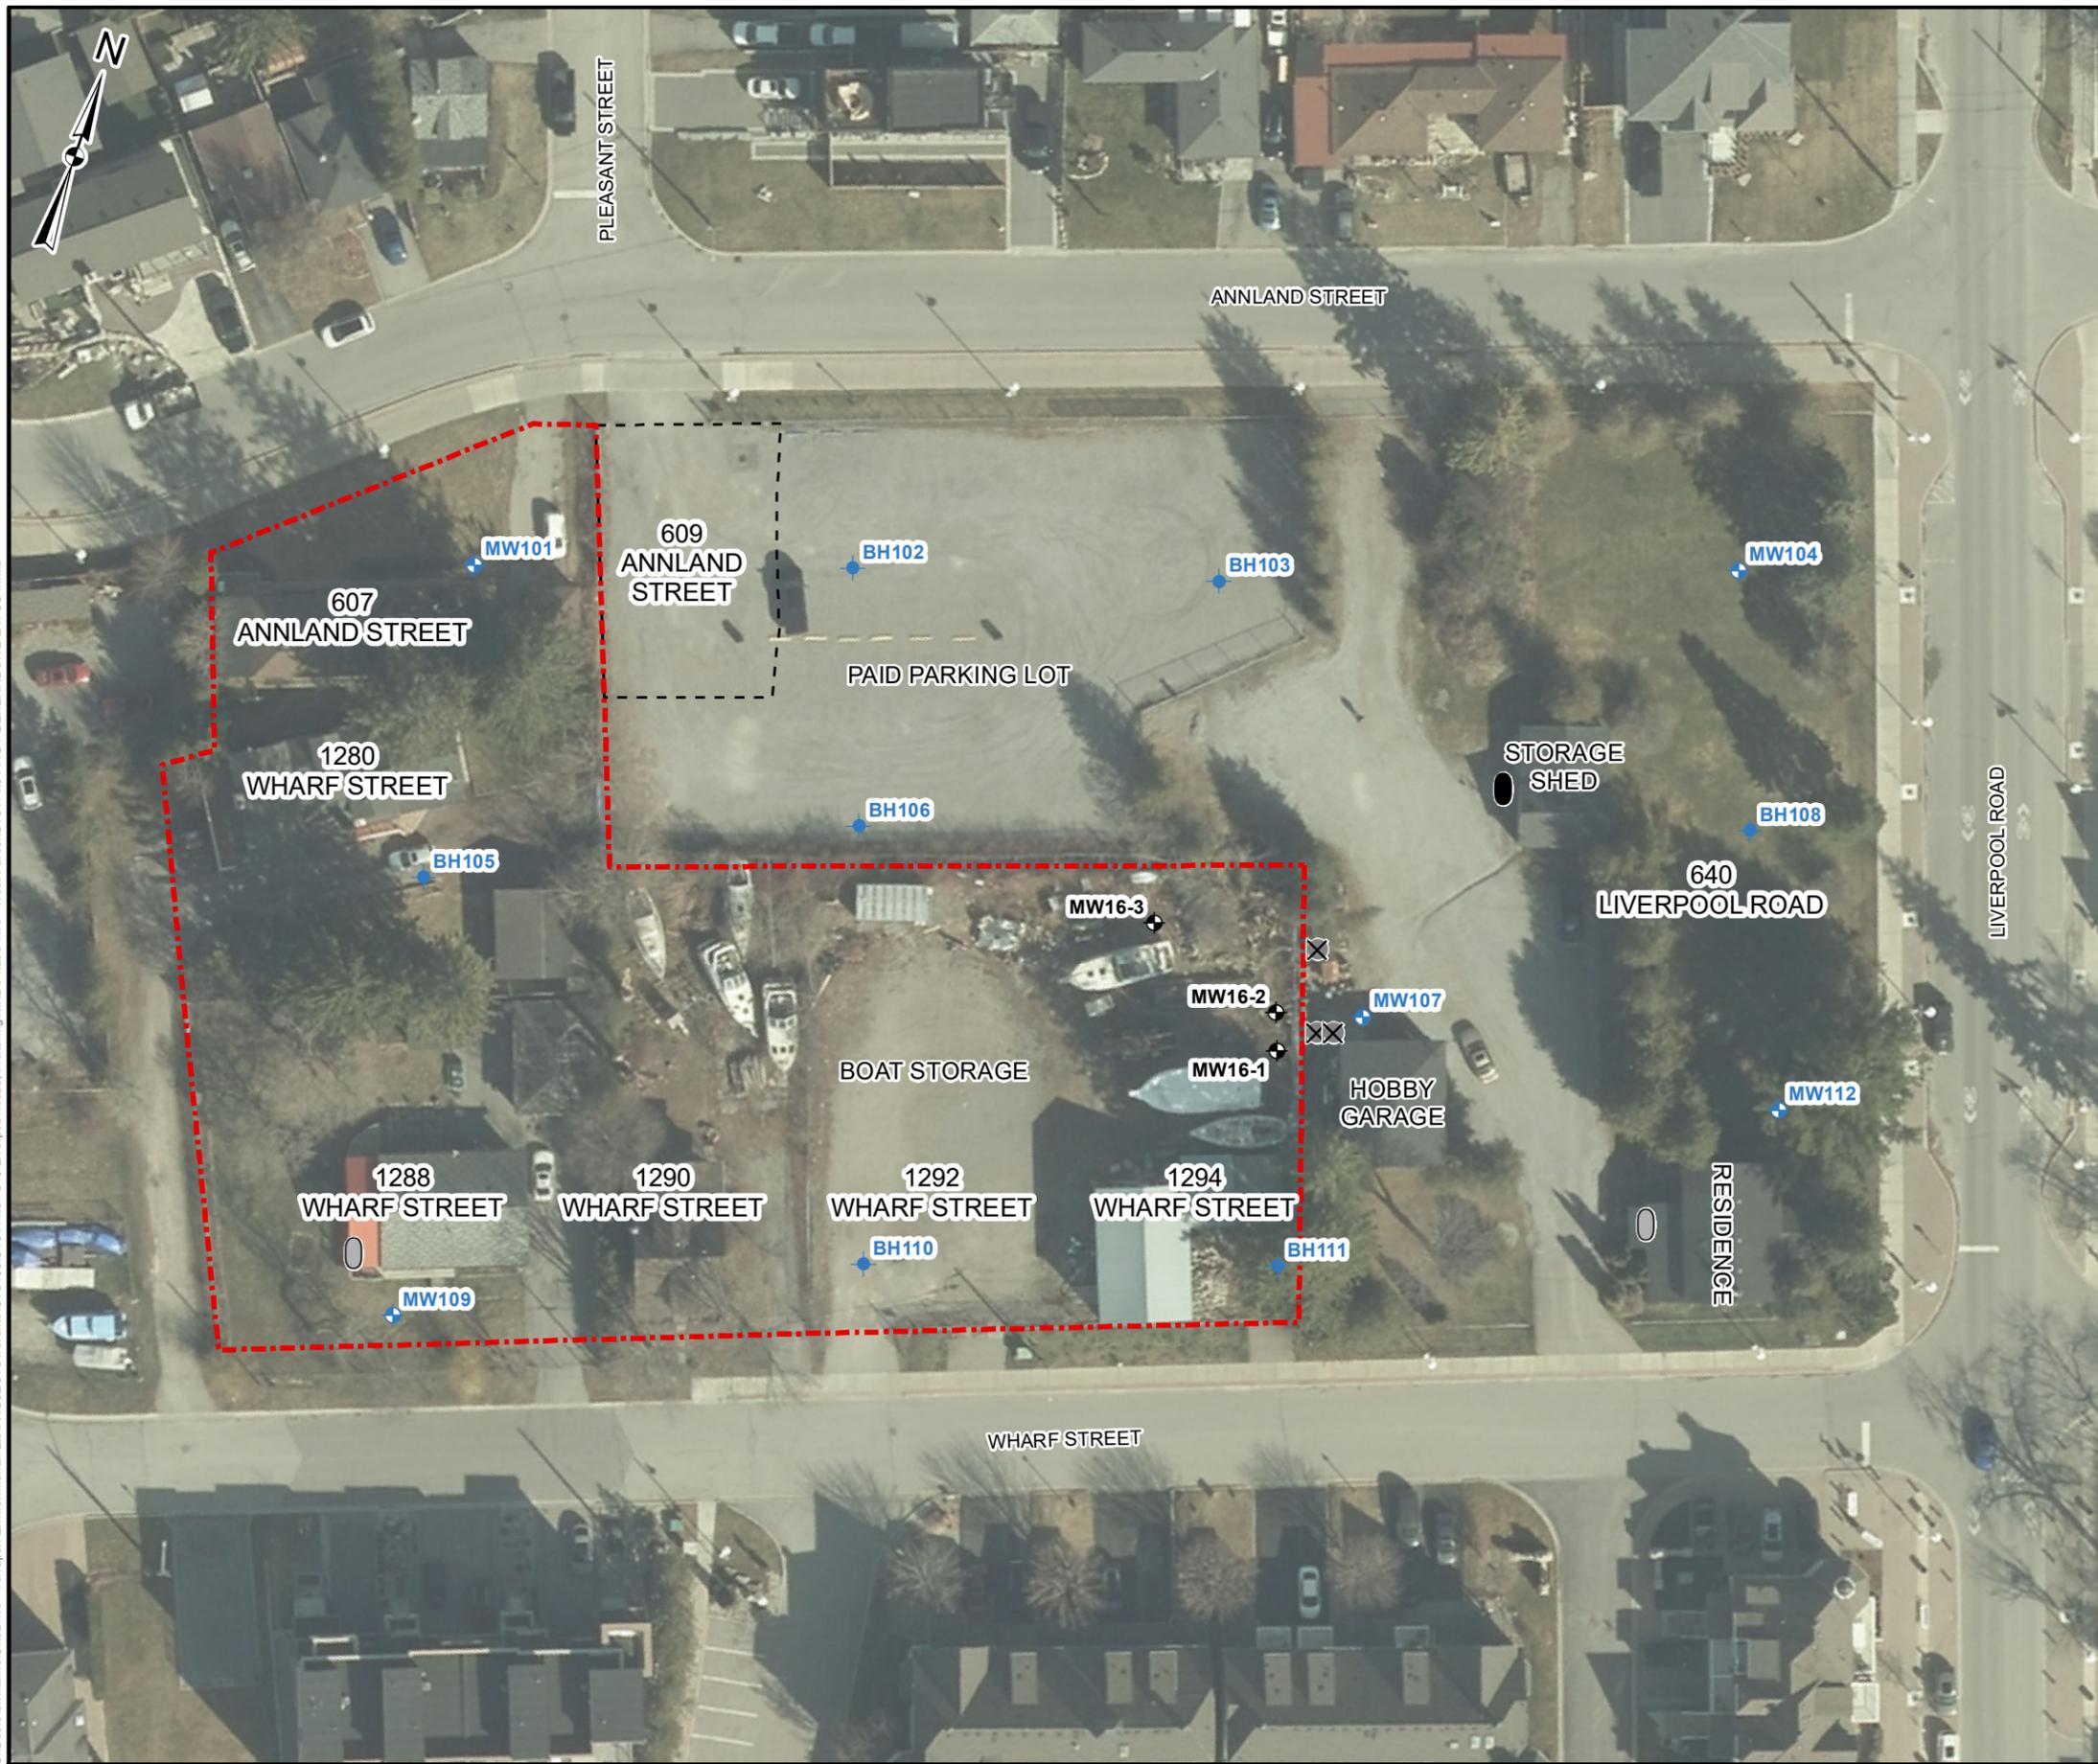
DRAWN BY: SW	PROJECT NO.: CT3414.01	CHECKED BY: SJS
REVISION: 00	DATE: NOVEMBER 2022	FIGURE: <b>1</b>

Terrapex Environmental Ltd. (Terrapex) was retained by Liverpool Limited Partnership to conduct environmental site assessment (ESA) activities at the property located at 1280, 1288, 1290, 1292, 1294 Wharf Street and 607 Annland Street, Pickering, Ontario (Site) since the filing of the Record of Site Condition (RSC) for the Site in 2018. The Site measures approximately 0.55 hectares (1.37 acres) and consists of seven lots situated on the north side of Wharf Street, approximately 50 (m) west of Liverpool Road (Figure 1).

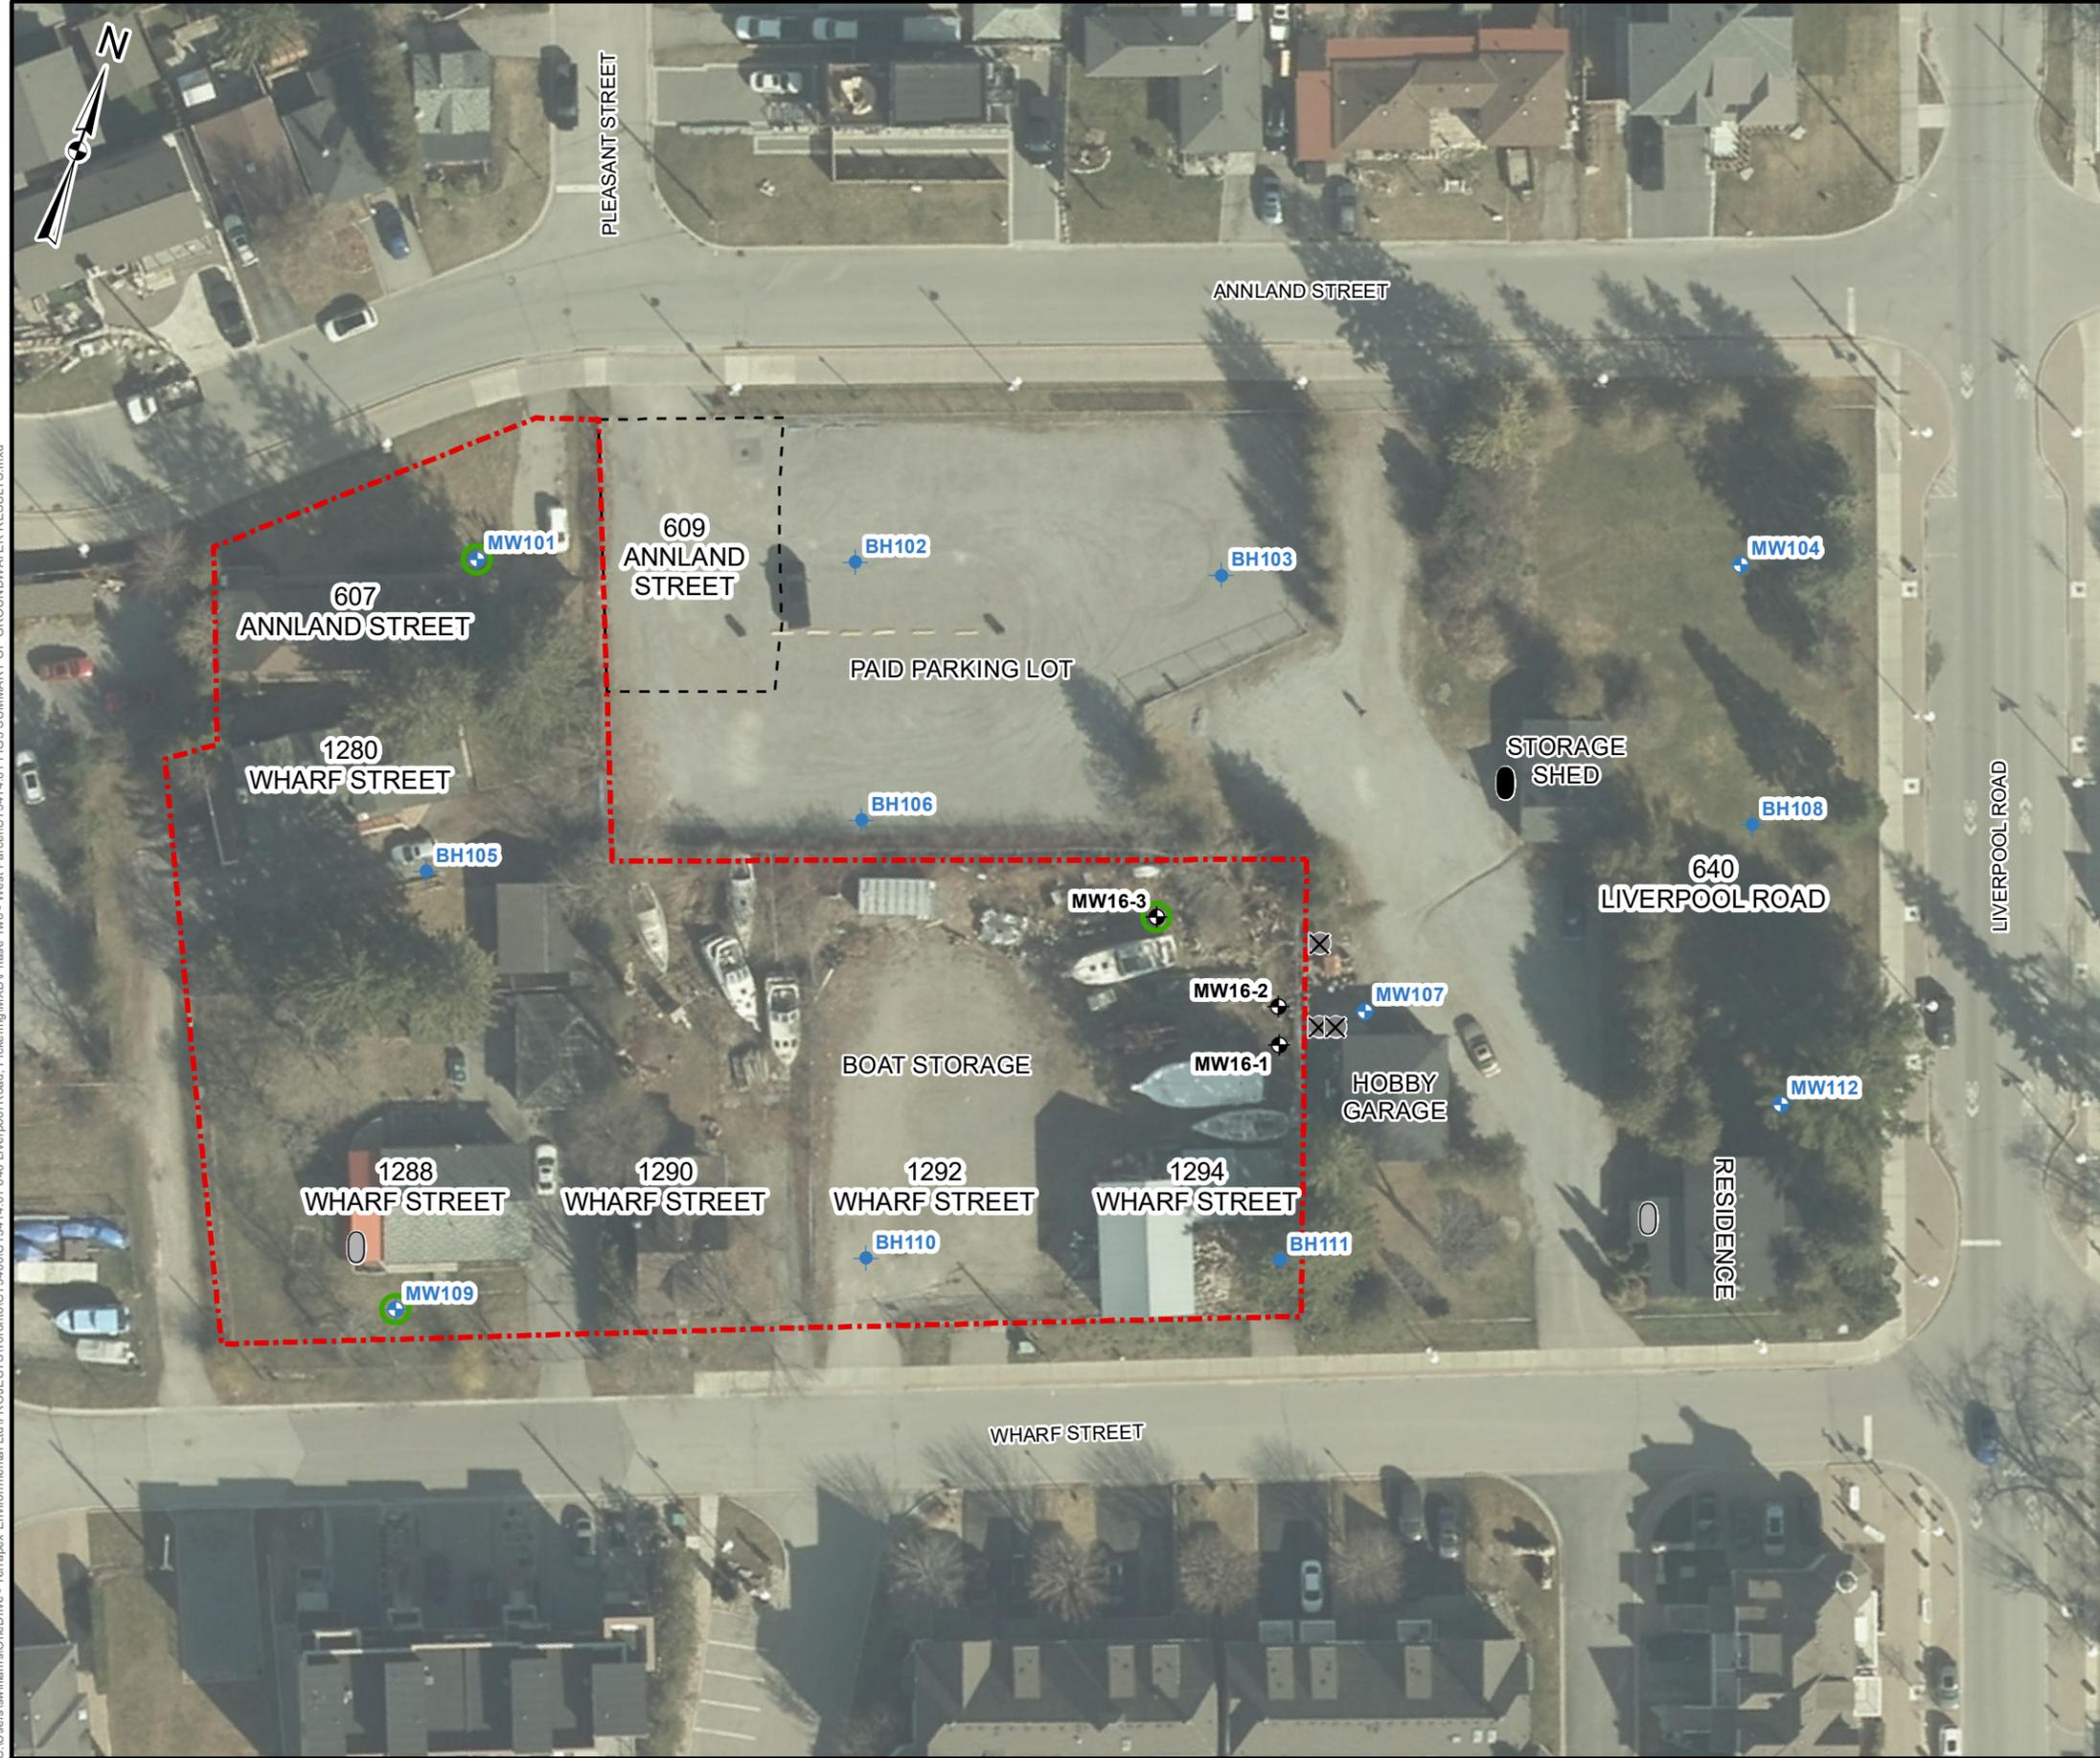
C:\Users\swilliams\OneDrive - Terrapex Environmental Ltd\PROJECTS\Toronto\CT3400\CT3414.01\_640\_Liverpool Road - Pickering\MXD\Phase Two - West Parcel\CT3414.01\_FIG3\_SUMMARY OF GROUNDWATER RESULTS.mxd

As summarised in the tables, concentrations of all parameters in the groundwater samples were below the applicable SCSs. However, it should be noted that the groundwater sample collected from MW101 on September 8, 2022 had a concentration of cobalt above the Table 2 SCSs. In order to confirm the lab data, groundwater samples were subsequently collected from MW101 on October 13 and 27, 2022 using finer (0.2 µm) inline filters and analysed for metals. Concentrations of all metal parameters in the two subsequent sampling events were below the Table 2 SCSs. As a result, the initial exceedance of cobalt was assessed to have been due to the presence of suspended particulate within the groundwater sample and not representative of groundwater quality.

Based on the Phase Two ESA findings, concentrations of all parameters in the analysed groundwater samples were below the Table 2 SCSs. As a result, no further investigation is recommended at this time.

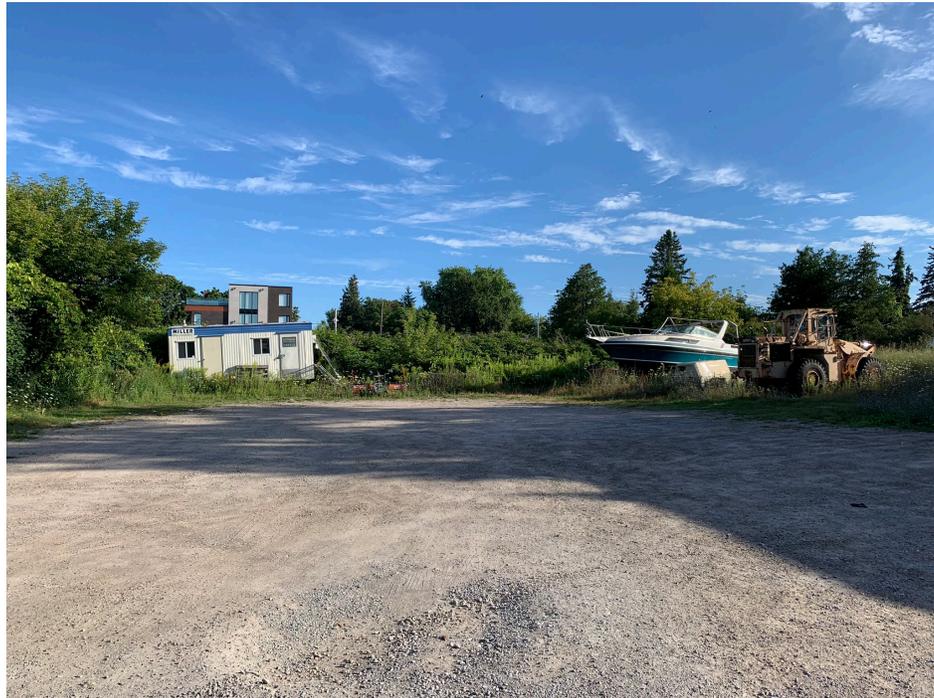
View of the gravel parking lot on the eastern portion of the Site. A trailer, heavy equipment, jet-ski, and boat were noted during the Site visit.

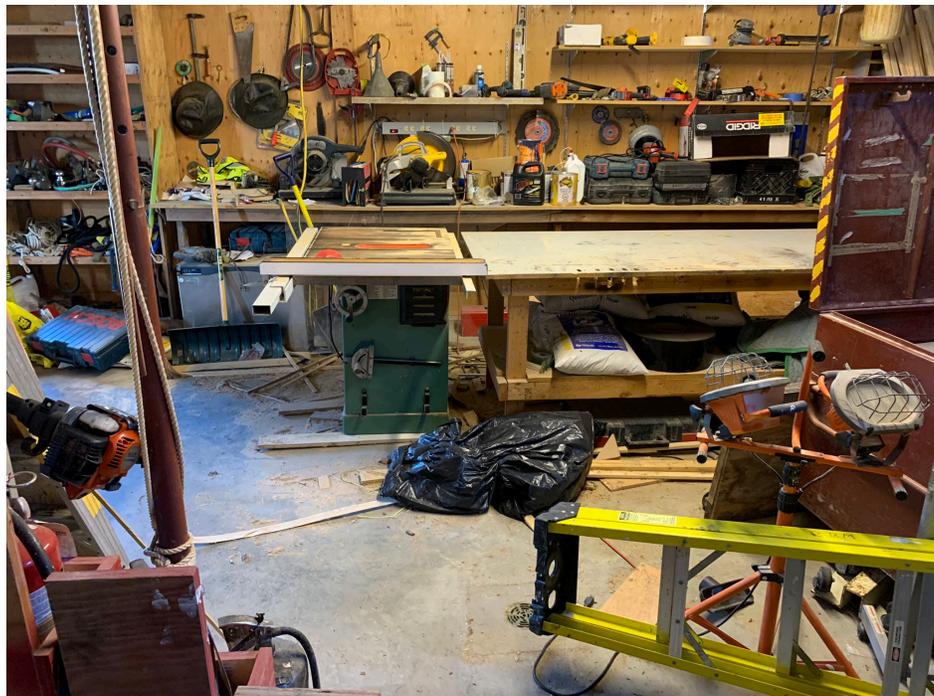
**Photo No:** 2

View of the interior of the 1294 Wharf Street workshop with floor drain and oil containers.

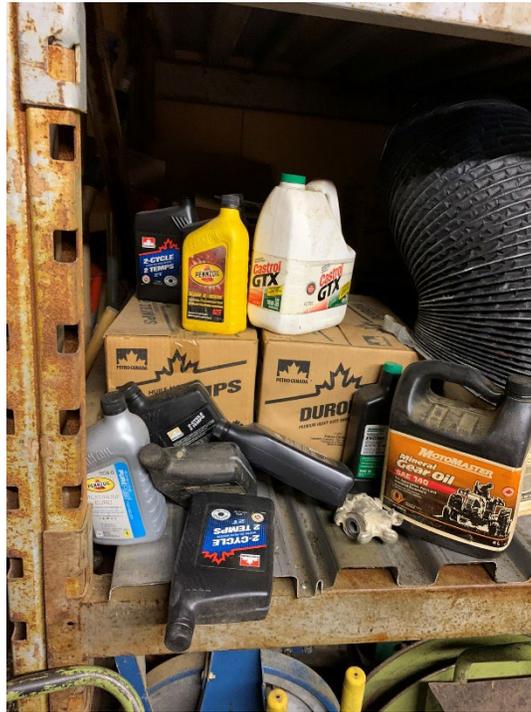
View of the containers of new motor oil in the 1294 Wharf Street workshop.

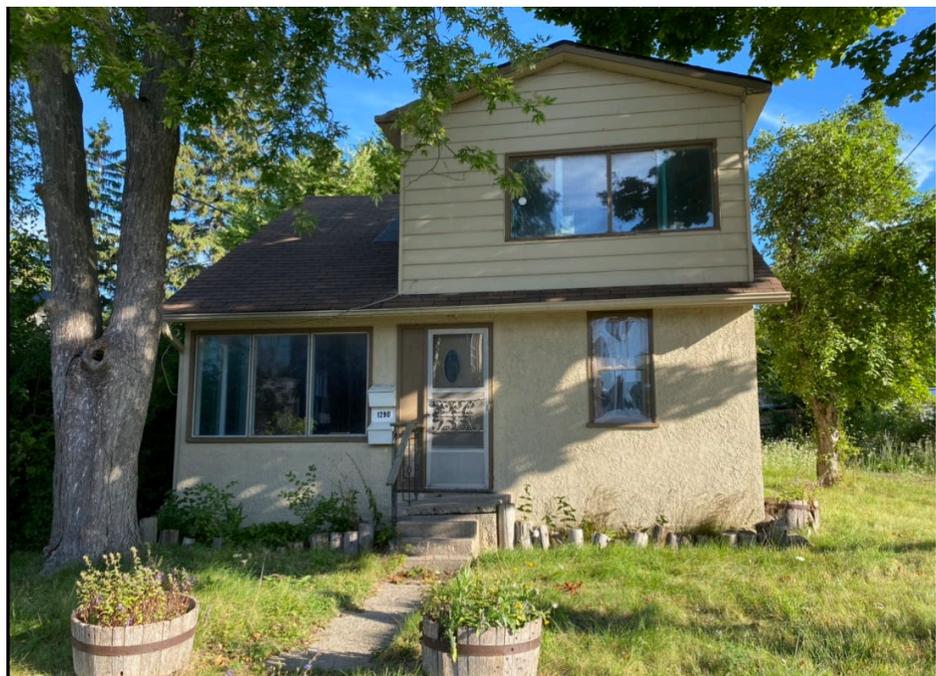
**Photo No:** 4**Date:** August 10, 2022**Viewing Direction:**  
North**Description:**

Exterior view of the vacant residential dwelling at 1290 Wharf Street.

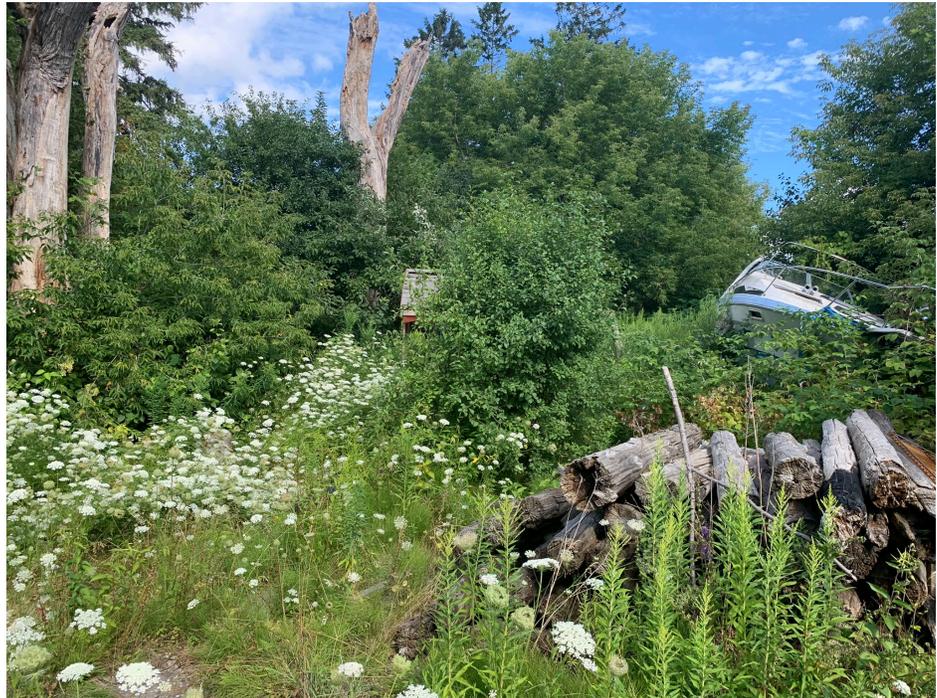
**Client:** Liverpool Limited Partnership**Site Location:** 1280, 1288, 1290, 1292, 1294 Wharf Street and 607 Annland Street, Pickering, Ontario, Canada**Project No:** CT3414.01**Photo No:** 5**Date:** August 10, 2022**Viewing Direction:** North**Description:**

View of the overgrown back yard at 1290 Wharf Street, including a pile of wood and a derelict boat.

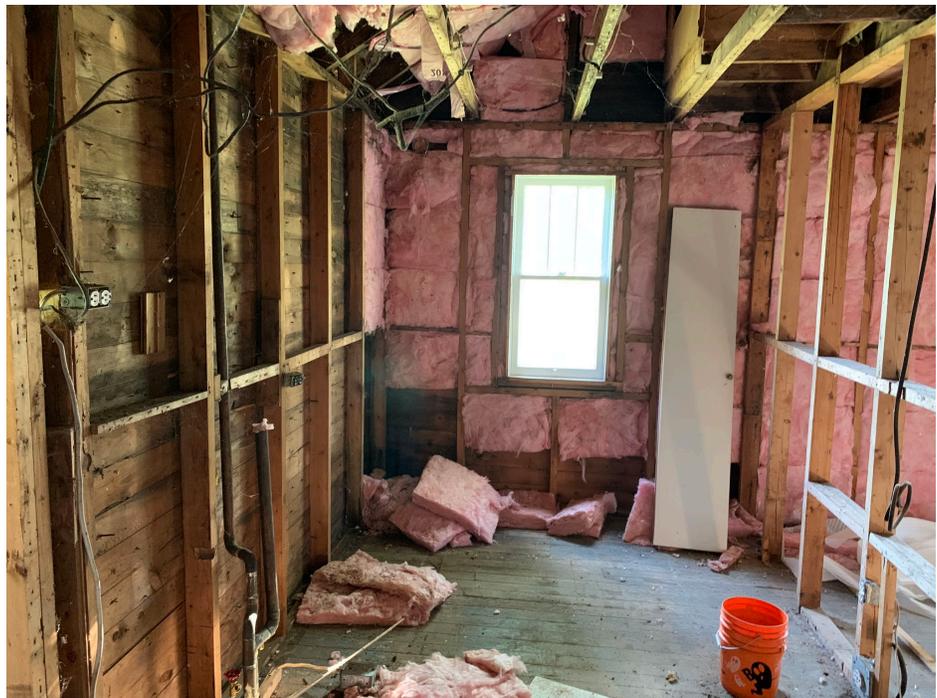
**Photo No:** 6**Date:** August 10, 2022**Viewing Direction:** N/A**Description:**

Interior view of the ground floor of the vacant dwelling at 1290 Wharf Street showing exposed insulation, framing, and wood floors.

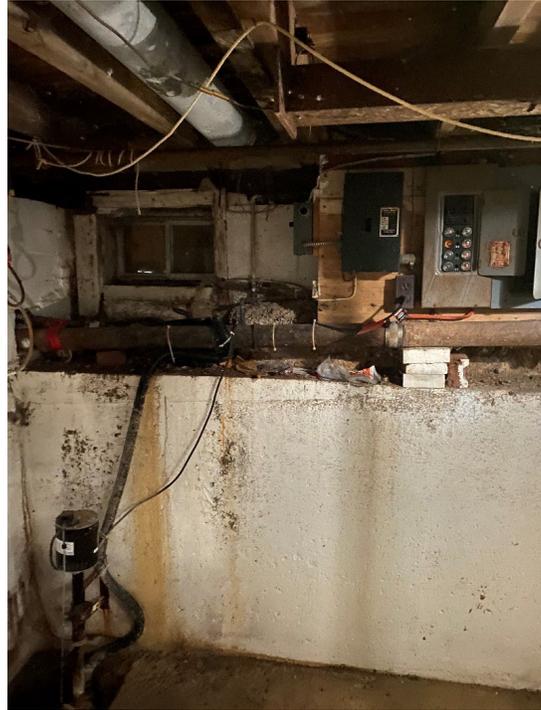
Interior view of the electrical panel and sump pump in the basement of the dwelling at 1290 Wharf Street.

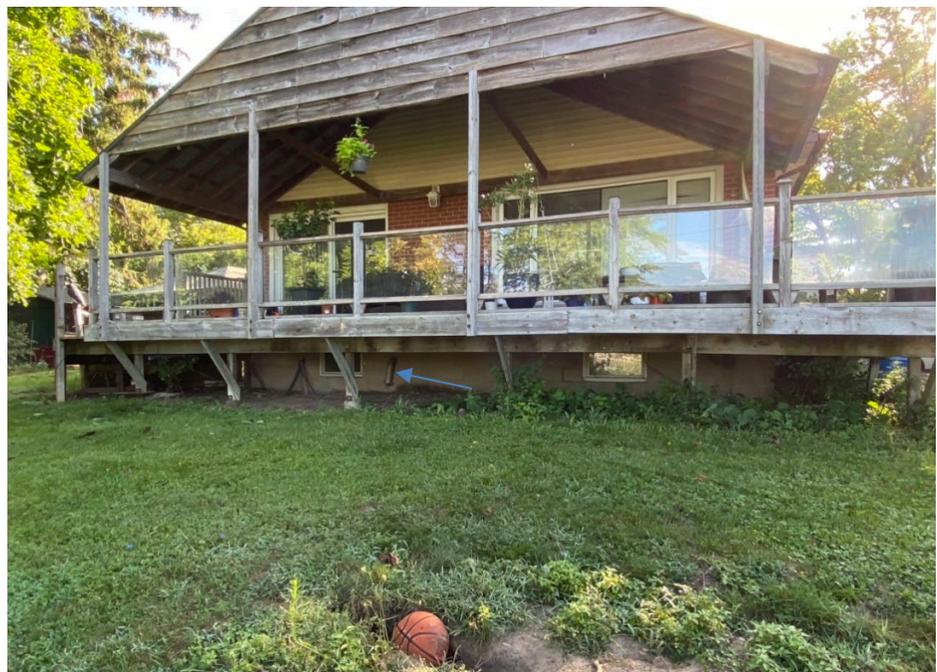
**Photo No:** 8**Date:** August 10, 2022**Viewing Direction:**  
East**Description:**

Exterior view of the west side of the dwelling at 1288 Wharf Street. Note the fill and vent piping under the deck, as indicated by the arrow.

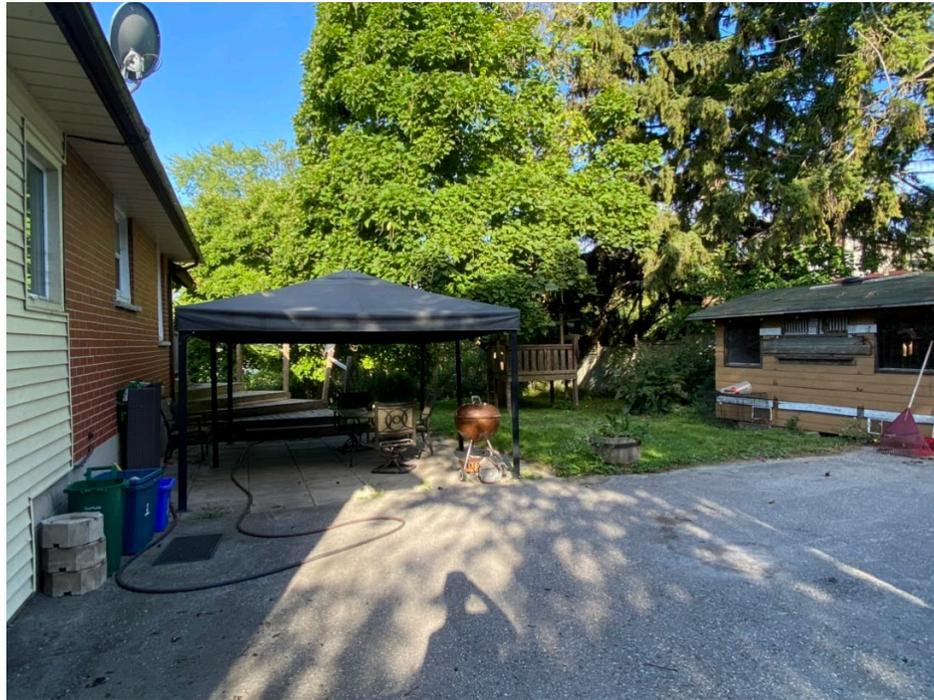
**Client:** Liverpool Limited Partnership**Site Location:** 1280, 1288, 1290, 1292, 1294 Wharf Street and 607 Annland Street, Pickering, Ontario, Canada**Project No:** CT3414.01**Photo No:** 9**Date:** August 10, 2022**Viewing Direction:** Northwest**Description:**

View of the backyard of 1288 Wharf Street. The structure on the right side is a chicken coop.

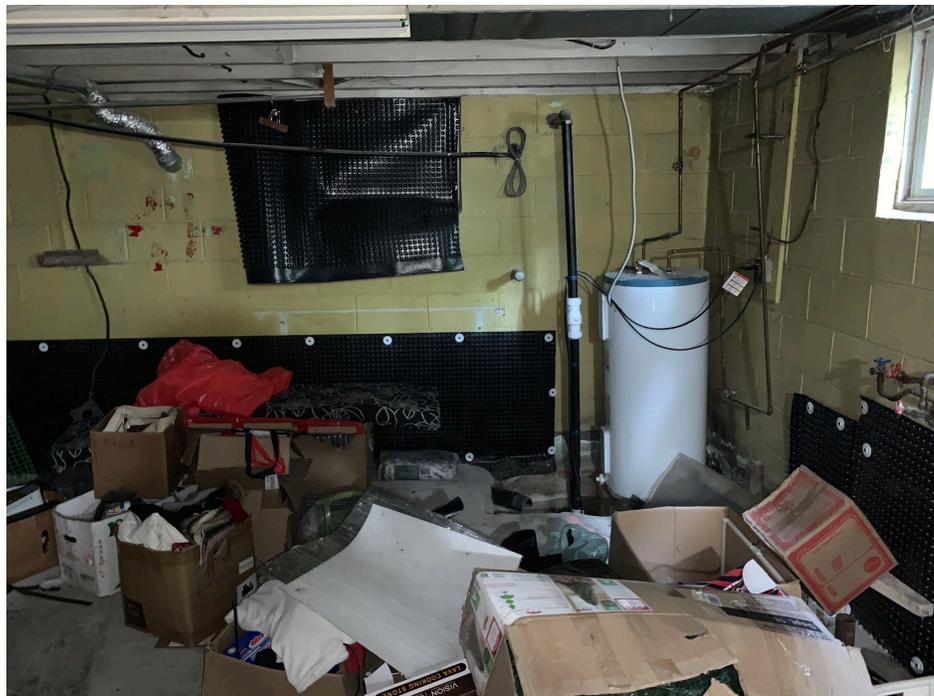
**Photo No:** 10**Date:** August 10, 2022**Viewing Direction:** N/A**Description:**

View of the basement at 1288 Wharf Street showing a new hot water tank and piping and debris covering the floor.

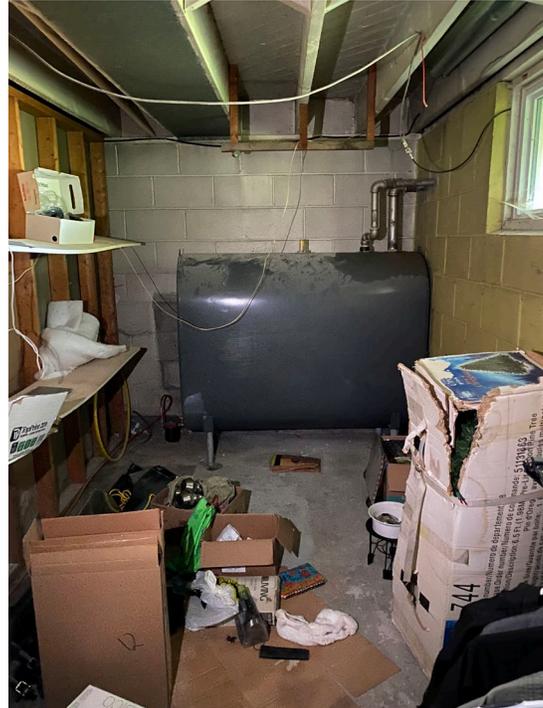
The Site visit identified an above ground storage tank in the basement of the residential dwelling at 1288 Wharf Street that was not previously identified during Pinchin's Phase One ESA. The AST was situated on the concrete floor at the southwest corner of the basement. Upon inspection, the AST and concrete floor appeared to be in good condition with no signs of staining. The heating oil tank appeared to be no longer in service as the heating system in the residence had been converted to a natural gas furnace. The visit didn't identify any other significant changes at the Site.

View of the above ground storage tank situated in the basement of the residence at 1288 Wharf Street. No evidence of a spill or release (i.e., staining) was observed on the concrete floor.

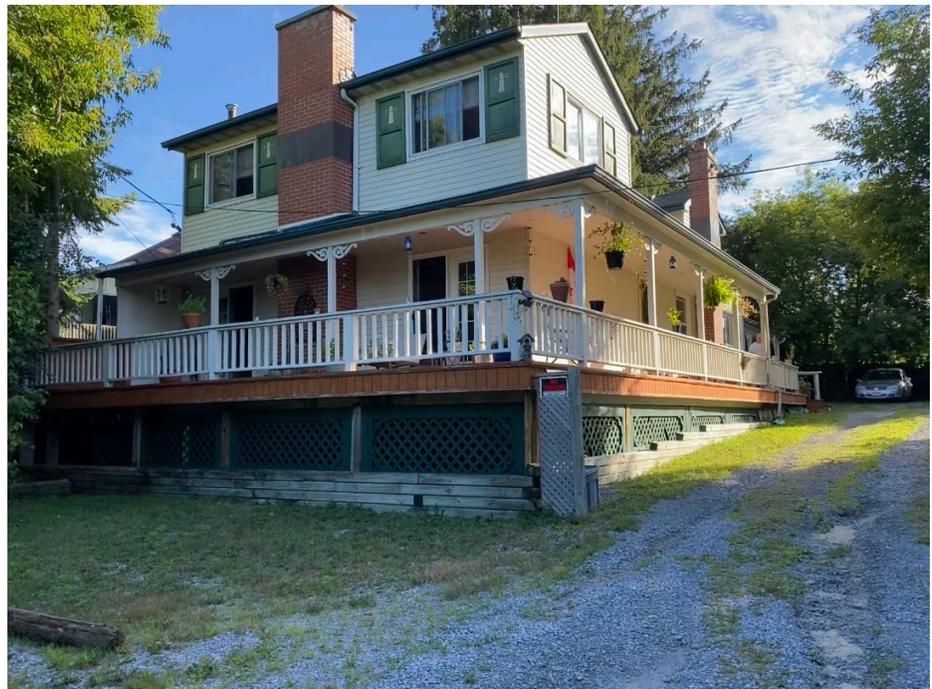
Exterior view of the dwelling at 1280 Wharf Street.

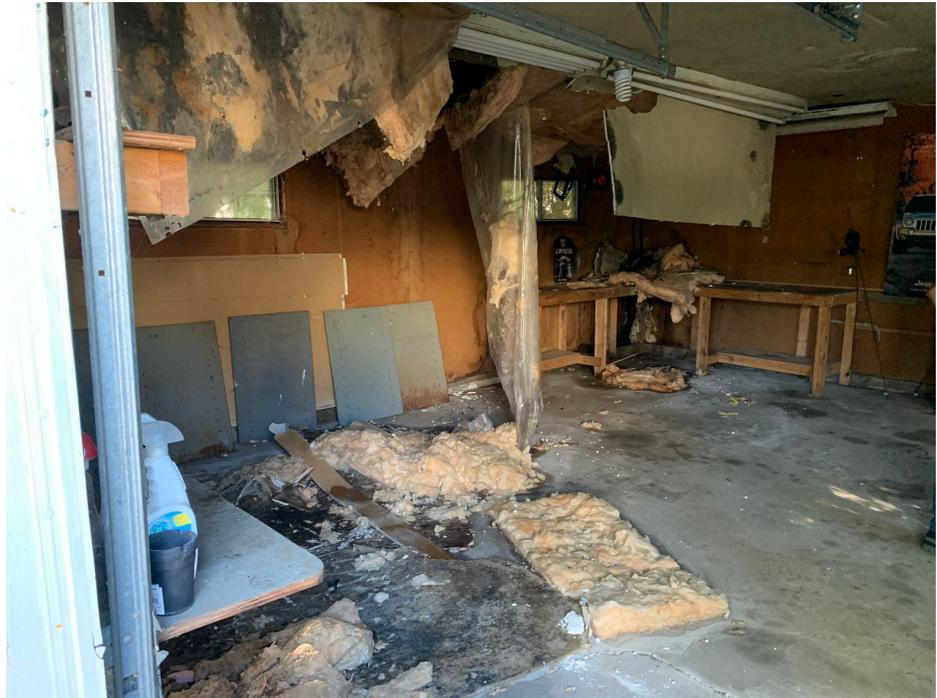
Interior view of the garage located at 1280 Wharf Street. Note the fallen insulation from the damaged ceiling, mould staining, and water damage.

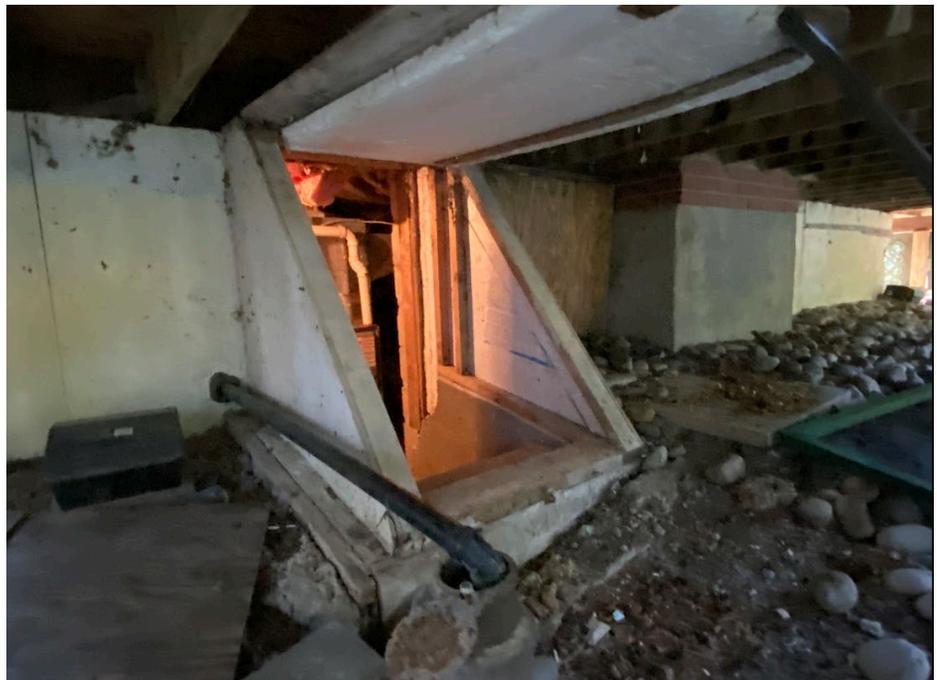
**Photo No:** 14**Date:** August 10, 2022**Viewing Direction:** Southeast**Description:**

View of the entrance to the crawl space below the dwelling at 1280 Wharf Street.

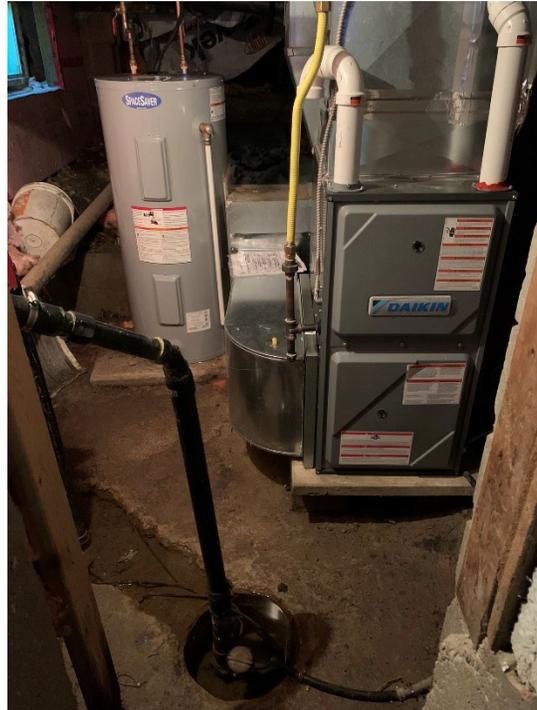
View of the hot water tank and natural gas furnace in the crawl space below the dwelling at 1280 Wharf Street.

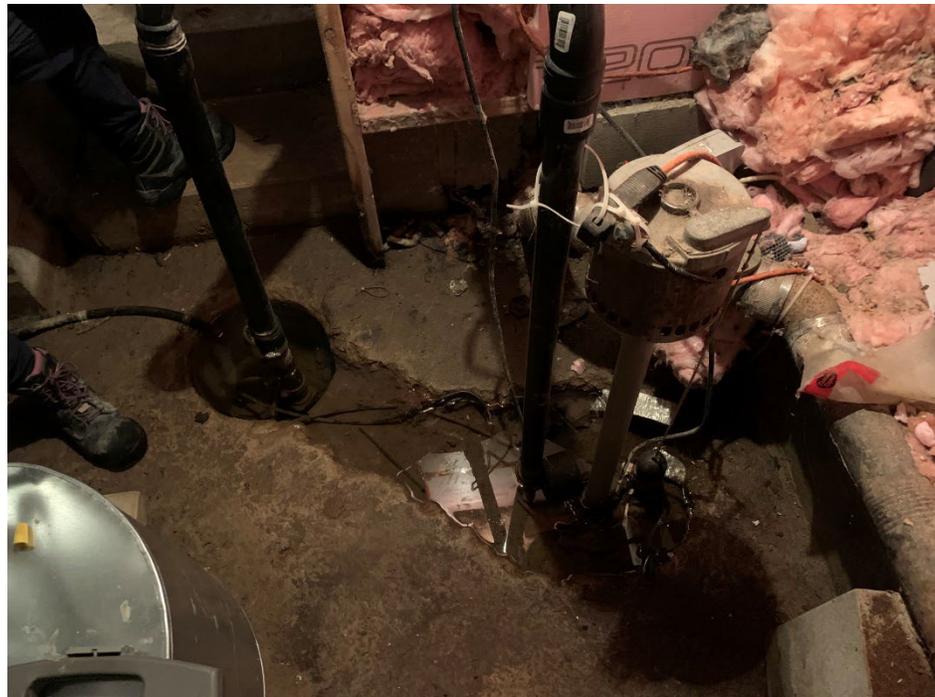
**Photo No:** 16

View of the sump pump and exposed insulation in the crawl space below the dwelling at 1280 Wharf Street.

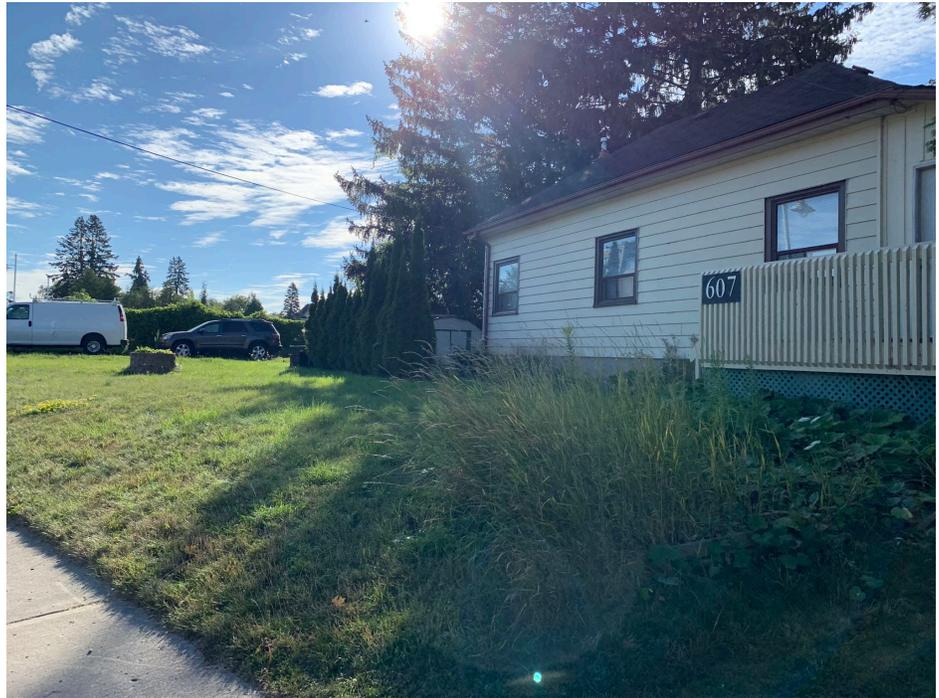
Exterior view of the north side of the dwelling at 607 Annland Street.

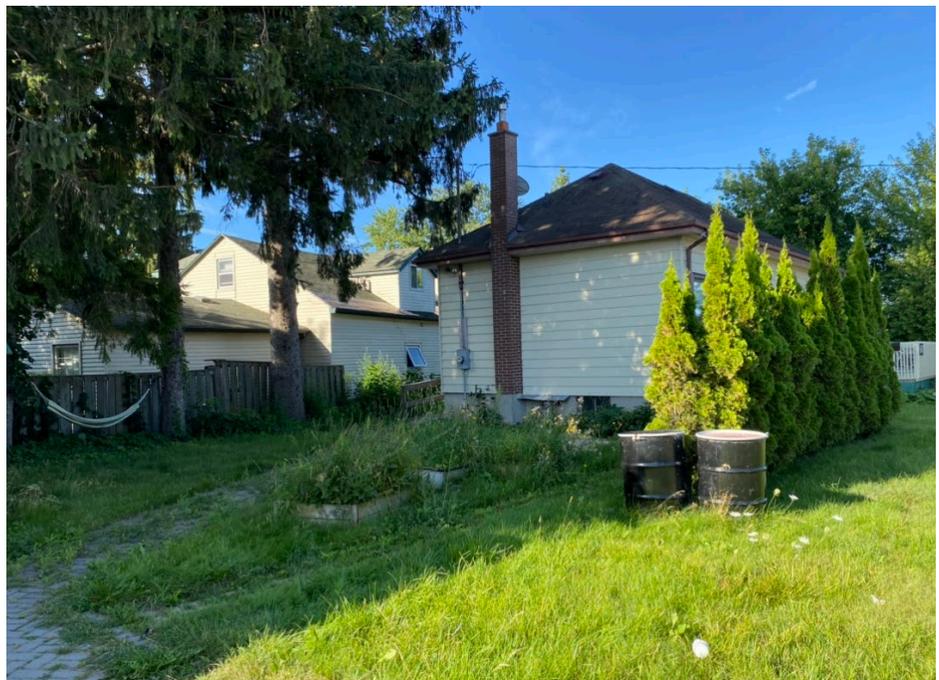
**Photo No:** 18

View of backyard of the dwelling at 607 Annland Street. The two drums contain soil cuttings from previous investigation activities.

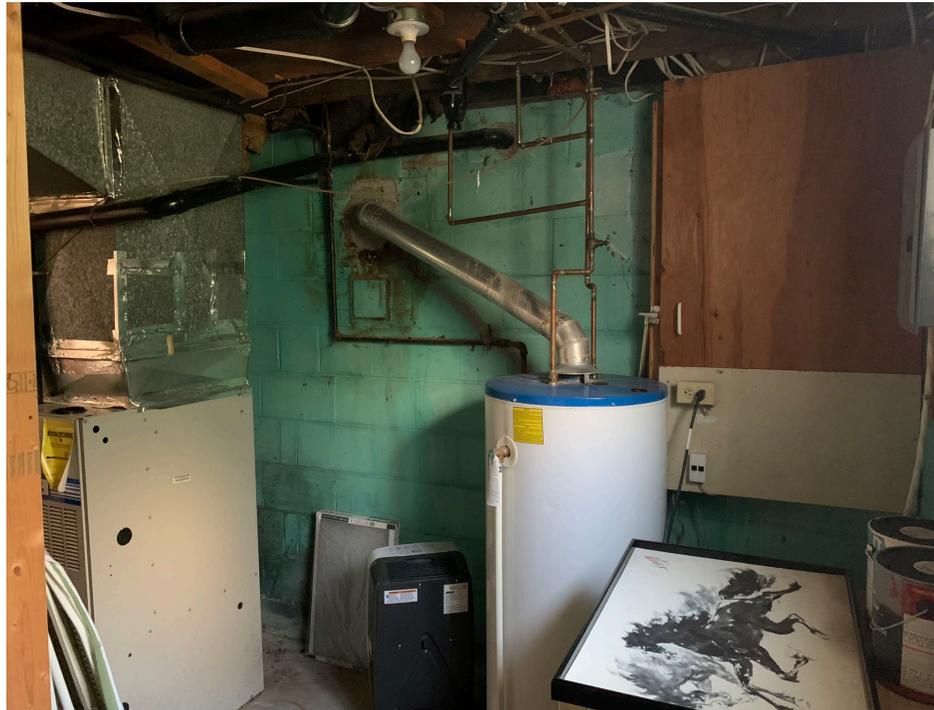
View of the hot water tank, natural gas-fired furnace in the basement of the dwelling at 607 Annland Street.

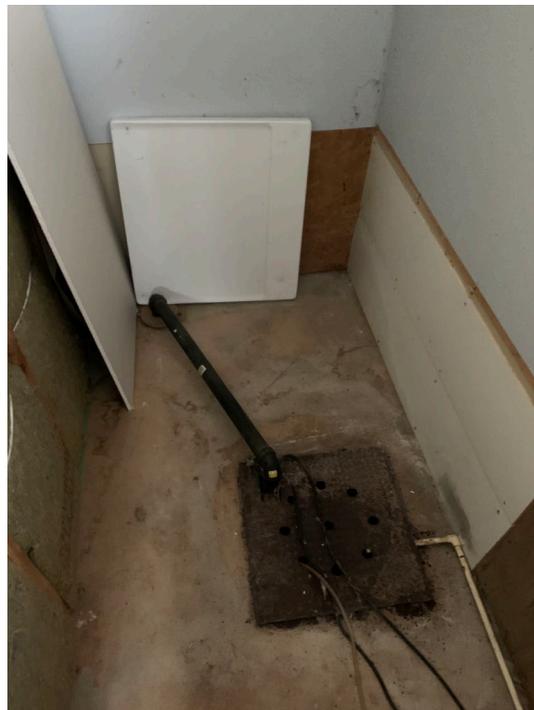
**Photo No:** 20**Date:** August 10, 2022**Viewing Direction:**  
N/A**Description:**

View of the sump pit in the basement of the dwelling at 607 Annland Street.

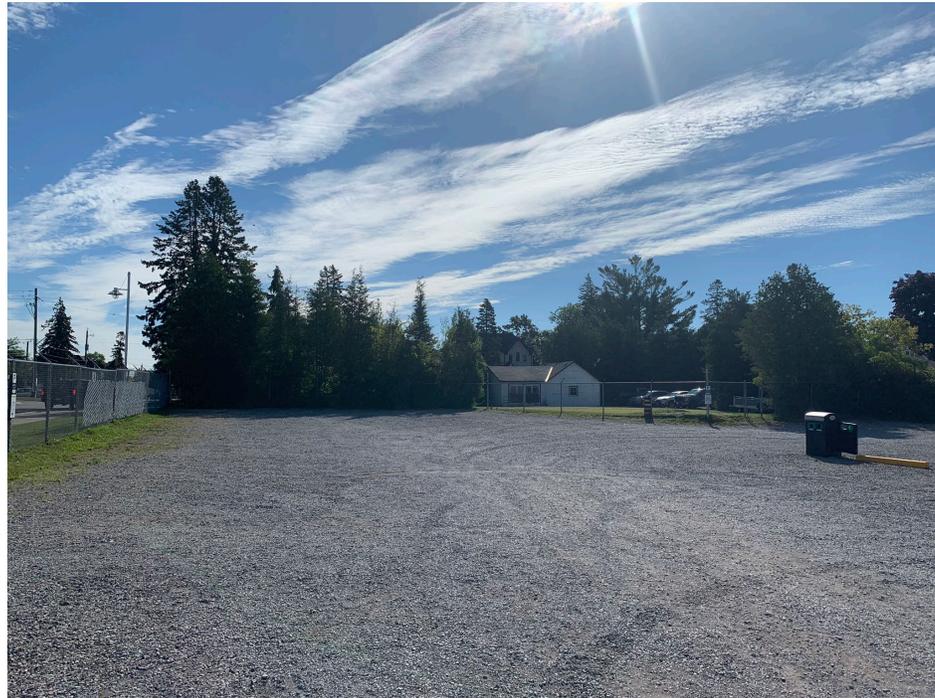
**Client:** Liverpool Limited Partnership**Site Location:** 1280, 1288, 1290, 1292, 1294 Wharf Street and 607 Annland Street, Pickering, Ontario, Canada**Project No:** CT3414.01**Photo No:** 21**Date:** August 10, 2022**Viewing Direction:**  
East**Description:**

View of the parking lot north and east of the Site.
