# **Ganatsekiagon Creek Parcel 24 Erosion Threshold Analysis**

**TACCGATE Parcel 24 Whitevale East  
Pickering, Ontario**

Submitted:  
**August 7, 2025**

GEO Morphix Project No. 24118

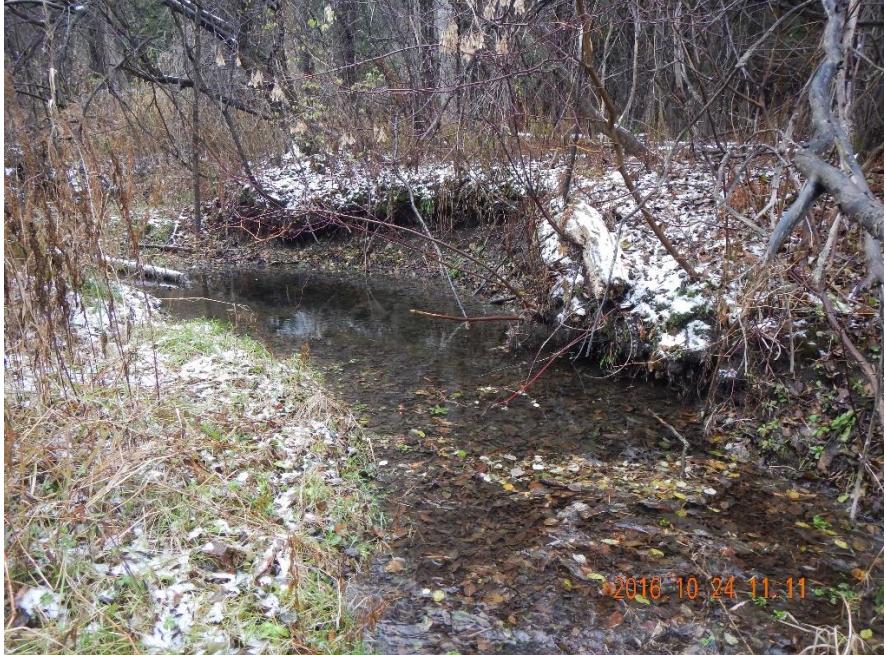
<p><b>Photo 13</b> Seaton Parcel 24, TACC Developments, Pickering, Ontario <b>Reach GB2</b></p>

<p>2016 10 24 11 10</p> <p>Photo taken facing upstream. Undercutting was prevalent within <b>Reach GB2</b>, observed along 60-100% of the banks. Bank angles were steep along the outside of meander bends.</p>

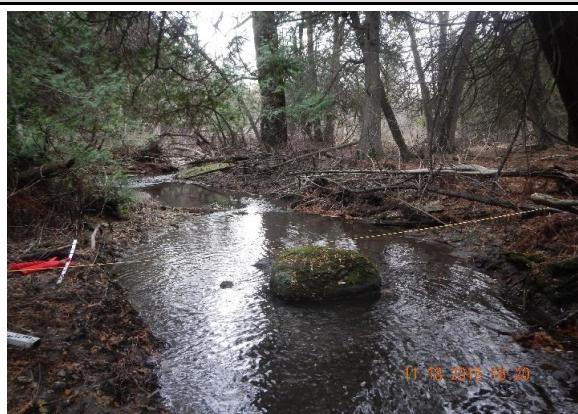
Photograph at cross-section 3 (looking downstream)

This sinuous reach lies along the main branch of Ganatsekiagon creek, within a forested valley surrounded by agricultural land. Average bankfull width and depth were 4.59 m and 0.52 m, respectively. Geomorphic units were well developed and riffle to pool spacing averaged 29 m. Bank substrate was primarily silt and sand. Bank angles ranged from 20° to 90°. Riffle bed material consisted of sand to boulders. Pool bed material ranged from sand to boulders, with a higher percentage of sand. Particle sorting and sand/gravel bar formation was also observed. Erosion was observed on both banks with undercutting up to 0.45 m. Low to moderate woody debris was present within the channel.

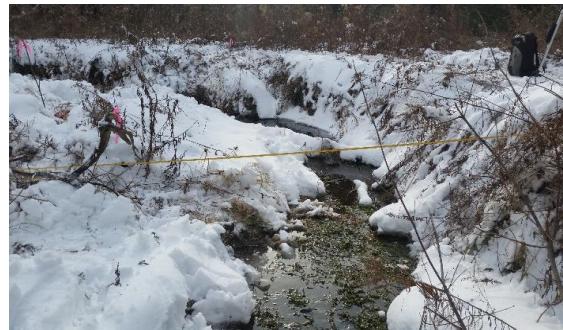
Photograph at cross section 4 (looking downstream)

This reach is meandering, has a low gradient and is within a partially confined valley. The riparian zone consisted primarily of cedar trees with no vegetative encroachment. Average bankfull width and depth were 4.02 m and 0.26 m, respectively. Bank material was primarily silt and sand, but ranged from clay to small cobble. Bank angles ranged from 30° to 90°. Erosion on both banks and undercuts of up to 0.30 m were observed. Riffle bed material consisted of gravel and cobbles. Pool bed material consisted of sand and gravel. High densities of woody debris were present within the channel and cutbank.
