June 11, 2025

Reference No. 2406-S114

**Re: Slope Stability Assessment  
For Proposed Residential Redevelopment  
1794 Appleview Road  
City of Pickering**

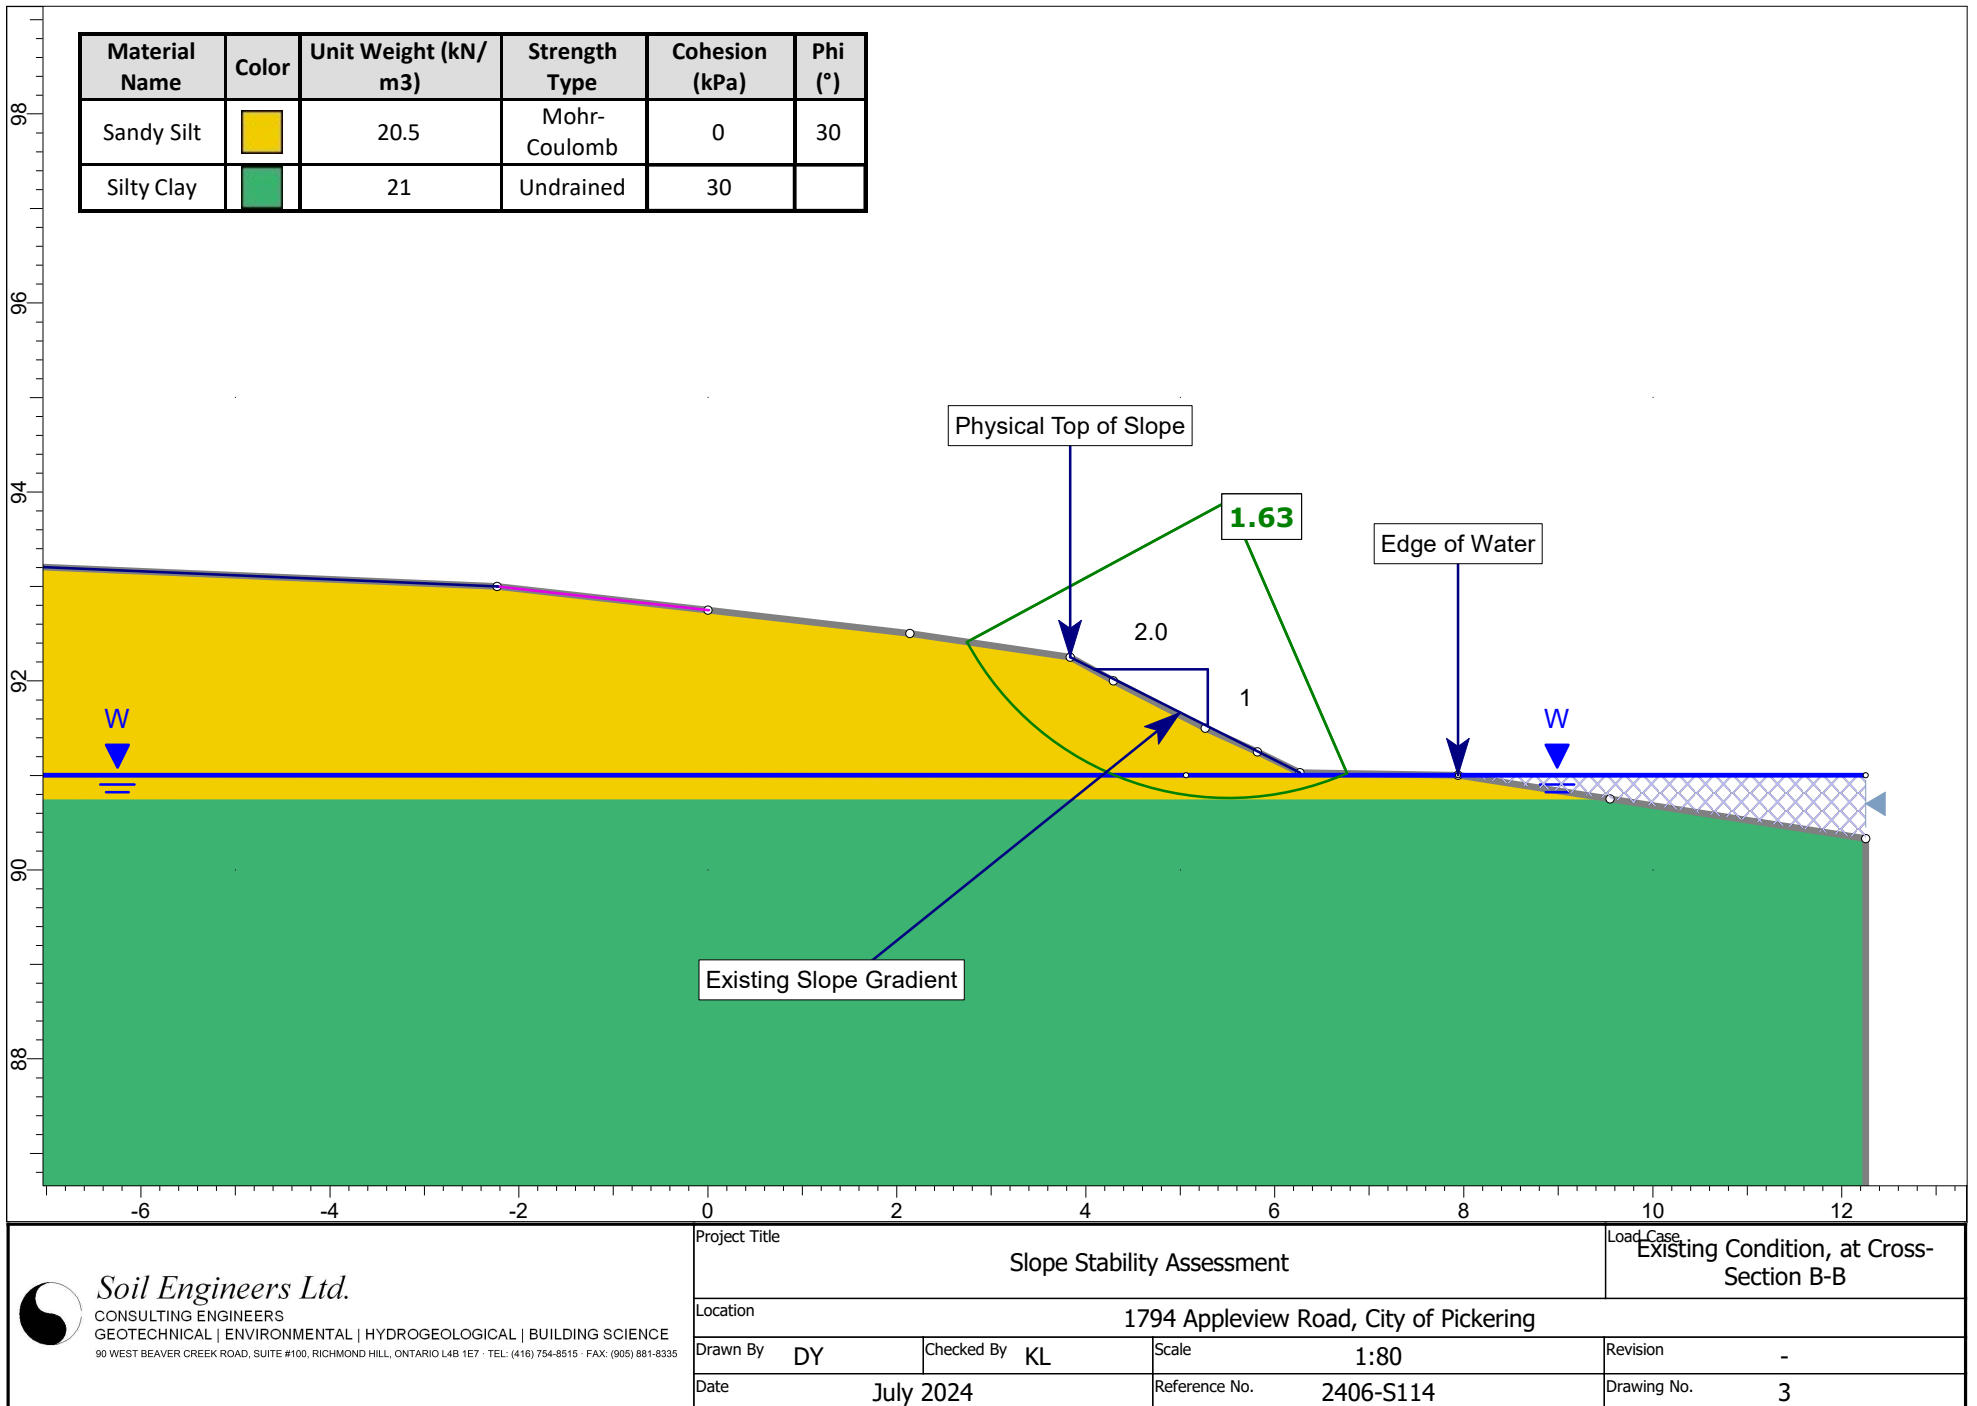
The result of the analysis at Cross-Sections A-A, under existing conditions, show that the minimum FOS is calculated to be 1.05, which fails to meet the Ontario Ministry of Natural Resources (MNR) guideline requirements for active land use (minimum FOS of 1.5), while Cross-Sections B-B and C-C yielded FOS above 1.50. The results of the analysis for the existing condition of the slope are presented on Drawing Nos. 2 to 4.
